(This Service Letter is FAA Approved)

SUBJECT: Oil Cooler Air Deflector  
MODELS AFFECTED: M20, Serial Numbers 1002 through 1200  
TIME OF COMPLIANCE: At Owner's Convenience

This Service Letter reidentified as  
Service Bulletin M 20-93  
per Service Instruction M20-15.

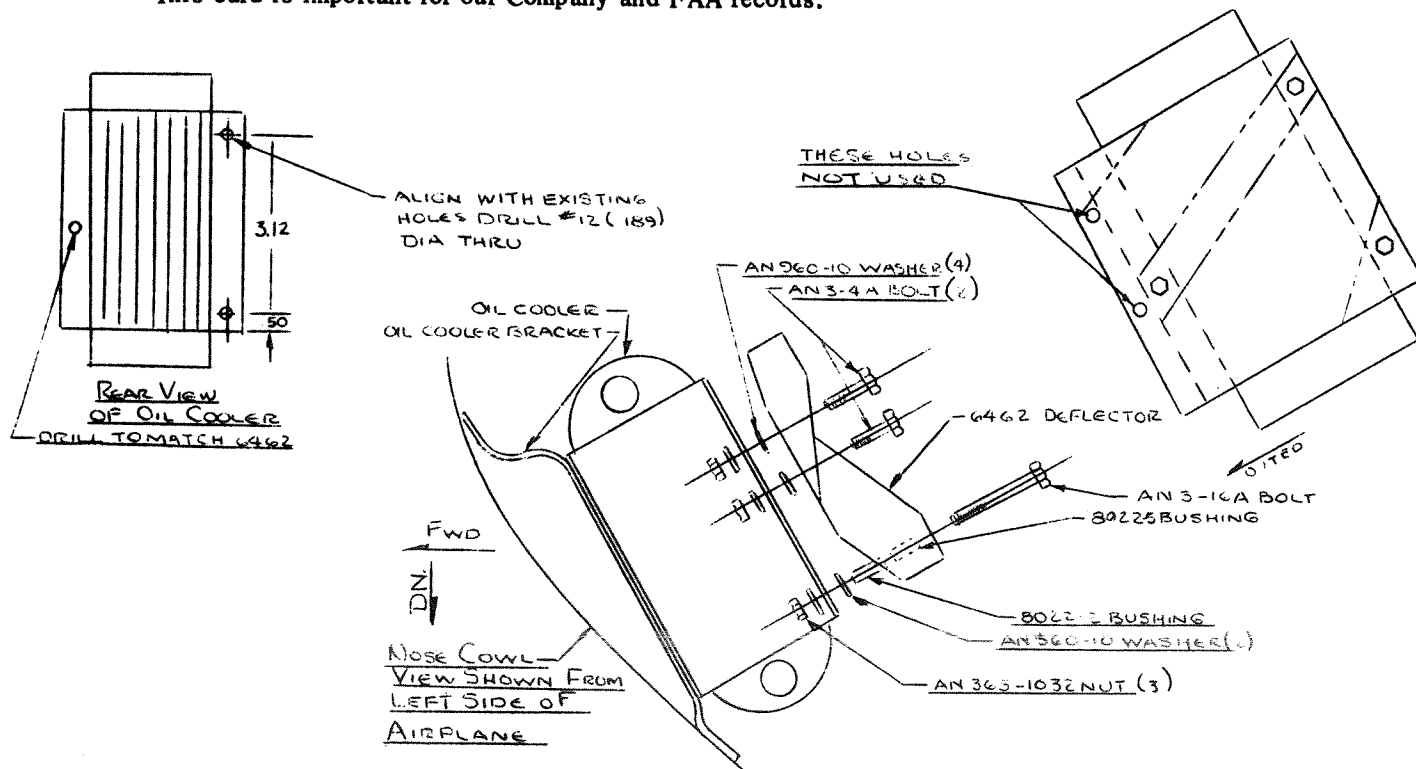
There have been some instances where the left front exhaust stack has cracked in the vicinity of the oil cooler air outlet. It is possible that a deflector, placed on the oil cooler outlet, would deflect cold air and moisture so it would not come in contact with the hot exhaust stack, thereby eliminating possible failures in this area.

It will be necessary to remove the left side cowl in order to take the oil cooler off. Completely remove the oil cooler by taking off four attach bolts and two oil hoses. Drill extra holes in oil cooler flange as called out in attached rework and installation diagram. Re-install oil cooler in reverse order of removal.
