SUBJECT: STORM WINDOW MOUNTING HARDWARE AND TORQUE VALUE

**MODELS/ SN
AFFECTED:** M20V ACCLAIM ULTRA 33-0002, 33-0003

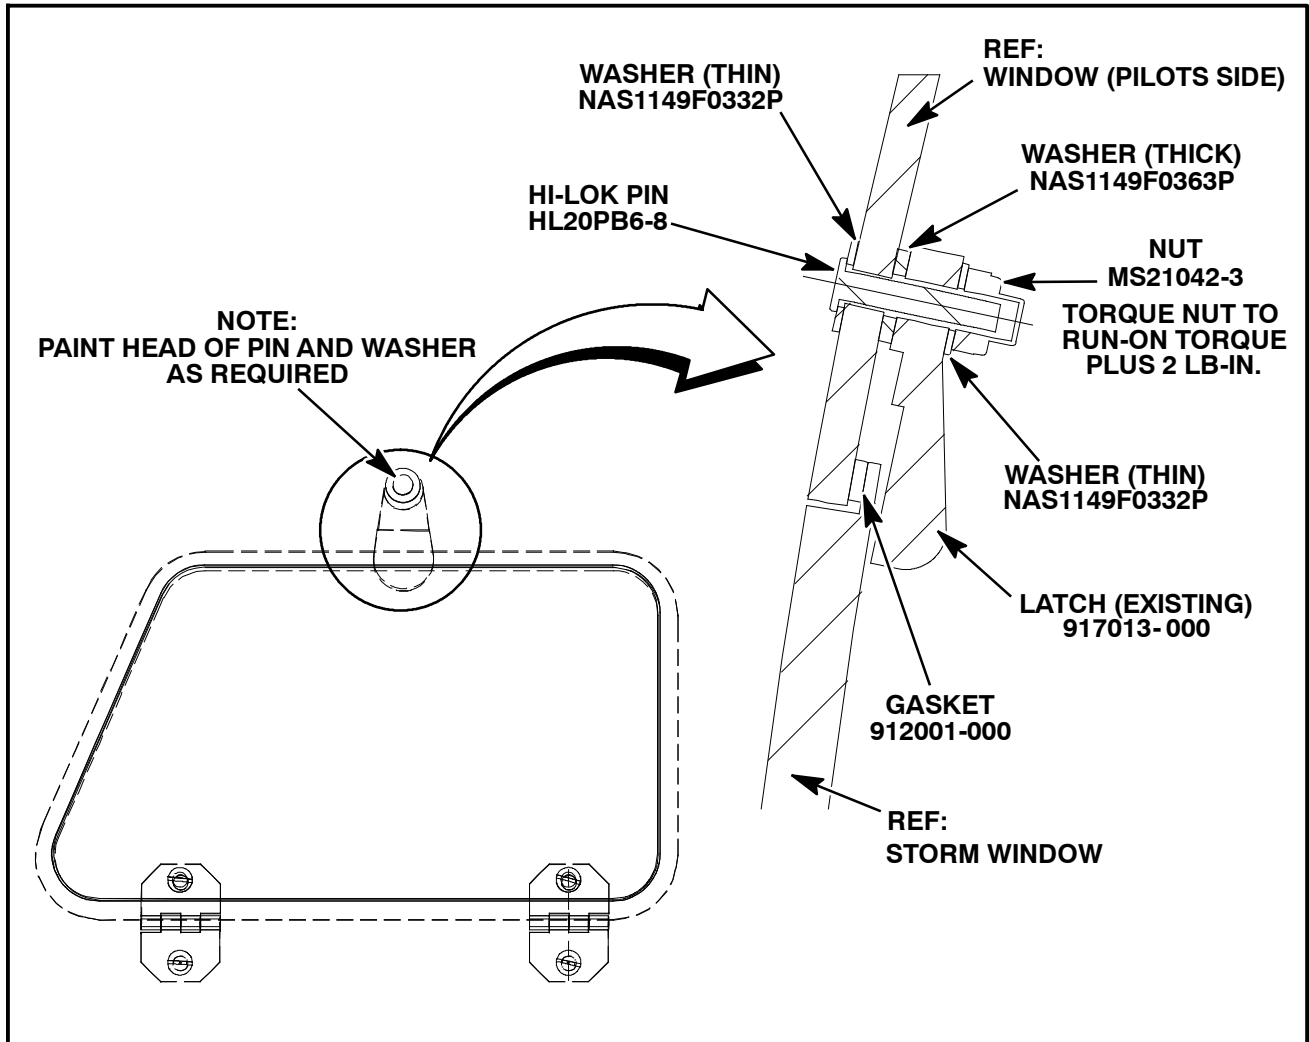
Figure SB M20-126-1 - STORM WINDOW MOUNTING HARDWARE AND TORQUE

INTRODUCTION: Mooney International Corporation has determined the necessity of a tamper-resistant fastener, for the storm window installation. This service instruction provides the procedure for adding fasteners to the Mooney aircraft listed above, with existing storm window installations.

- 1.1. Remove AN526-1032R12 screw, AN960-10 washer and 22K2-02 nut from the storm window latch assembly.
- 1.2. Install (1) Hi-Lok pin (HL20PB6-8 - Painted), (1) Washer (NAS1149F0332P) thru window and from inside aircraft, add (1) Washer (NAS1149F0363P), existing latch, (1) Washer (NAS1149F0332P) and (1) Nut (MS21042-3) (refer to Figure SB M20-126-1).
- 1.3. Torque nut to run-on torque + 2 LB-IN (refer to Figure SB M20-126-1)

Carefully Torque Nut to Run-On Torque + 2 LB-IN. Do not use isopropyl alcohol to clean plexiglass surfaces or attaching hardware. Clean per FAA AC 43.13-1B, paragraph 3-25.
