SUBJECT: GEAR WARNING CIRCUIT & THROTTLE SWITCH MODIFICATION

AFFECTED: MOONEY M20J, S/N 24-3201, 24-3218 THRU 24-3402  
MOONEY M20M, S/N 27-0001 THRU 27-0229  
MOONEY M20R, S/N 29-0001 THRU 29-0110

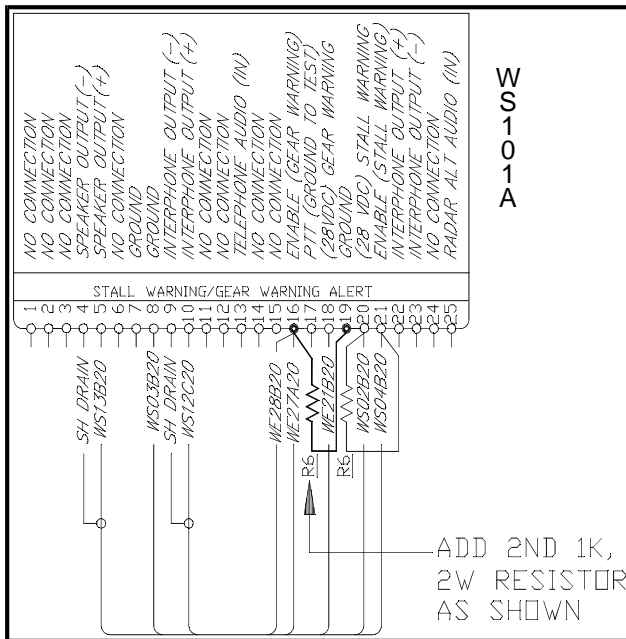
FIGURE SI M20-103-1

INTRODUCTION: OPERATIONS IN PRECIPITATION MAY CAUSE GEAR WARNING HORN TO ACTIVATE AT A REDUCED AUDIBLE SIGNAL WHILE AIRCRAFT IS IN LEVEL CRUISE FLIGHT. THIS CAN BE PREVENTED BY ADDING A SECOND RESISTOR TO THE WIRING CIRCUITS AND MODIFICATION OF SWITCH WIRE HARNESS PER INSTRUCTIONS BELOW.

3. Reference schematic shown in Figure SI M20-103-1 and solder the MIL-R-11-RC42, 1K 2W resistor, (Allen-Bradley P/N RC42-GF102J, included in kit) between the designated pins (16 - ENABLE-GEAR WARNING and 19 - GROUND). The resistor must be positioned so it will not interfere with the connection of the wire harness back to the Tone Generator. Protect resistor with heat shrink or other insulation.

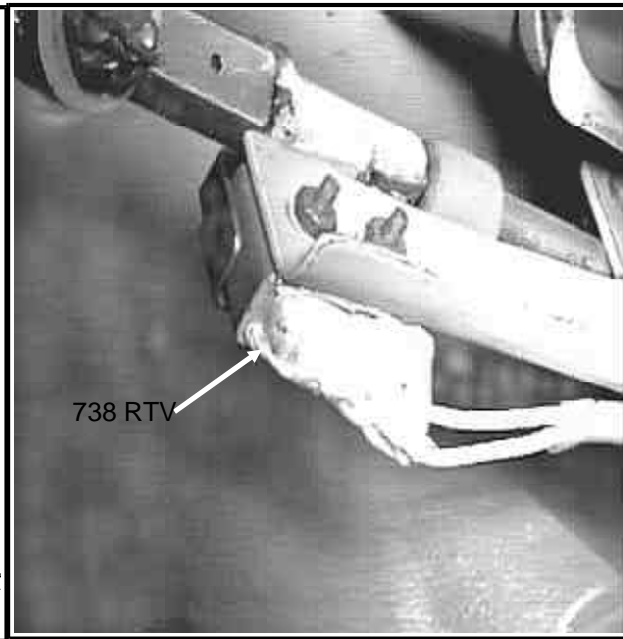
FIGURE SI M20-103-2

6. Inspect wire leads at switch for sealant covering wire/switch connection area. If sealant is found, verify integrity of sealant application over wire and switch connections.

7. If no sealant is found or integrity is compromised, apply Dow Corning 738 RTV Silastic Sealant, covering wire/switch connections completely. Switch is Micro Switch P/N 1SE1-T. Reference Figure SI M20-103-2.
