SERVICE INSTRUCTION M20-115

SUBJECT: TO ADVISE OWNERS OF PRECISION AIRMOTIVE LLC SERVICE BULLETIN NO. PRS-107 REV. 1 (ATTACHED)

Bulletin No.: PRS-107

SUBJECT: HEX PLUG 383493 COMING LOOSE FROM REGULATOR COVER

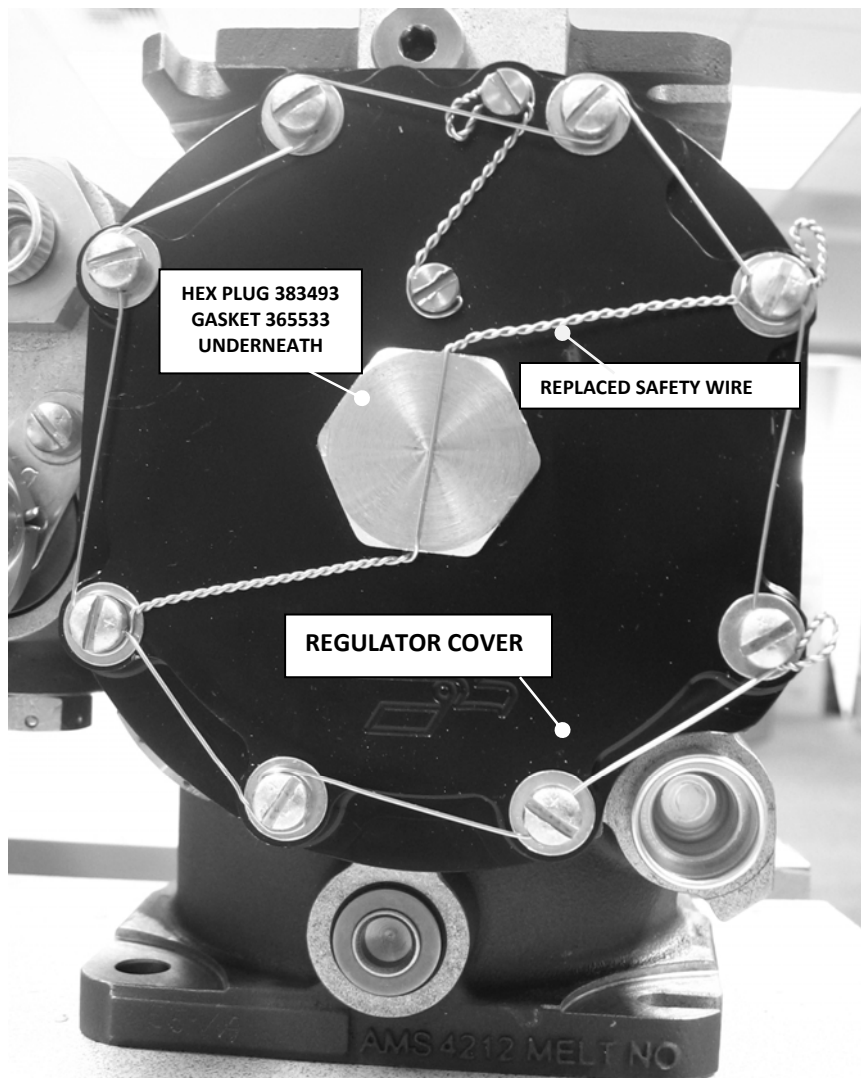
Note: Plug safety wire is wrapped around regulator screws under existing wire. It does not go through the holes in the screws.

7. The hex plug must be safety wired with .025 inch diameter wire to the regulator cover as shown in the figure below. The wire shall pass thru the plug such that it pulls the plug in the tightened direction and does not touch the corners of the hex on the plug.
