SERVICE INSTRUCTIONS #4

MOONEY AIRCRAFT, INC.

August 14, 1964

TO: MOONEY OWNERS
FROM: CUSTOMER SERVICE DEPARTMENT
SUBJECT: FLUSH AIRSCOOP LIP ATTACHMENT OPTIONAL EQUIPMENT

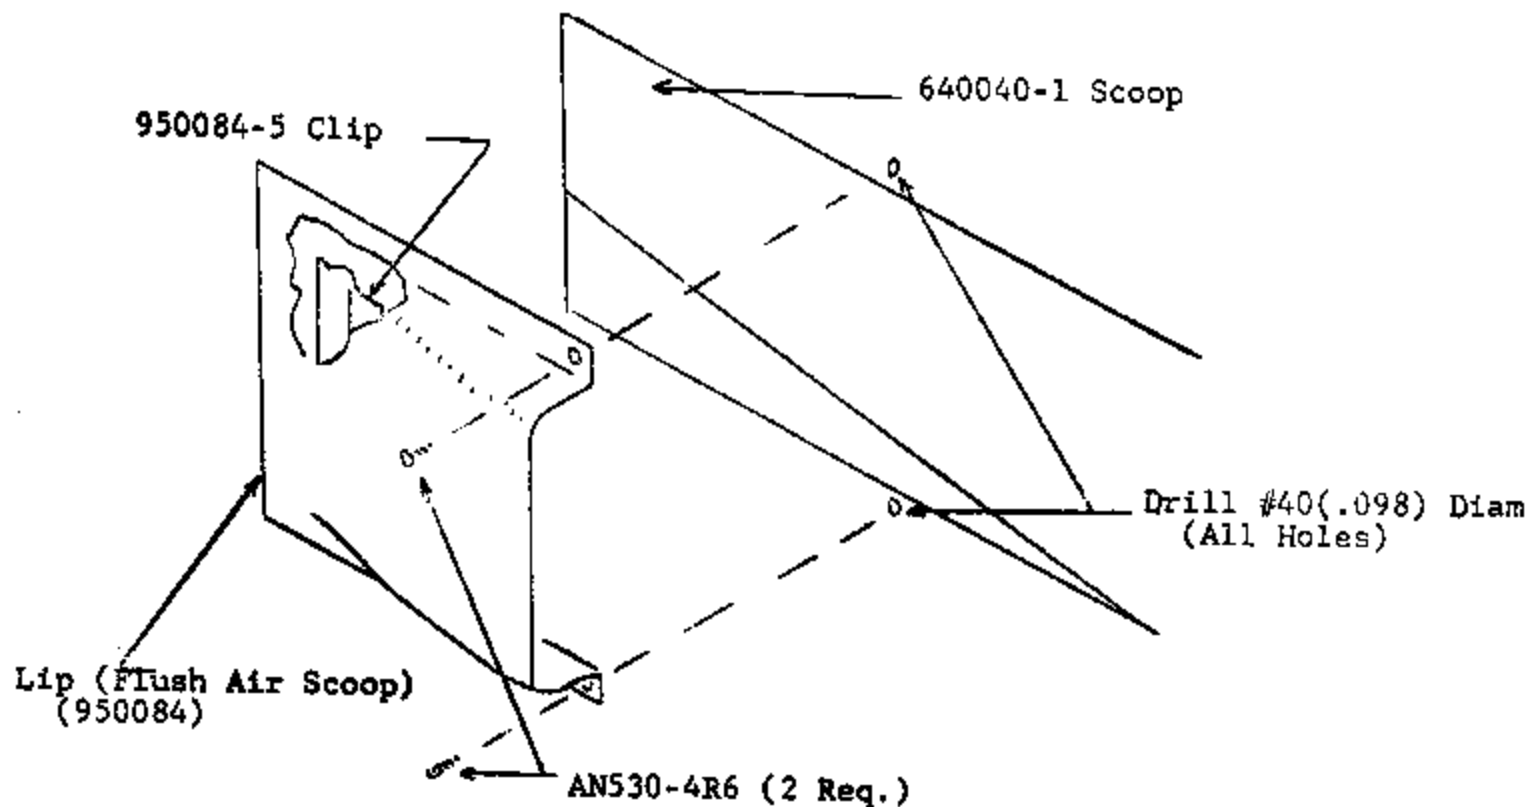
There have been reports of the flush air scoop lip blowing off in flight, and in at least one instance, causing slight damage to the stabilizer. To prevent this, the installation of this part has been modified to include two No. 4 sheet metal screws tapped through the Royalite and into the fuselage on the forward side of the lip flanges. This change is described on drawing 950084, change letter A. Aircraft in the field using these parts may have these screws added.
