S.I. M20-54  
DATE 1-19-81

**SUBJECT:** Installation of Cushioned Retainer Assemblies behind light bulbs.

Mooney Model M20K, S/N 25-0001 thru 25-0609.

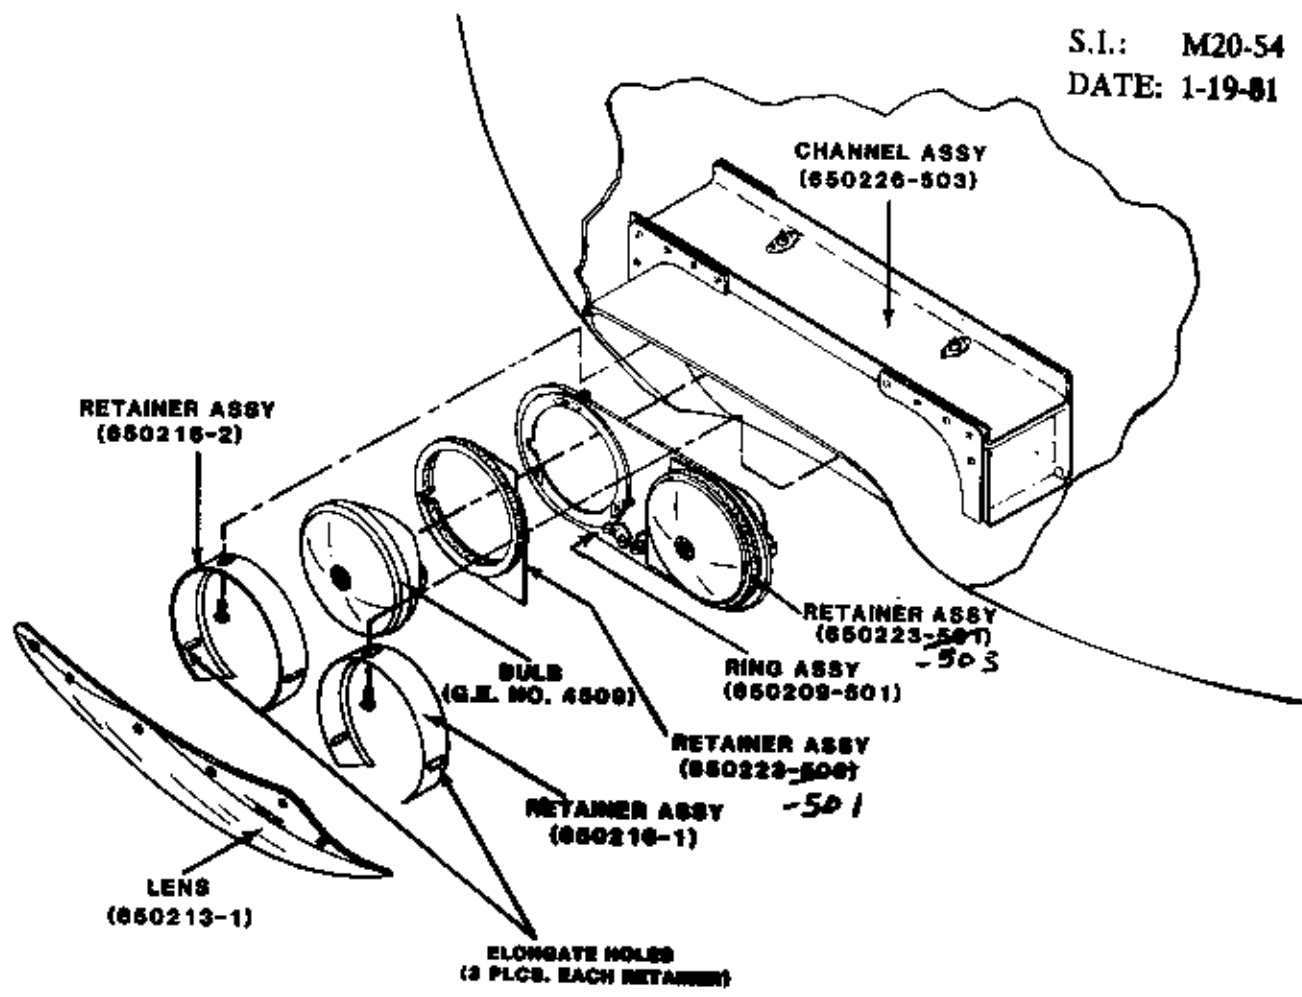
**FIGURE 1**

Reports from the field have indicated failure of landing light bulbs. In some cases the bulb is cracked causing the filament to be destroyed when landing light is turned on.

1. Remove the landing light lens P/N 650213-1 from the front of cowling.
2. Remove retainer rings, P/N 650216-1 & -2, from front of light bulbs. Retain for rework and reinstallation later. (Ref. Figure 1)

3. Pull light bulbs out from mounting brackets and disconnect electrical wires.
4. Place new retainer assemblies, P/N 650223-501 and -503, cushion side toward bulb, in place against ring assy, P/N 650209-501. (Ref. Figure 1). Trim edges to fit inside landing detent in cowling if necessary.
