NUMBER: M20-60

**SUBJECT: TELEDYNE CONTINENTAL MOTORS (TCM) AIR REFERENCE TUBE REPLACEMENT ON TS10-360GB ENGINES.**

M82-7

**SUBJECT:** TUBE ASSEMBLY (Air Reference Tube)

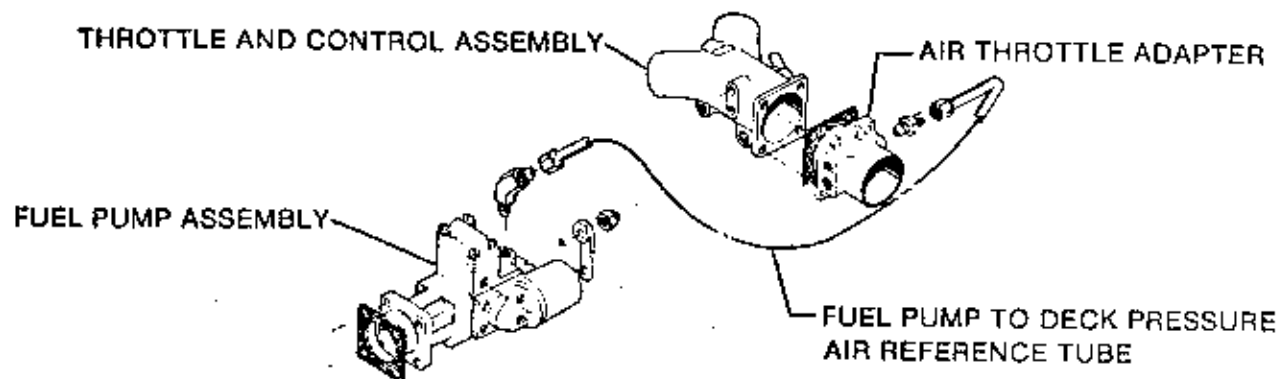
FIGURE 1

Teledyne Continental Motors has received reports of fractures in the air reference tube, P/N 641082, on engines installed between the air throttle adapter and the fuel pump in Mooney 231 aircraft. See Figure 1.

Since any bending of this preformed tube can cause damage which can result in a fracture, it is extremely important that the tube not be bent from its original configuration.

Teledyne Continental Motors recommends that within the next 50 hours or next scheduled maintenance, whichever occurs first, the air reference tube, P/N 641082, on engines installed in affected Mooney 231 aircraft be visually inspected for any cracking, crazing or deformity from its preformed configuration and that any tube having any such discrepancy be replaced with P/N 646114.
