SERVICE INSTRUCTION #7

MOONEY AIRCRAFT, INC.

January 26, 1965

TO: DISTRIBUTORS - DEALERS - SERVICE CENTERS
FROM: Customer Service Department
SUBJECT: Installation of Mooney "P.C." Servos,
Especially Aileron Servo (Brittain P/N 2980)

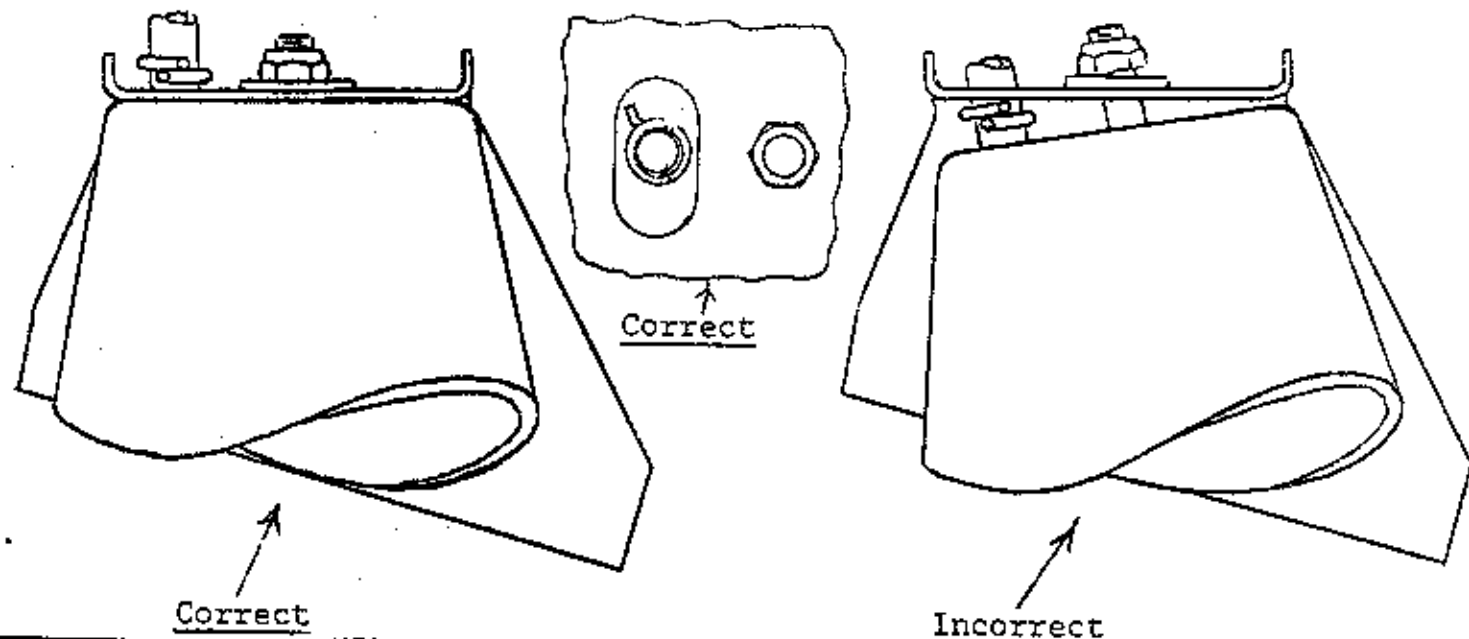
When removing any or all servo assemblies for compliance of the Brittain Service Bulletin 004, care should be exercised in the re-installation of these servos so as not to have the A6 Corbin clamp interfere with the seating of these servos with their respective bracket. This Corbin clamp should be installed on the line outlet before inserting the servo unit into the respective bracket. Be sure the clamp is positioned vertically in a manner to clear the oblong hole provided. After the nut is torqued to secure the servo tightly to bracket, a visual inspection by mirror should be done to be assured the proper position of this clamp. The below views shows the right and wrong methods of installation as well as hardware call-out and spacing. Failure to comply with this instruction could cause unnecessary binding of aileron due to mis-alignment of this servo unit.
