SERVICE INSTRUCTION M20-80
DATE 8-15-87

SUBJECT: TS10-360-GB, -LB & -MB ENGINES - TURBO-CHARGER CHECK VALVE CLAMPS INSPECTION.

M87-14

SUBJECT: TURBOCHARGER CHECK VALVE CLAMPS

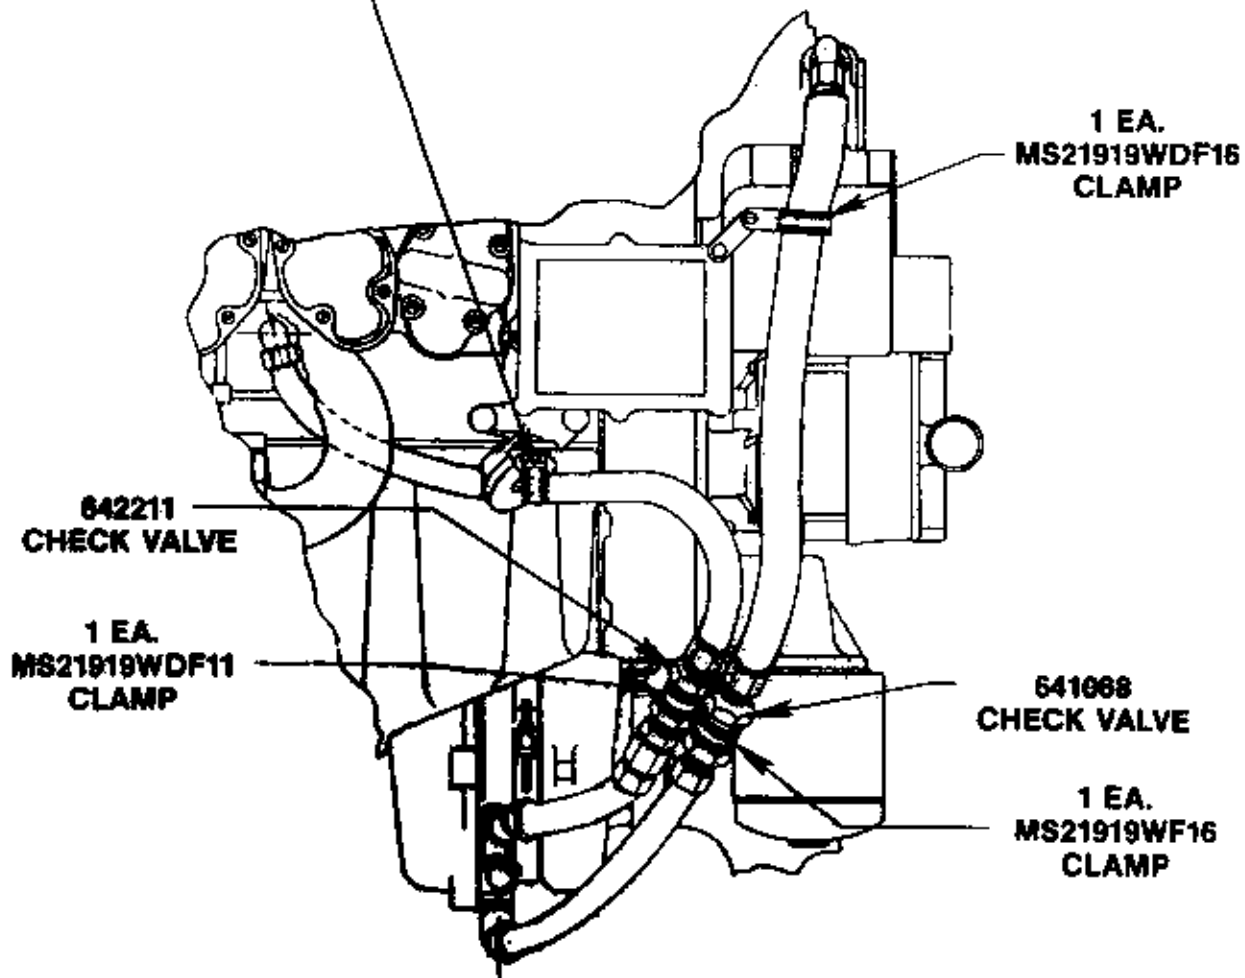
FIGURE 1

The clamp retaining the check valves and hoses on the above mentioned engines have, in some cases, exhibited premature deterioration of the rubber which then allows the metal band of the clamp to chafe directly on the hose or check valve as the case may be. If not corrected this chafing could wear through the check valve or hose and cause oil exhaustion and subsequent engine failure.

The new clamp part numbers are shown in Figure 1. (A total of three clamps.) These new clamps incorporate a cushion that is yellow in color; the clamps being replaced have a cushion that is black in color.

NOTE: This clamp does not require change.

It is, therefore, required that these clamps be replaced with the current part number clamp. Inspect the check valves and hose for evidence of chafing. If present, the valve(s) or hose must also be replaced.

Installation of these clamps and routing of the hoses must be done in such a manner as to avoid placing the check valves in a bind in the clamp as this could cause a similar wear pattern.
