SERVICE INSTRUCTION M20-83

FEBRUARY 20, 1988

- SUBJECT:** MOONEY ALTERNATE AIR DOOR MAGNETIC LATCH MODIFICATION
- MODELS/S/N EFFECTIVITY:** MOONEY MODEL M20K, S/N 25-0781 THRU 25-1151, 25-1153 THRU 25-1157, 25-1159 THRU 25-1161 AND ANY M20K AIRCRAFT, S/N 25-0001 THRU 25-0780, WHICH HAVE RETROFIT KIT 940029 (S.I. M20-71) INSTALLED.

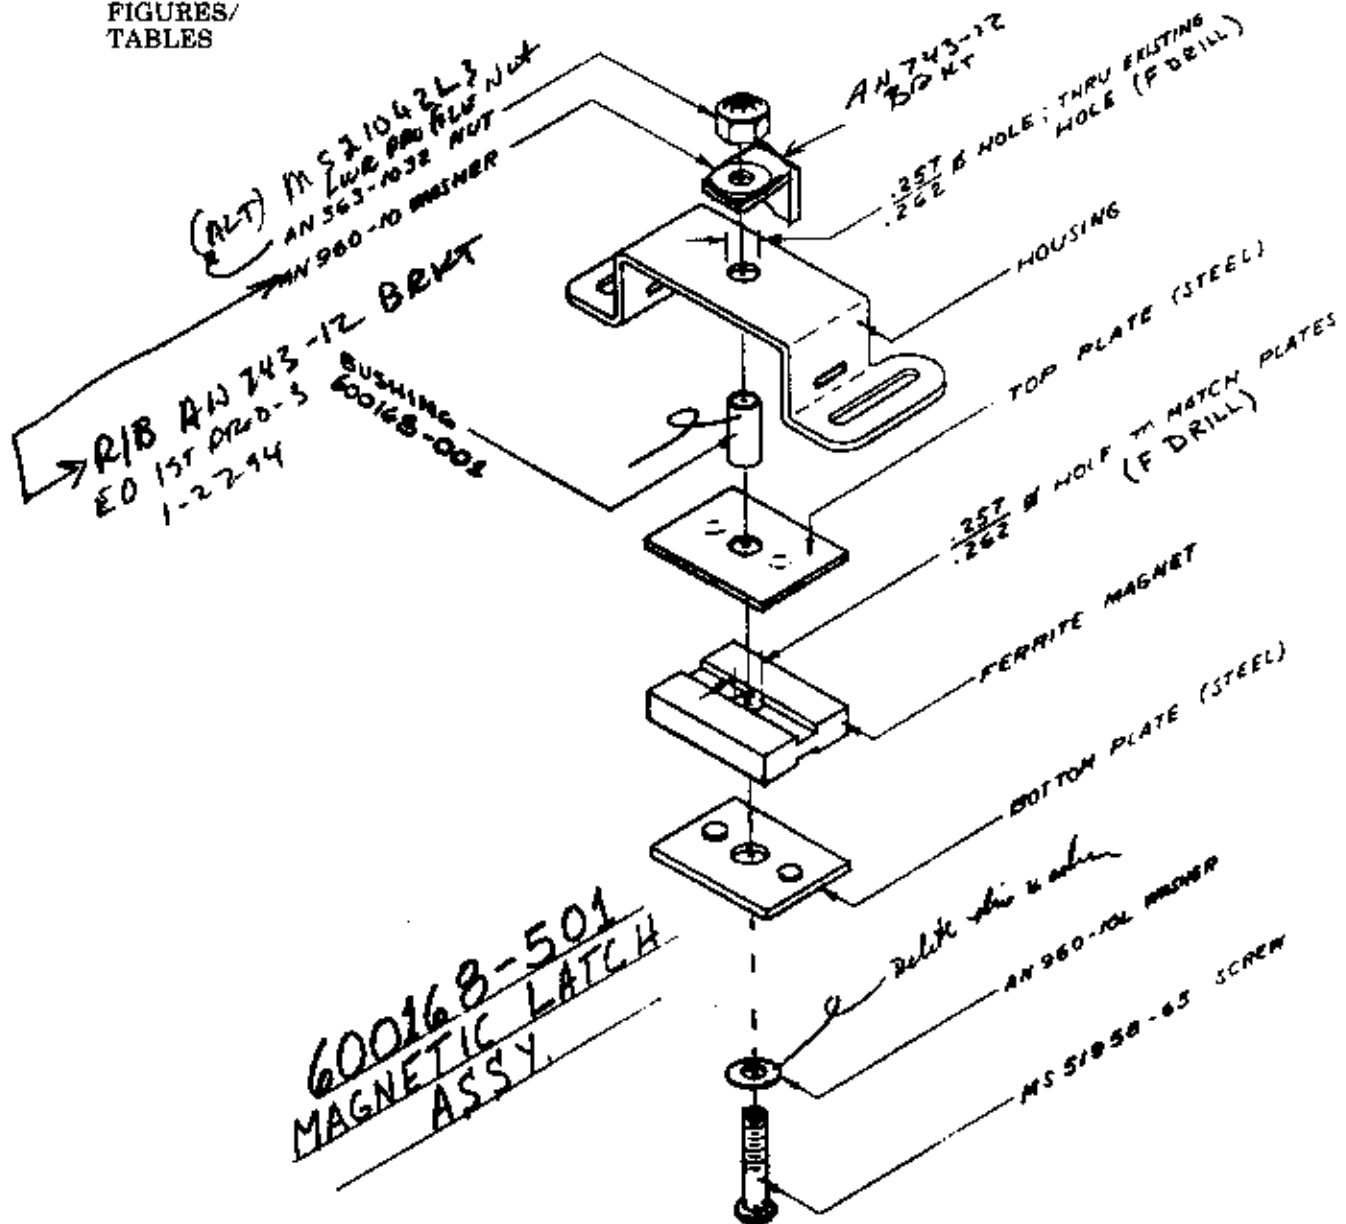
FIGURE M20-83-1

- INTRODUCTION:** The safety wire holding components of the magnetic latch assembly together have been found broken and pieces of the magnetic latch assembly have been injected into the turbo-charger causing impeller blades to be damaged. This may reduce the available power of the engine at high power settings or at high altitude.

- INSTRUCTIONS:** Remove top and bottom cowling per Service and Maintenance Manual, Section 71.
- PART I**
1. Remove magnetic latch assembly from alternate air housing assembly by removing 1 screw from each side of the magnetic latch mounting flanges (2 screws).

2. Ensure that the manual alternate air door control is in the closed position and door is closed against housing.
 3. Install modified magnetic latch assembly to Alternate Air Assembly using original screws (2 ea.). Do not tighten screws until the magnetic latch assembly is in full contact with the Alternate Air Door in the closed position.

4. When assured that Alternate Air Door is FULLY closed and magnetic latch is in full contact with the door, tighten the two mounting screws to secure magnetic latch to Alternate Air Assembly.
