SUBJECT: FUEL TANK FILLER CAP AND ADAPTER ASSEMBLY, MODIFICATION TO REMOVE O'RING FROM LOWER SEALING FLANGE

MODEL/S/N AFFECTED: Mooney M20K, S/N 25-0001 THRU 25-1213

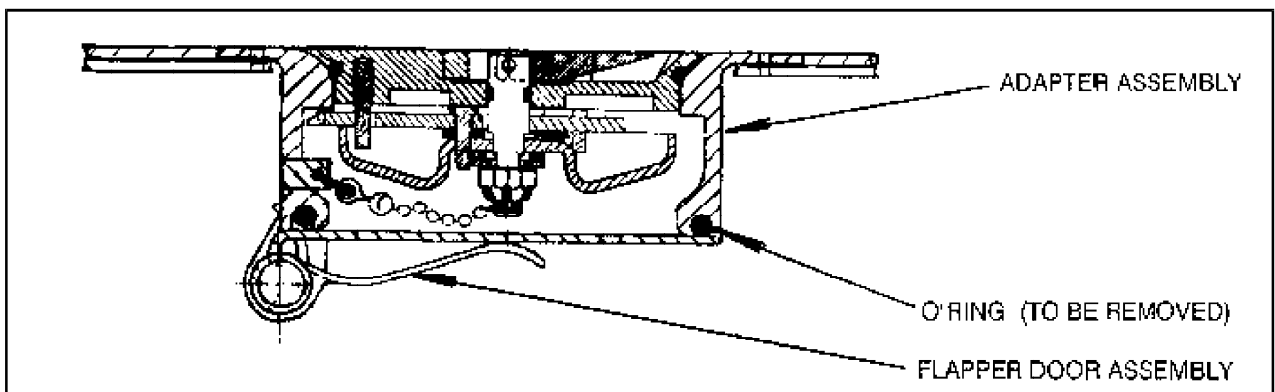
FIGURE SI M20-84-1

INTRODUCTION: Field reports have been received of aircraft landing after flights at high altitude where fuel tank caps are very difficult to remove for refueling purposes. This is suspected to be caused by vacuum forming between the filler cap and the flapper door assembly in the fuel cap adapter assembly.

To eliminate this condition, it is authorized to remove the O'ring from the lower sealing surface of the adapter assembly if desired.

1. This procedure should not be attempted when fuel tanks are more than 3/4 full.
2. Remove fuel tank filler cap assembly; leave attached to lanyard.
3. Push flapper door assembly down and wedge it in the open position with any suitable non-metallic item. Place restraint on wedge used so that it can be recovered if dropped inside tank.
4. Using a sharp, curved pick, ie., dental tool, or similar device remove O'ring that is installed in a groove on the bottom surface of the adapter assembly (Refer to Figure SIM20-84-1).
BE CAREFUL THAT THE REMOVED O'RING DOES NOT FALL DOWN INTO THE FUEL TANK.
5. Repeat steps 1. through 4. on other tank.
6. Re-install fuel filler cap assembly on both tanks
7. Enter compliance data into aircraft logbook and return aircraft to service.
