SUBJECT: Rear engine baffle assembly, P/N 600411-501, modification.

AFFECTED: MOONEY M20K, (Mooney 252),* S/N 25-1000 thru 25-1217
* (Only dual alternator equipped aircraft are affected.)

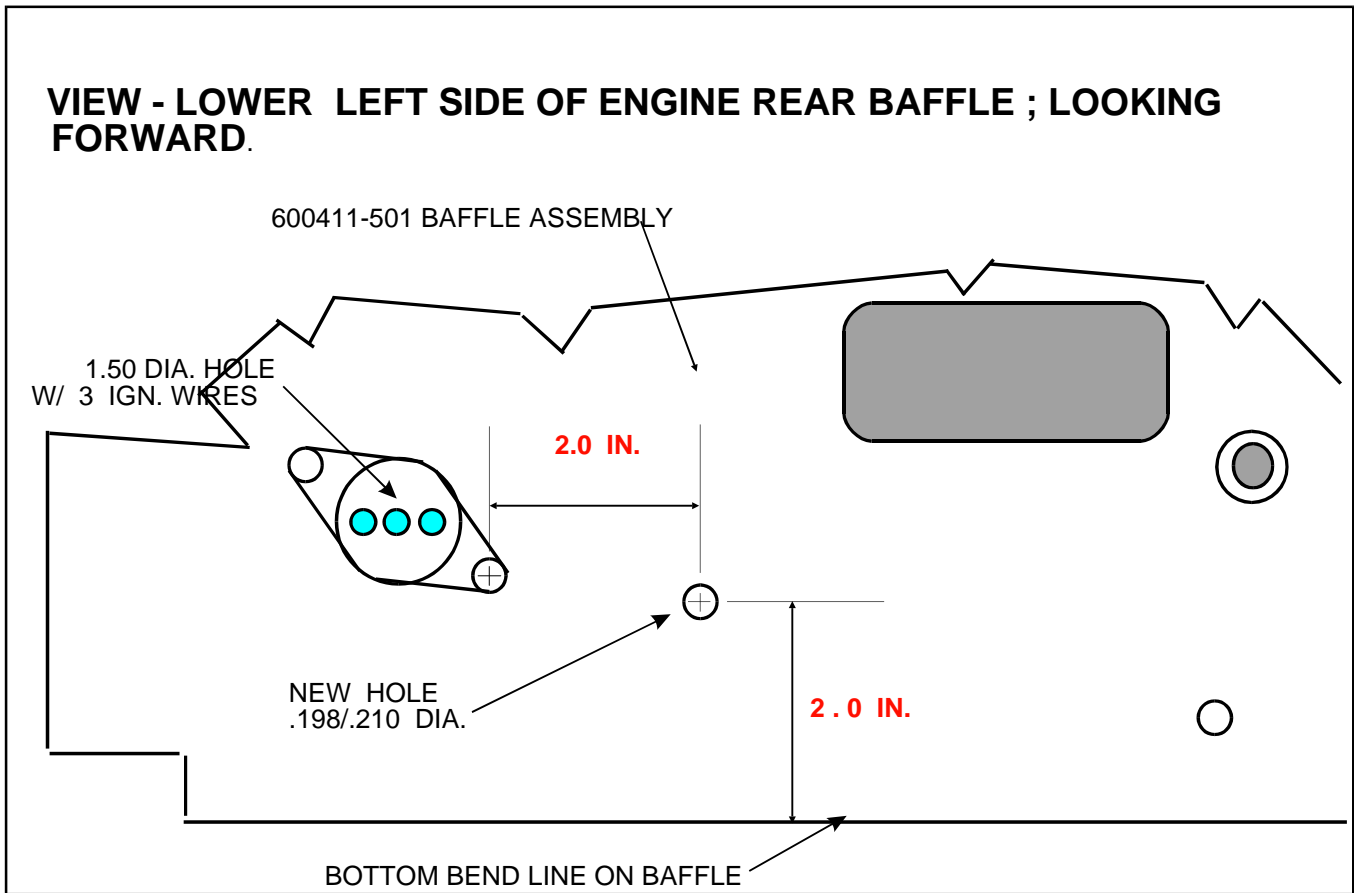
FIGURE 1

INTRODUCTION: There have been reports of the alternator output wire connector breaking at the terminal of the No. 2 alternator on MOONEY 252, TSIO360-MB1, engine installations. This is dependent upon how tight the No. 2 alternator output wire may be secured at various points. If desired, aircraft owners may elect to have this S I incorporated on any of the above S/N aircraft.

1. Remove upper cowling (lower cowling removal is optional) per S & M manual, Section 71-10-00.
2. Refer to Figure 1 to locate and drill the new hole (.198/.210 dia.) to be added to 600411-501 baffle assembly. New hole location does not have to be exactly to the dimensions shown on Figure 1. Deburr hole as needed.
3. Alternator output wire is routed along left diagonal engine mount w/existing clamps. Leave sufficient slack to allow coordinated movement between the alternator, baffle and the wire.
4. Clamp alternator output wire at new hole in rear engine baffle using MS21919DG5 clamp, AN3-5A, AN960-10 and MS21045-L3, bolt, washers and nut.
5. Check wire routing to insure freedom of movement with engine.
6. Enter compliance note into logbook and return aircraft to service.
