# 3cm Landfill Liner Breach Detected with Accurate As-Builts, Drone Data Visualization

May 2019

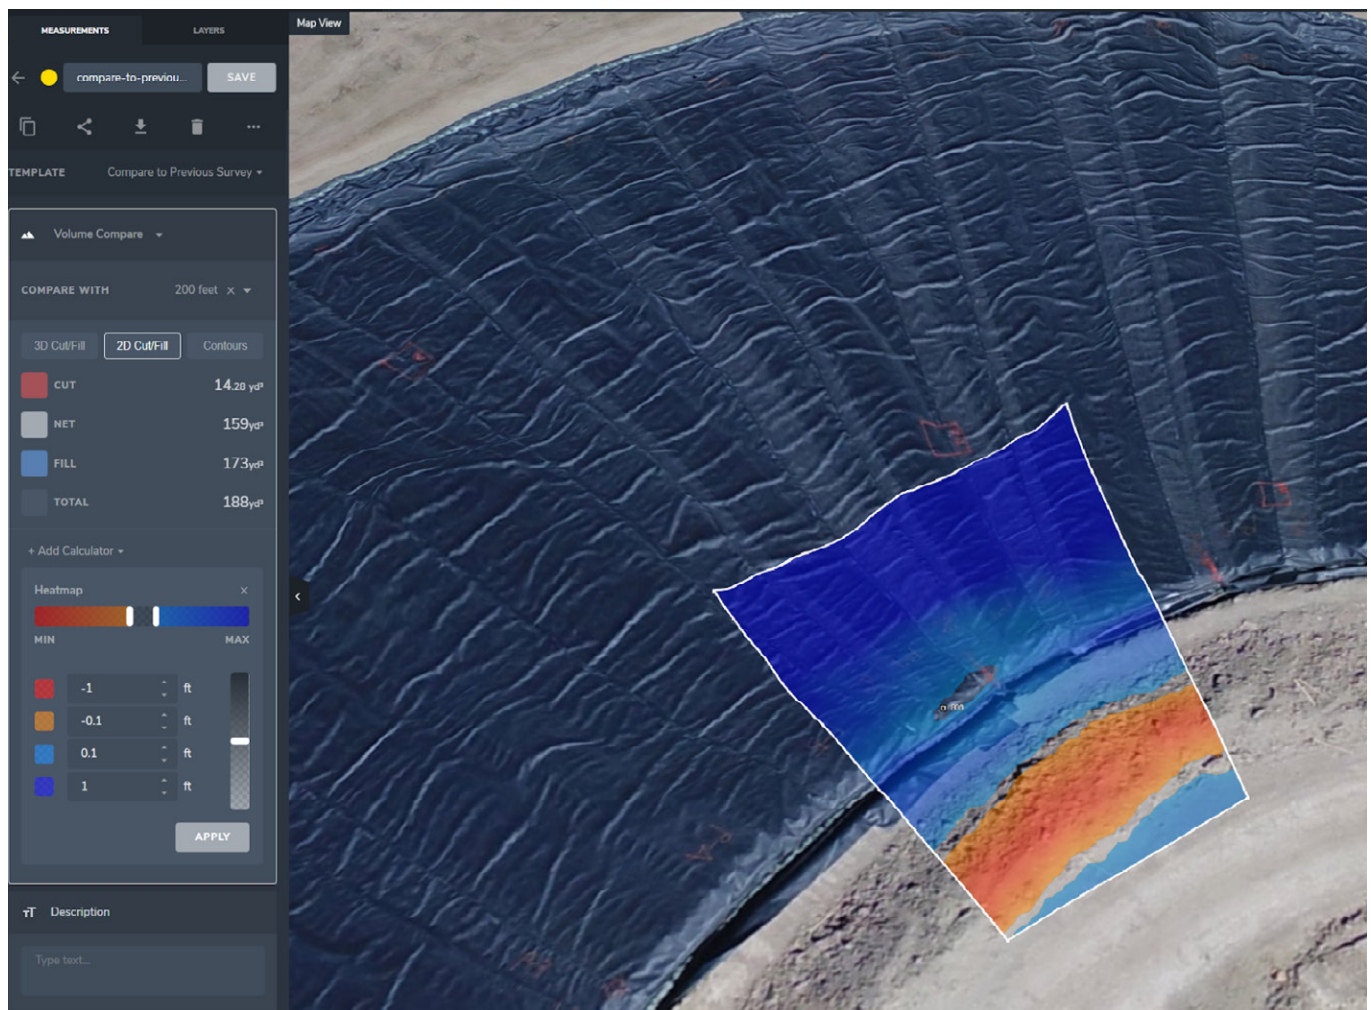
The landfill's surveyor had flown the site with a drone when the liner was exposed a couple of months earlier. As such, they had aerials showing the exact spot where the machine had been when this possible breach had occurred.

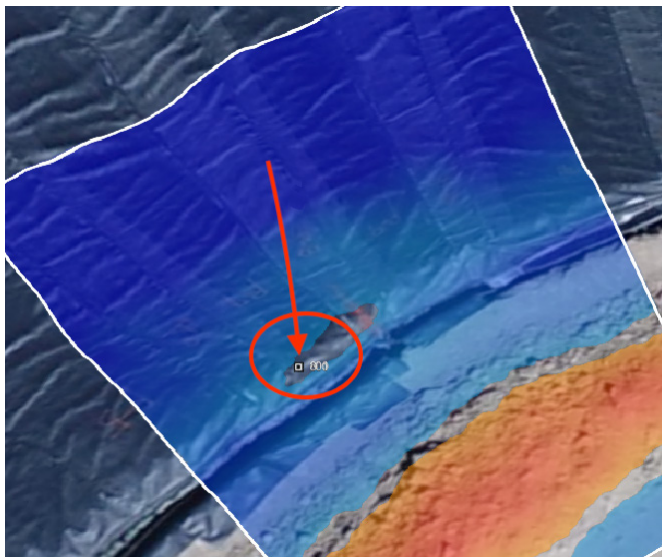
Once notified about this issue, the surveyor took a shot at the suspected location with their rover. With the as-built surface from the earlier survey loaded into the rover, this surveyor was able to tell instantly if a breach had occurred.

From there, they created a KML point from that shot and loaded into the [Propeller Platform](#) to visually see where that point sat (pictured above). After this confirmation, the site was again surveyed by drone.

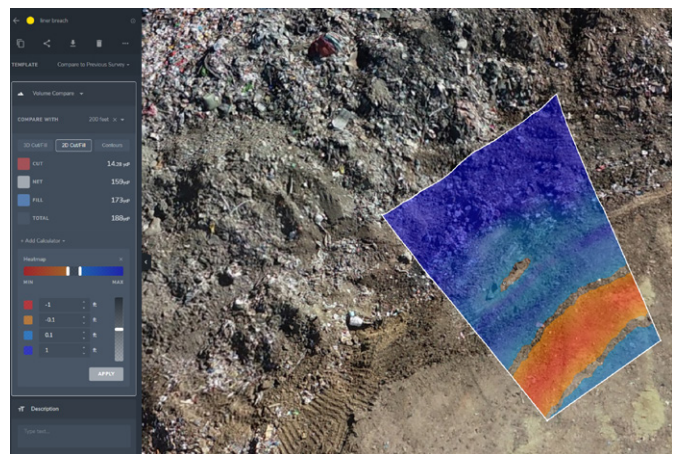
Now the landfill had an accurate as-built surface and a recent surface of the site after the excavator had moved material. Taking these two flights, you can simply draw a polygon around the area of interest and see the recent flight relative to the flights a couple months ago.

The difference at the point in question? 1/10ft (3cm). Meaning they detected that the excavator did breach the liner, even by such a small amount.

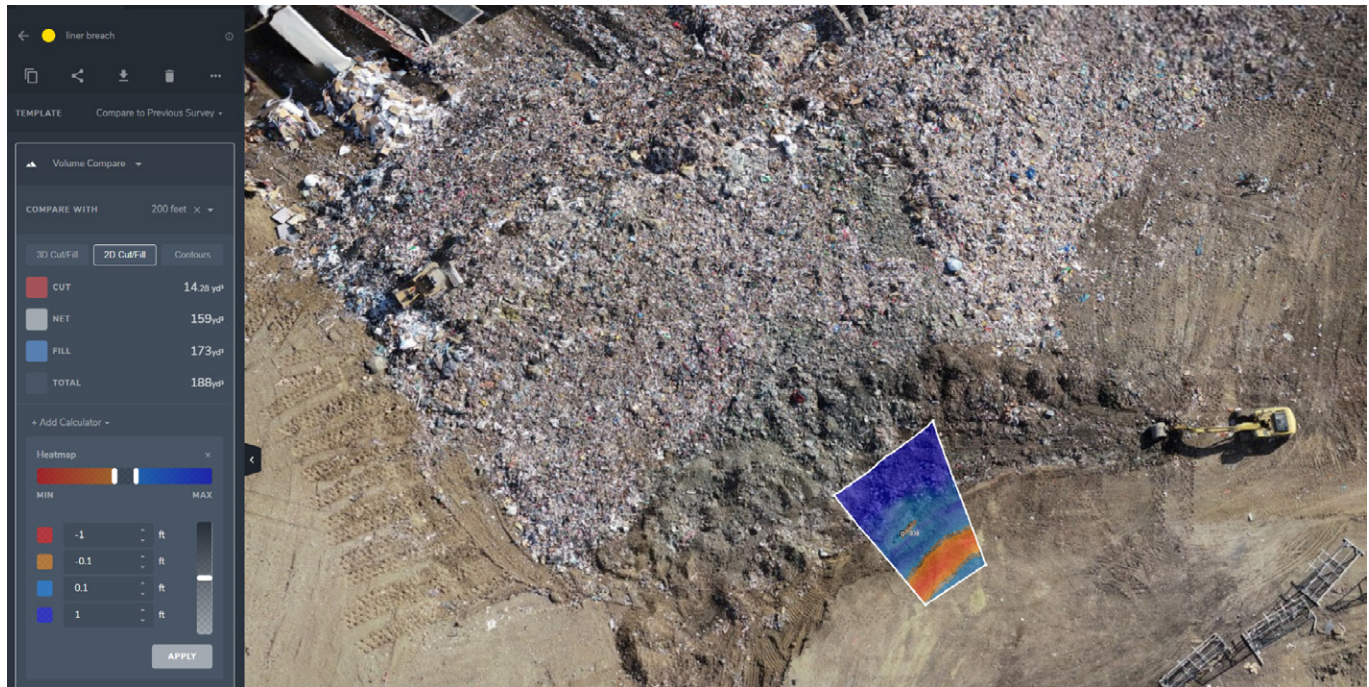
“We could see that they hit really close to the anchor trench. Knowing this gave us a good understanding of the magnitude of the repair effort required,” said the landfill's surveyor who confirmed the breach.

As far as corrective measures go, the landfill was able to call the contractor back in to repair the liner they'd installed. “They understood exactly where the break was, as it was fully visible with the drone data and imagery, so when they called the contractors to fix it, they could show them precisely where it was,” said the landfill's surveyor.
