Project Case Study - Mission Critical Data Center

Project Type: Mission Critical Data Center
Location: Missouri, USA
Sprinkler Systems: 100,000 sq. ft. facility
 5 Galvanized Preaction Systems
 Multiple Leaks on Mains
Nitrogen Introduced: 1st quarter of 2011
Results: No Reported Leaks in 7 Years

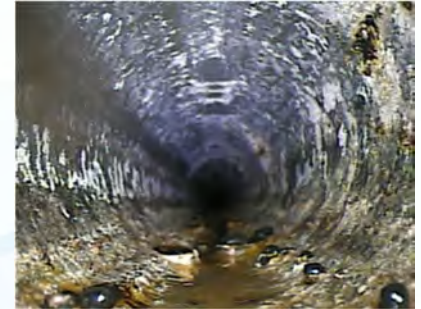
Corroded Galvanized Main

The 100,000 square foot data center was originally built and opened in 2002 with double interlock preaction fire sprinkler systems to protect the data halls. Galvanized steel piping was used for all of the preaction fire sprinkler systems. After 8 years of service leaks began to develop in the 3" galvanized schedule 10 main piping. All of the leaks occurred within the main line piping under accumulations of trapped water. The metal loss was characterized by highly localized attack with many deep singular round bottomed pits beneath the trapped pools of water.

- No pipe replacement was performed
- Installation of ECS Nitrogen Generator (PGEN-20)
- Performed DPNI on all 5 preaction fire sprinkler systems using ECS nitrogen inerting protocol for dry pipe fire sprinkler systems

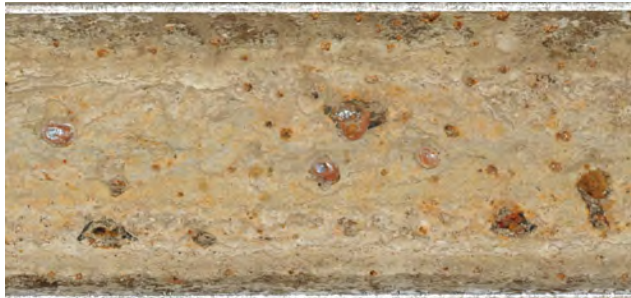
Zinc Oxide and Iron Oxide Deposits on Bottom of Main

The oxidation reaction of galvanized steel pipe and oxygen produces zinc oxide and iron oxide deposits. Once the protective zinc layer has been breached, oxygen corrosion is liberating iron atoms from the underlying black steel substrate resulting in highly localized corrosion and resultant failures.

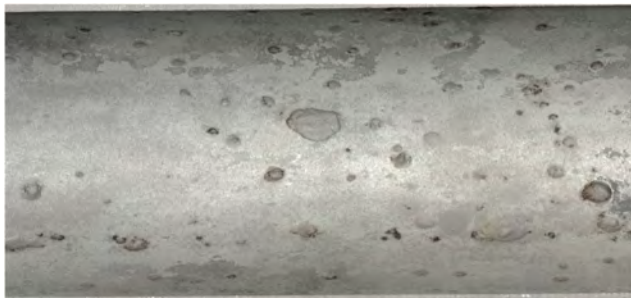
Under Deposit Accelerated Oxygen Corrosion

A corrosion assessment survey was performed in July 2010 to determine the extent of damage within the fire sprinkler piping. The video scoping results indicated that there was extensive damage due to oxygen corrosion within the schedule 10 mains at any location that acted to trap water, which was present throughout much of the mains. The schedule 40 galvanized branch lines exhibited minor corrosion and contained only minor amounts of trapped water. Analysis of pipe samples extracted from the system mains revealed oxygen corrosion pitting resulting in wall penetrations of up to 62.5%.

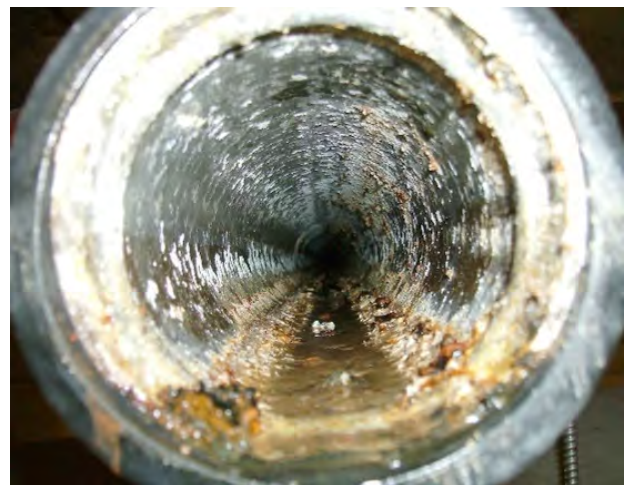
Corroded Galvanized Main with Trapped Water

Despite the significant damage found during the assessment, no fire sprinkler system piping was replaced within the facility prior to the installation of the ECS nitrogen generation system. Under a nitrogen atmosphere the corrosion in the fire sprinkler system piping would be stopped, even in locations with trapped pools of water. Since repair of initial leaks and installation of the ECS PGEN-20 nitrogen generator there have been no recorded additional leaks within the preaction fire sprinkler systems in the facility.
