### Project Case Study - Arizona Home Improvement Center

**Project Type:** “Big Box” Home Improvement Store  
**Location:** Arizona, USA  
**Sprinkler Systems:** 100,000 sq. ft. of coverage area, 5 wet pipe risers, average size 1,500 gallons  
**Nitrogen Introduced:** March, 2011

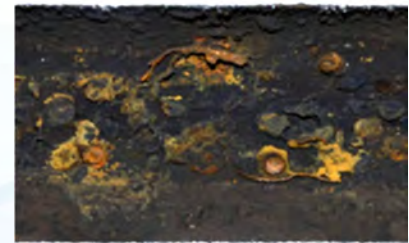
Corroded Branch Line

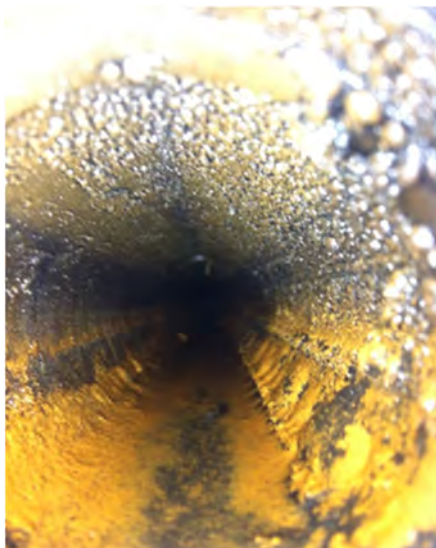
Corrosion from Trapped Air

The profile determined that the root cause for corrosion within the systems was oxygen attack of the black steel piping. The majority of the damaged piping was found at the air/water interface adjacent to trapped pockets of air within the piping at the front of the building. Because of the system design, there were areas within the fire sprinkler piping network which trapped large amounts of air after filling the systems with water.

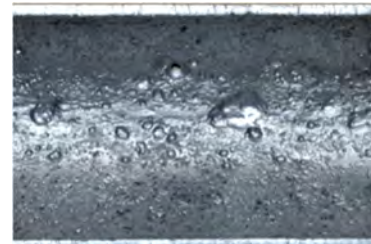
Under Deposit Oxygen Corrosion

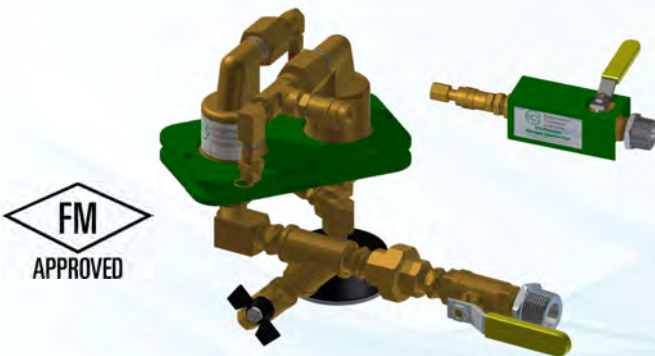
ECS Nitrogen Inerting Vent

- Install ECS Protector Nitrogen Inerting Vents on each of the wet pipe zones
- Install ECS Protector Nitrogen Injection Ports on each of the wet pipe risers
- Perform nitrogen inerting of the fire sprinkler systems using the ECS nitrogen inerting protocol for wet pipe fire sprinkler systems
- Use the nitrogen cylinders to supply the necessary nitrogen gas for the inerting procedure on the fire sprinkler systems

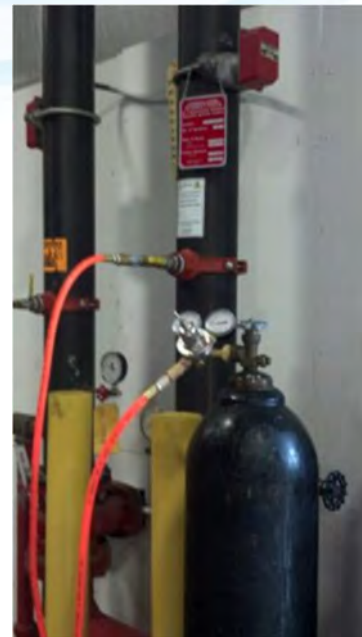
Pressurized cylinders provide nitrogen gas through injection ports at risers
