### Project Case Study - California Mission Critical Manufacturing

**Project Type:** Aerospace Manufacturer  
**Location:** California, USA  
**Sprinkler Systems:** 1 million sq. ft. of coverage area, 25 wet pipe risers, average size 1,500 gallons  
**Nitrogen Introduced:** October, 2010

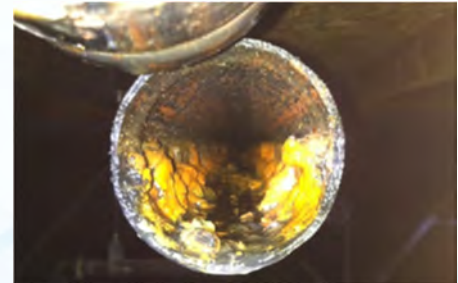
Corrosion from Trapped Air

The assessment study determined that the root cause for corrosion within the systems was oxygen attack of the black steel piping. The majority of the damaged piping was found at the air/water interface adjacent to trapped pockets of air within the piping. The large main risers above the control valve were also damaged due to oxygen corrosion. Although bacteria were found throughout the fire sprinkler system, they were determined to be very minor contributors to the corrosion related leaks. Because of the system design, there were areas within the fire sprinkler piping network which trapped large amounts of air after filling the systems with water. Much of the fire sprinkler mains contained large amounts of corrosion by-product (iron oxide-hematite) solids.

1. Flush the fire sprinkler mains from the far end of each of the fire sprinkler zones to remove trapped solids from the piping
2. Install ECS Protector Nitrogen Inerting Vents on each of the wet pipe zones
3. Install ECS Protector Nitrogen Injection Ports on each of the wet pipe risers
4. Perform nitrogen inerting of the fire sprinkler systems using the ECS nitrogen inerting protocol for wet pipe fire sprinkler systems
