Project Case Study - Illinois Distribution Center

| Project Type: | Large Distribution Center |
| Location: | Illinois, USA |

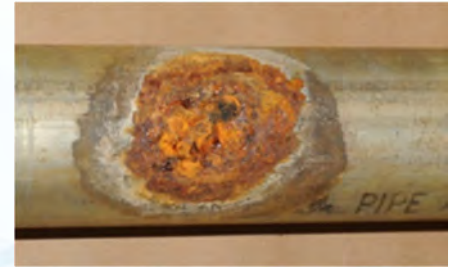
Exterior of Branch Line Leak

- Leaks occurring in branch lines at apex of building on the branch lines
- Leaks occurring on the top side of the mains at the mechanical tee connection for the branch lines
- Content damage risk due to fire sprinkler water leak
- \$25,000 cumulative repair expenses

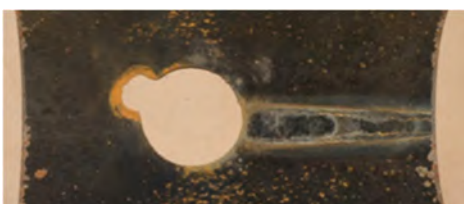
Air Trapped at Top of Main

The assessment study determined the root cause for corrosion within the systems was oxygen attack of the black steel piping. The majority of the damaged piping was found at the air/water interface adjacent to trapped pockets of air at high points at the apex of the building. The mains also showed corrosion at the base of the mechanical tee at the riser nipple. Although bacteria were found within the fire sprinkler system, they were determined to be very minor contributors to the corrosion related leaks. Much of the fire sprinkler mains contained accumulations of corrosion by-product (iron oxide-hematite) solids.

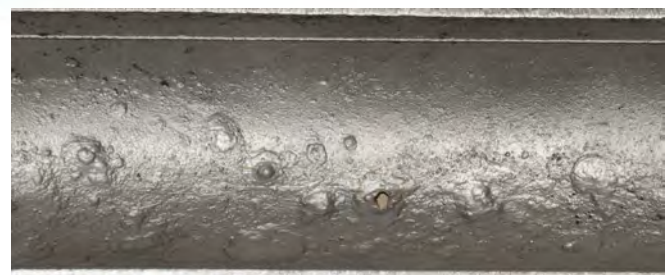
Corrosion on Bottom of Branch Line

- Perform limited pipe replacement of the 2" branch lines on either side of the roof apex, approximately 50 linear feet per zone
- Install ECS Protector Nitrogen Inerting Vents on each of the wet pipe zones
- Install ECS Protector Nitrogen Injection Ports on each of the wet pipe risers
- Perform nitrogen inerting of the fire sprinkler systems using the ECS nitrogen inerting protocol for wet pipe fire sprinkler systems
- Use nitrogen cylinders to supply the necessary nitrogen gas for the inerting procedure on the fire sprinkler systems

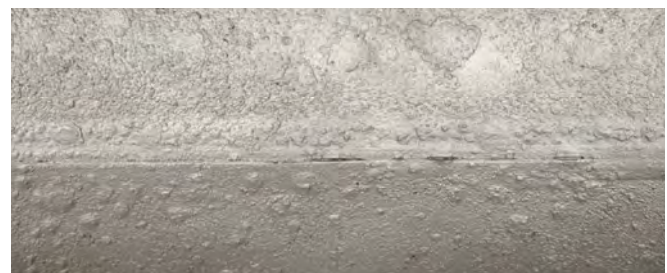
Corrosion on Bottom of Main

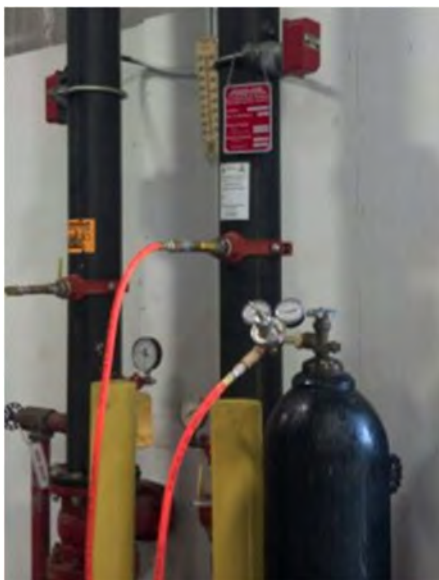
Pressurized
Cylinders
Provide
Nitrogen Gas
through
injection ports
at risers
