Project Case Study - Indiana Warehouse

Project Type:	Large Warehouse Facility
Location:	Indiana, USA
Sprinkler Systems:	12 Black Steel Wet Pipe Systems for 450,000 sq. ft. of Coverage
Nitrogen Introduced:	January, 2013
Results:	No Reported Leaks in 5 Years
Cost Savings:	Savings of \$810,000

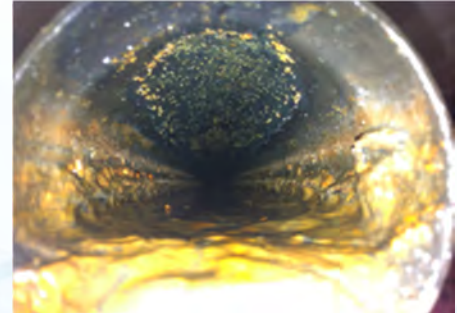
Tuberculation and resulting Iron Oxide Deposits

The assessment study determined that the root cause for corrosion within the systems was oxygen attack of the black steel piping. The majority of the damaged piping was found at the air/water interface adjacent to trapped pockets of air at the high points at the apex of the building. The mains contained no evidence of trapped air and were free of corrosion. Although bacteria were found within the fire sprinkler system, they were determined to be very minor contributors to the corrosion related leaks. Those sections of the branch lines that contained pockets of trapped air contained large amounts of iron oxide solids, which have led to under deposit corrosion resulting in pin-hole leaks.

- Perform limited pipe replacement of the 2" branch lines on either side of the roof apex, approximately 60 feet of pipe on each branch line
- Install ECS Protector Nitrogen Inerting Vents on each of the wet pipe zones
- Install ECS Protector Nitrogen Injection Ports on each of the wet pipe risers
- Perform nitrogen inerting of the fire sprinkler systems using the ECS nitrogen inerting protocol for wet pipe fire sprinkler systems
- Use nitrogen cylinders to supply the necessary nitrogen gas for the inerting procedure on the fire sprinkler systems
