Project Case Study - Mission Critical Data Center

Project Type:	Enterprise Data Center
Location:	Saint Louis, Missouri
Sprinkler Systems:	Five Double Interlock Pre-action Systems
Nitrogen Introduced:	July 2011

Project Case Study - Mission Critical Manufacturing Facility

Project Type: Large Aerospace Equipment Manufacturing Warehouse
Location: Los Angeles, California
Sprinkler Systems: 25 Wet Pipe Systems
Nitrogen Introduced: October 2010

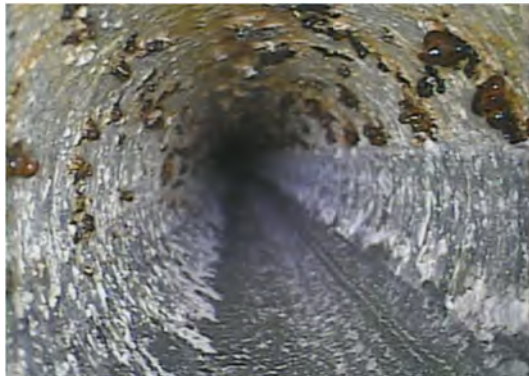
The 100,000 sq. ft. data center opened in 2002 with pre-action fire sprinkler systems used to protect all critical areas. After 8 years in service leaks began to develop in the 3-inch galvanized schedule 10 main piping within the facility. Multiple leaks per year were reports and all occurred within the supply main piping under accumulations of residual trapped water. Because of the age of the system, piping was not required to be pitched when installed so the system was filled with a significant volume of trapped water. The metal loss was characterized by highly localized attack with many deep pits beneath the trapped pools of water. The average corrosion pit depth from the pipe samples extracted from the facility was 45% wall penetration.

Galvanized Pipe Corrosion under Trapped Water

In 2011 the owner installed an ECS Protector Nitrogen Generation System that utilized patented “fill and purge” breathing technology to remove oxygen from the fire sprinkler piping and provide nitrogen gas for pressure maintenance. ECS has been retained to perform annual inspections of corrosion management equipment.

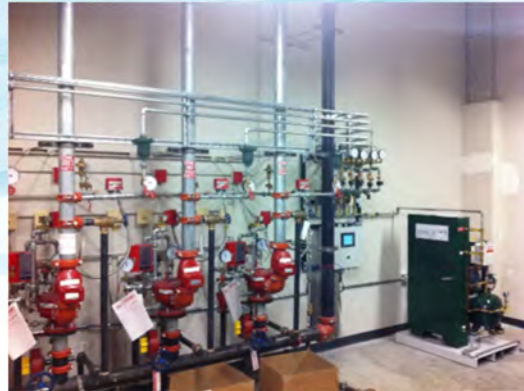
Nitrogen Generator installed in Riser Room

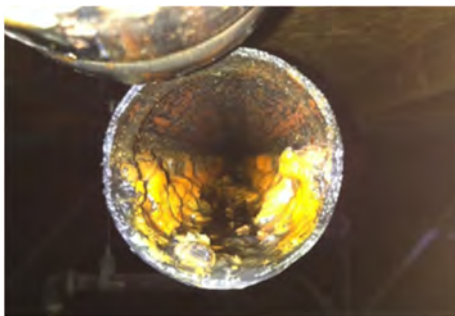
The one million sq. ft. building was built in the 1960's and protected by twenty-five overhead wet pipe sprinkler systems that had been renovated many times to accommodate changes to building operations. The building had a long history of leak repairs (one leak every 2 weeks) and some systems were completely replaced once leak frequency became untenable. The wet pipe systems were characterized by many elevation changes to accommodate protection of high bays, below finished ceiling office areas, and mezzanine areas. There was a tremendous amount of trapped air in each system. The majority of the damaged piping was found at the air/water interface adjacent to trapped pockets of air within the piping. Much of the fire sprinkler supply mains contained large amounts of corrosion by-product (iron oxide) solids from the black steel piping.

Corrosion at Air/Water Interface

Later that year the owner installed ECS Protector Nitrogen Inerting Vents and injection ports on each system to remove oxygen from the fire sprinkler piping. A portable nitrogen generator was used to supply nitrogen gas at the external riser of each fire sprinkler system. ECS has since provided assessment services and corrosion management equipment for several other buildings on the same campus.

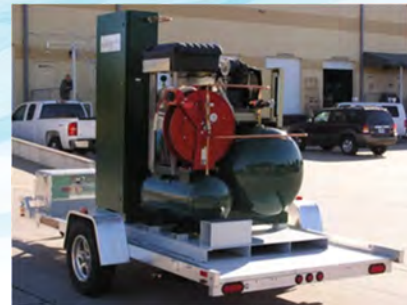
Portable Nitrogen Generator for Facility
