Rock Slope Remediation at the Penobscot Narrows Bridge

**Bryan C. Steinert, P.E., Laura Krusinski, P.E., Amber B. Granger, P.G., and
Wayne A. Chadbourne, P.E.**

Abstract

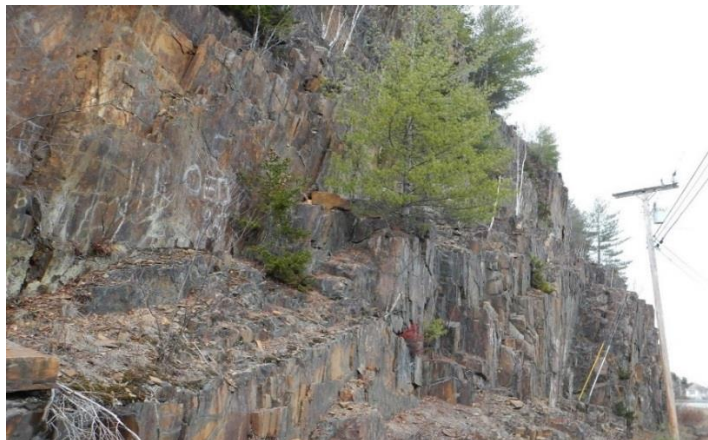
Figure 4 – Existing Rock Slope

The observed bedrock consists of hard, gray, slightly weathered, fine-grained to aphanitic quartzite with occasional pyrite mineralization and a few calcite veins up to 2-in. thick. The rock mass contains three main joint sets. One set is parallel to foliation and dips steeply to the northwest. Another set dips steeply to the northeast, and the third set is low angle to nearly horizontal. The combined orientation of the joint sets results in a blocky structure. Typical block sizes range from about 2 to 5 feet.

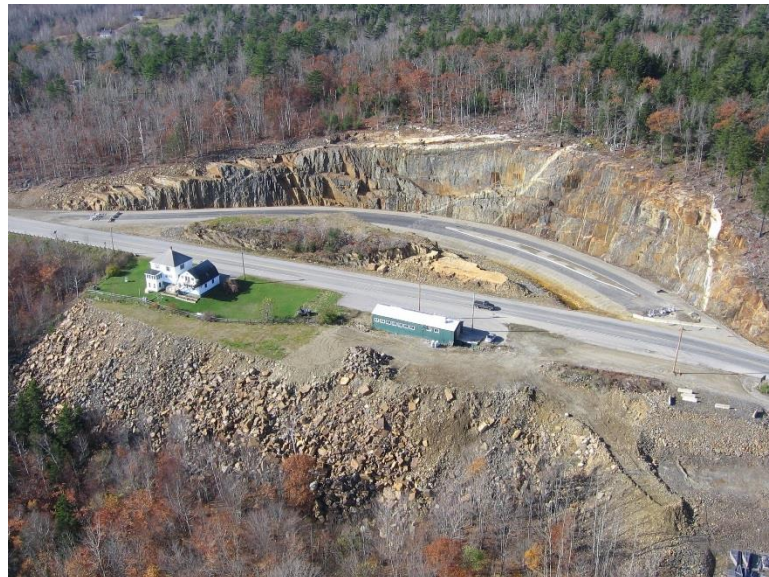
Figure 7 – Completed Rock Slope

During construction and excavation of the rock slope multiple site visits were made by Haley & Aldrich staff during which portions (Areas) of the rock slope were identified as needing remediation (stabilization). Draft sketches, details and/or specifications for remedial measures were prepared during construction and again in 2005/2006 in an effort to stabilize the identified Areas. MaineDOT elected not to perform the recommended rock slope remedial work during the original bridge and approach roadway construction due to project-specific constraints at the time of the work.

In 2009 and again in 2012, Haley & Aldrich was re-engaged by MaineDOT to further evaluate the condition of the rock slope, design new and/or refine previous stabilization measures and prepare bid documents in an effort to stabilize identified Areas along the rock slope during demolition of the Waldo-Hancock Bridge. MaineDOT elected to temporarily delay proposed rock slope remedial work until after the completion of the bridge demolition. As a result, the 2012 Haley & Aldrich work plan was modified to include recommendations for a long-term rock slope maintenance and monitoring (M&M) program. The condition of the rock slope was monitored and documented by MaineDOT in 2014.
