# Observational Design Approach:

Foundation Construction beneath the Philadelphia Museum of Art

Timothy S. Becker, P.E. M.ASCE R. Scott Goldkamp, P.E. Mark X. Haley, P.E. M.ASCE Haley & Aldrich, Inc. 465 Medford Street, Suite 2200

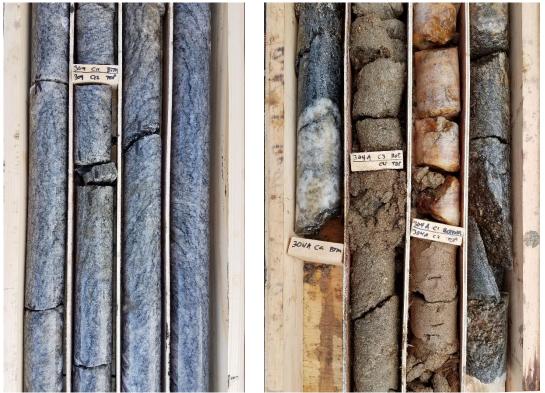
Waterworks Gneiss observed at the site was highly resistant to weathering but was often observed as slightly weathered to shallow depths. Site-specific unconfined compressive strength testing data (ASTM D7012 Method C) from sound Gneiss bedrock cores indicated strengths varying from approximately 92.4 MPa to 121.3 MPa (13,400 to 17,600 psi). Refer to Figure 4 for rock core samples.

The Wissahickon Formation at the site was observed to be moderately resistant to weathering, but in select locations was observed to be highly weathered to a moderate depth below the top of geologic bedrock. Site-specific unconfined compressive strength testing data (ASTM D7012 Method C) from sound Schist rock cores indicateed strengths varying from approximately 49.6 MPa to 57.2 MPa (7,200 to 8,300 psi), an approximate 50% reduction in compressive strength compared to the Waterworks Gneiss. Refer to Figure 4 below for rock core samples.

Figure 4. Waterworks Gneiss (left) and Wissahickon Schist (right) bedrock cores (images by Becker).

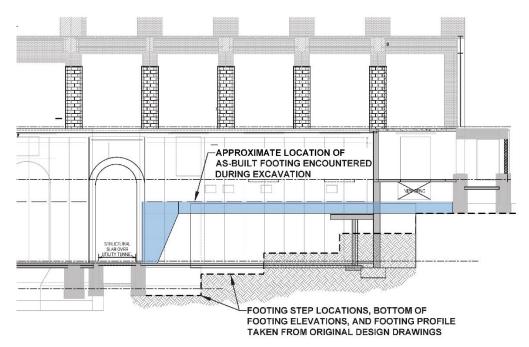
The excavation for the new Forum space required removal of a portion of the existing strip footing and vertical excavation within the underlying bedrock to meet the dimensional requirements of the design (Figure 7). The excavation approach included underpinning a portion of the north and south walls of the proposed Forum and relocation/redesign of proposed utilities to reduce the magnitude of bedrock excavation and associated building underpinning. Construction protocols to control potential building movement, vibrations, noise and dust were critical to limit impacts to the Museum and its operations.

# Figure 7. Cross-Section Through Wall Showing Record and As-Built Foundation Conditions (image adapted by authors; original courtesy of Magnusson Klemencic Associates)

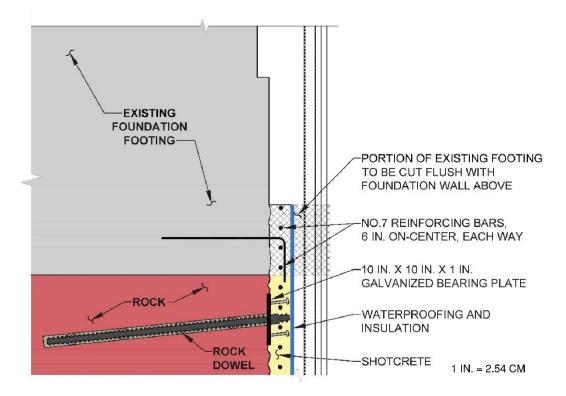
Figure 8. Rock Dowel and Shotcrete Underpinning Solution (image by authors)

**Permanent Support of Excavation System Design.** Long-term stability of the bedrock excavations required that no active or passive pressures be exerted from the bedrock onto the new, interior foundation walls. Reinforcements were designed to prevent failure from sliding along horizontal bedrock surfaces, limit over-stressing of the bedrock (including structural footing loads) with a minimum safety factor of 2, and limit the potential for movement of the structure. Based on engineering observations where bedrock was to remain below the existing foundations, permanent reinforcement consisted of a system of steel rock dowels and a permanent reinforced shotcrete wall (Figure 8).

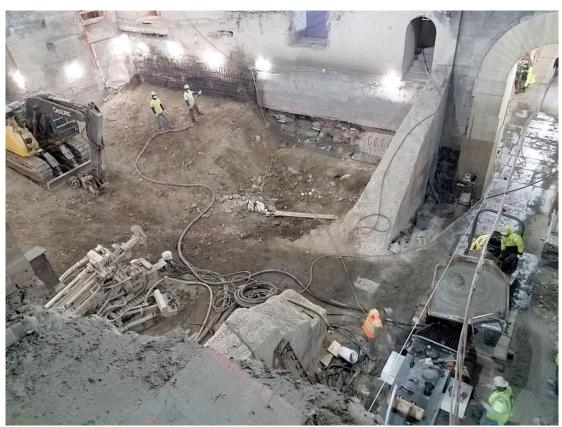
**Temporary and Permanent Support of Excavation During Construction.** Following the start of excavation in the Forum, located directly beneath and supporting the Museum's Great Hall, the foundation bearing conditions were observed to be different than the existing design drawings. Foundations were encountered at approximately El. 18.4 m (60.5 ft), 2.4 m (8 ft) higher than anticipated below the north and south foundation walls. Finished grades in the Forum required excavations to about 3.6 m (12 ft) below observed foundation level, to approximately El. 14.8 m to El. 15.1 m (48.5 to 49.5 ft) with some locally deeper utility excavations beyond the zone of influence for the footings. This depth of excavation below the existing footings required modification of the original design to account for the different foundation geometry, bearing level and variable bedrock conditions. Start of construction shown in Figure 9.

Figure 9. View of Support of Excavation Solution during Construction (image by Becker)

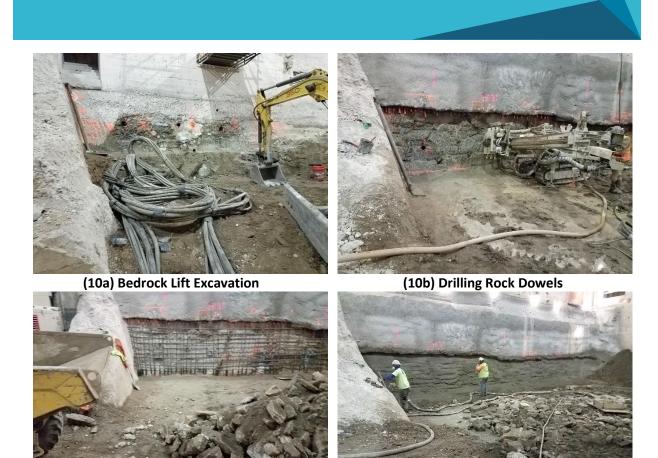
(10c) Installing Reinforcement Grid (10d) Shotcrete Wall Figure 10. Progression of Work (images "a" through "d" by Becker)

The as-designed support of the excavation system was modified during construction in accordance with geotechnical design requirements. Key modifications included adjusting the sequencing of the excavation to maintain safety and stability of the rock face and adjusting the rock dowel spacing based on the bedrock conditions encountered. Figure 10 shows the modified rock dowel and reinforced shotcrete wall underpinning solution, which consisted of:

- Assessing the quality of bedrock exposed during vertical cuts by a licensed professional geotechnical engineer or engineering geologist to evaluate bedrock conditions exposed versus the design criteria established.

- Excavating in approximately 1.2 to 1.5-m (4 to 5-ft) maximum depth "lifts";
- Applying a flashcoat shotcrete protection layer as required, which was dependent on the quality of exposed face of bedrock after excavation of each "lift" and before installation of rock dowels.

- Installing approximately 10.2-cm (4-in) diameter rock support dowels. Permanent rock support dowels consisted of 2.5-cm (1-in.) diameter and 4.4-cm (1-3/4 in.) diameter galvanized, high strength, upset threaded or deformed rebar (ASTM A-722 Grade 1034 MPA series), galvanized mechanical couplers, a galvanized bearing plate, and galvanized washer and nut.

- Torqueing to 150 ft-lbs to lock-off each rock dowel for passive resistance.
- Installing a reinforced shotcrete wall, minimum 0.23-m (9-in.) thickness and consisting of minimum 27.6 MPa (4000 psi) concrete, and a 15-cm (6-in.) on center vertical and horizontal no. 7 bar reinforcement matrix, fully encapsulating the rock dowel system.

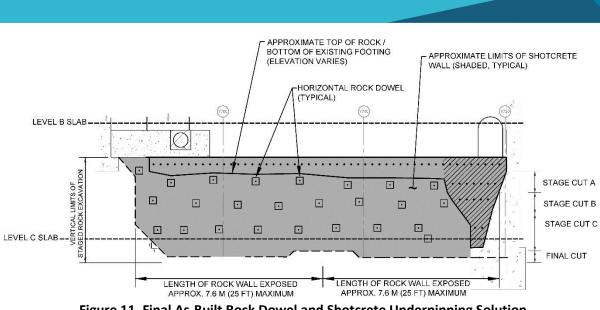
Prior to excavation, the original design included a total of four vertical rows with between seven and nine rock dowels per row. However, as excavations progressed, observations of bedrock competency improved considerably with depth. At approximately El. 17.1 m (56 ft), the quality of the bedrock transitioned to more competent, massive gneiss bedrock. As a result, the design was reevaluated, and the frequency of rock dowels was reduced to one final row of rock dowels centered at approximately El. 16.0 m (52.5 ft) rather than the two vertical rows originally anticipated.

Figure 11 indicates the as-built layout of dowels, with the shaded zone indicating the installed limits of the shotcrete wall.

Figure 11. Final As-Built Rock Dowel and Shotcrete Underpinning Solution (image by authors)
