# Problem solving

**Maki Onari, William D. Marscher, Eric Olson, and Chad Pasho, Mechanical Solutions Inc., USA**, introduce a specialised testing method to resolve problems that can arise in natural gas turbines.

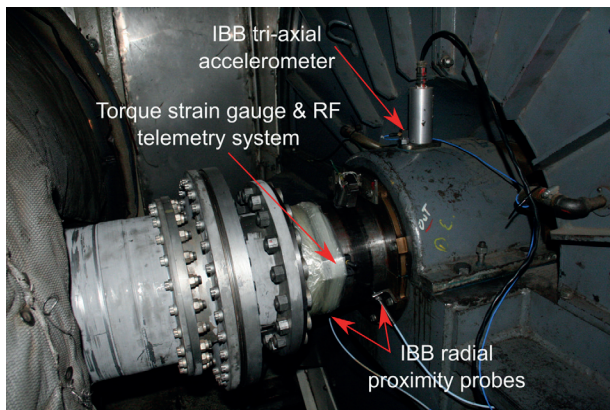
In this particular case, the power turbine of a 22 MW aeroderivative gas turbine driver was suffering from excessive vibration after the original rigid coupling was

replaced with a flexible diaphragm coupling (Figure 1). The excessive vibration of 0.50 in./sec. rms on the power turbine (PT) occurred at 2 higher vibration vs non-idle operating conditions. This article discusses the specialised testing used to determine the root cause of the problem in order to provide specific and successful solutions.

**Figure 1.** The power turbine (PT) of an aeroderivative gas turbine. Also shown is the recently installed new diaphragm coupling with some of the sensors used for the testing. Excessive vibration occurred after the old rigid coupling was replaced with the diaphragm coupling.

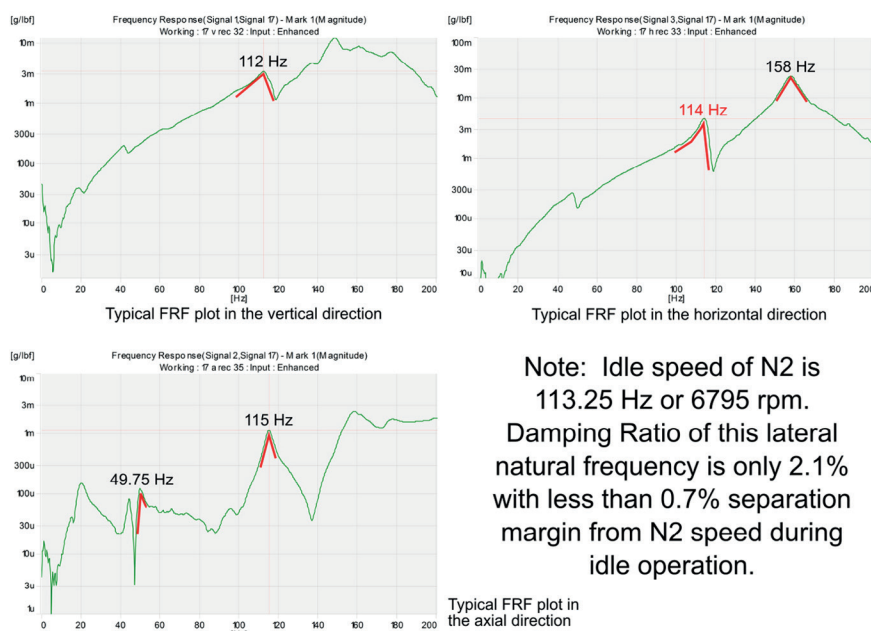
The EMA test determined that the newly installed coupling and shaft combination had a structural natural frequency in the lateral direction (horizontal) at 114 Hz (Figure 4). This natural frequency indicated only +0.7% separation margin from the HP rotor speed (N2), which is 113.25 Hz or 6795 rpm. Typically, the recommended separation margin between a natural frequency and the excitation source is approximately 10% based on a properly performed EMA test. The damping ratio of this natural frequency was measured to be 2.1%, which represents an amplification factor (AF) of approximately 24. This is a high AF, indicating that even a minimal amount of excitation force could lead to a resonant condition with high (and potentially damaging) vibration.

**Figure 4.** The Frequency Response Function (FRF) resulting from the EMA testing indicating that the coupling had a natural frequency near the HP rotor idle speed creating a potential resonant condition (high vibration).

Based on the modal testing performed on the newly installed coupling, it was clear that the main issue was that a strong lateral natural frequency was at 114 Hz – close enough to the idle speed of the HPT to cause resonant response at 113.25 Hz. As the turbine powered through this speed to a 7% higher speed, vibration dropped dramatically.

- ▶ The coupling resonance issue was resolved by changing the HP rotor speed to increase the separation margin with the lateral mode of the coupling from 0.7% to approximately 10%. Another option was to replace the new coupling with a different new coupling with a slightly different mass.
- ▶ The PT casing vibration issue was resolved by increasing preloading of the centre support by adding shims underneath the main support plate. Similarly, the lateral supports were also pre-loaded by a larger amount for safety.

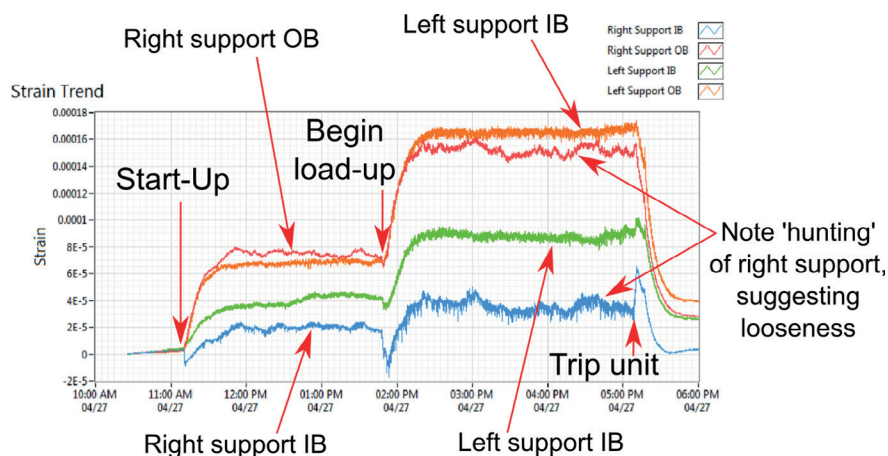
same day. The data indicated that the PT vibration amplitude was reduced by over a factor of 2 when the PT speed increased by only 7% from 6850 rpm to 7355 rpm. Figure 5 shows the trend plot from the strain gauges mounted on each side of the PT support 'A' frame (see Figure 2). This strain indicated that once the turbine is loaded, the strain value increased by a factor of 2 in tension, when the vibration was reduced considerably. This implies that during idle operation, the supports of the turbine need additional pre-load to reduce this high vibration. The correct pre-load needs to be applied between the pylons and the pillow-blocks, accounting for the support underneath the turbine. Also, note the variation, or 'hunting', of the right support, suggesting looseness.

**Figure 5.** Strain vs time plot for the strain gauges mounted on each side of the PT support 'A' frame. A Lack of pre-load on the support was detected to be a problem contributor.

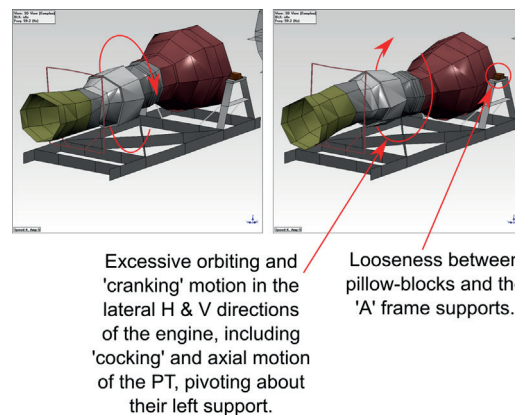
Figure 6 is an example of one still-frame ODS animation of the entire unit at the idle speed. The animation shows the relative motion of the turbine system components in exaggerated fashion. From the animations, it is evident that there is an excessive orbiting or corkscrewing motion of the PT, mostly in the vertical direction. In addition, soft-foot was detected between the PT pillow-blocks and the 'A' frame support structure. The lateral rocking motion of the left support could be attributed to the severe vertical motion of the PT casing. The ODS results supported the need to increase the pre-load of each support of the PT (lateral and bottom supports), in order to reduce the excessive motion of the unit at idle operation. As for the natural frequency of the

**Figure 6.** Still-frame of one ODS animation of the entire turbine unit at the synchronous speed. The animation shows the relative motion of the turbine system components in an exaggerated fashion.

Based on the ODS testing, during idle operation MSI detected looseness in the support assembly, which allowed a large orbiting motion of the PT casing mostly in the vertical direction, causing possible damage to the bearings. When combined with the support leg strain gauge strain vs turbine load results, this visibly evident support looseness in the ODS animations indicated a mechanically unloaded condition of the centre support under the turbine at idle. In turn, this mechanically unloaded the right-side lateral supports, consistent with the ODS (Figure 6).

coupling at 114 Hz, it was recommended to increase the PT speed by approximately 7% at the idle condition in order to reduce vibration on the right support during idle operation. The ODS animations at full turbine speed indicate much less motion (and vibration), since under load, the machine steady movement under torque tightens this joint, which resulted in lack of support pre-load and resulting looseness.
