Nursing an Unreliable Boiler Feed Pump Back to Health

William Marscher and Eric Olson, Mechanical Solutions, Inc., Whippany, NJ

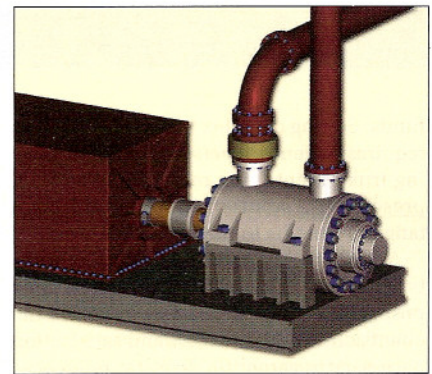
Figure 1. Steam-turbine-driven, barrel-type, main boiler feed pump.

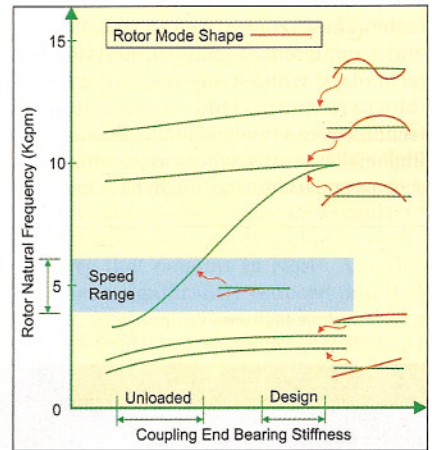
Analyses were then conducted to help identify the source of the shift in the rotor-critical speed. A number of "what-if" iterations were performed using the OEM's rotor-dynamic computer model (Figure 3). These were verified with a similar model that was constructed by MSI engineers using the ROMAC (rotating machinery and controls) software code from the University of Virginia's ROMAC Industrial Research Program. The analytical results from both models consistently showed that the particular rotor natural frequency value and the rotor mode deflection shape could best be explained by improper operation of the pump's coupling end bearing.

Figure 3. Results of "what-if" rotor dynamic analysis of boiler feed pump.
