# VIBRATION FAILURES

DYNAMIC TESTING AND FINITE ELEMENT MODELING HAVE BEEN SUCCESSFUL DIAGNOSTIC METHODS

MAKI ONARI & CHRIS HURRELL  
MECHANICAL SOLUTIONS, INC.

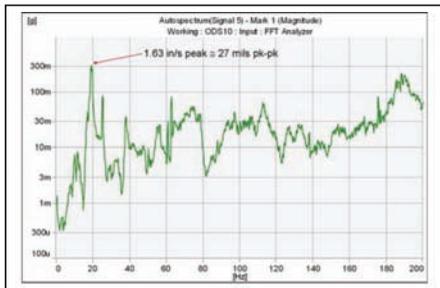
**Clockwise from top**  
**Figure 1: Vibration spectrum measured at the discharge valve after the first elbow from the compressor in the horizontal direction**

However, when the compressor was operating in parallel with a sister unit, sharing the refrigeration load, the discharge piping of the tested compressor started to vibrate violently, increasing the bending stresses at the location where previous failures took place. The maximum vibration amplitude was measured on the discharge piping with approximately 1.63 in/s peak at 19.5 Hz (1,170 cpm) or 26.6 mils peak-to-peak in displacement (Figure 1).

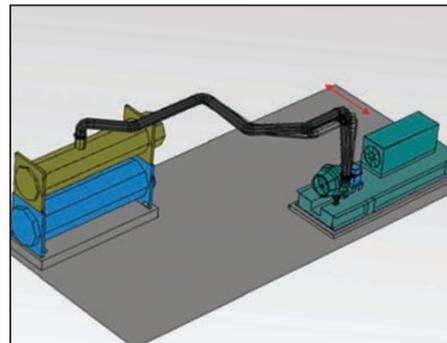
**Figure 2: ODS test results during rotating stall of the compressor (50% load), showing motion of the discharge piping pivoting on the compressor at 19.5 Hz**

ASTM A53 Gr. B seamless black steel). The ODS plot at a “strong” subsynchronous frequency of 19.5 Hz showed the discharge piping rocking and pivoting at the compressor discharge flange, while the rest of the unit remained stationary (Figure 2). Figure 3 shows the ODS plot of the condenser-evaporator shell stack during the same sub-synchronous frequency. Rotating stall in the compressor stage was determined to be the cause of this phenomenon.

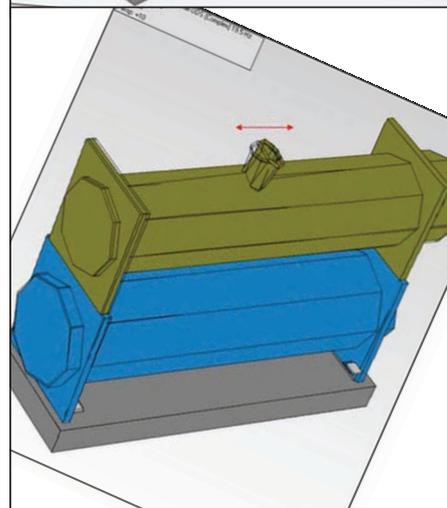
**Figure 3: ODS tests showing the motion of the condenser nozzle pivoting on the shell structure at 19.5 Hz**

**Figure 4: Typical frequency response spectrum of the compressor discharge pipe during the impact modal testing measured in the horizontal direction**

Figure 4 shows a typical spectrum of the frequency response measured on the piping in the horizontal direction. The spectrum shows the discharge piping structural natural frequencies at 5.9 Hz, 8.0 Hz, 11.4 Hz, and 19.8 Hz. The natural frequency at 19.8 Hz had the strongest response.

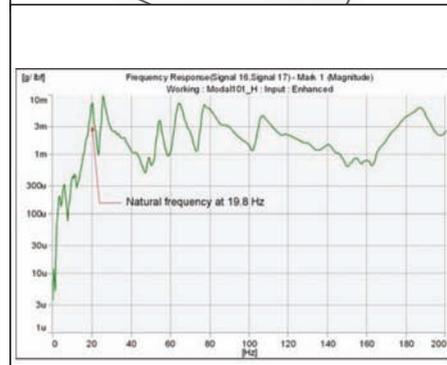
**Figure 5: Mode shape of the discharge piping at natural frequency of 19.8 Hz with the compressor non-operating. Rocking motion seen on the piping pivoting on the flange**

Figure 5 shows the plot of the mode shape in the horizontal direction, where the discharge piping is rocking side to side pivoting on the compressor flange as seen during operation. The compressor and gear box modal testing by itself did not reveal any harmful structural natural frequency on those structures at or close to the running speeds.

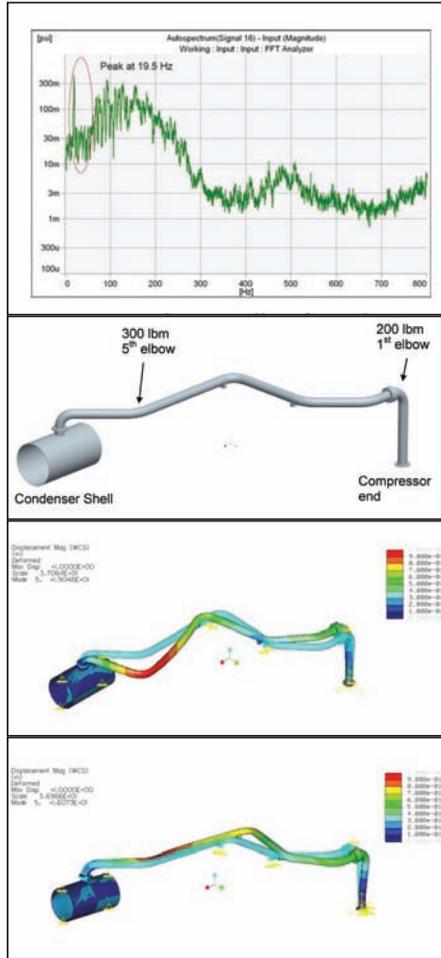
**Figure 6: Dynamic pressure transducer reading from the compressor discharge during full load of the unit**

**Figure 7: Dynamic pressure transducer reading from the compressor discharge during rotating stall of the unit**

**Figure 9: Mode shape of the offending mode at 19.1 Hz calibrated approximately with the field test result (19.8 Hz)**

However, when both the engine-driven compressors operated simultaneously at part load (around 50% each), with independent evaporator-condensers, and with two chillers in service, the evaluated compressor became aerodynamically unstable. The characteristic of the spectrum changed completely, showing a strong peak at 19.5 Hz (Figure 7) as a result of rotating stall of the compressor.

This aerodynamic instability recirculated the discharge gas, and generated pressure pulsations at 19.5 Hz. This pressure pulsation tuned into the 19.8 Hz structural natural frequency of the piping, dramatically increasing the vibration level of the piping, and therefore the piping stresses, in a classic case of fluid-structure interaction.

**Figure 8: Solid model of the discharge piping and the proposed modification by attaching 200 lbm at the 1st elbow and 300 lbm at the 5th elbow**

**Figure 10: Mode shape of the offending mode shifted down to 16.1 Hz after adding masses at the 1st and 5th elbow**

Based on iterative FEA calculations, by adding 200 lbm attached at the 1st elbow, and 300 lbm at the 5th elbow from the compressor discharge piping (Figure 8), the calculated structural natural frequency shifted downwards from 19.1 to 16.1 Hz (Figures 9, 10). By the third quarter of 2007, the OEM and the end-user implemented this fix recommendation on a trial basis by tack welding several split-plates around the piping to provide the required weight, and the vibration level reduced considerably and sufficiently (from 1.63 inches/sec peak to 0.38 in/s peak), particularly during the rotating stall of the compressor.

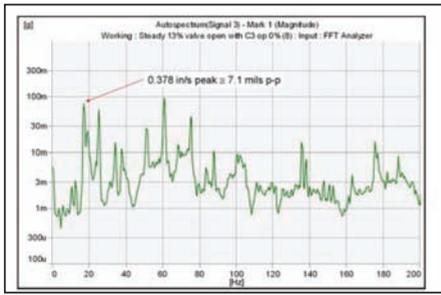
**Figure 11: Vibration spectrum after implementing the modifications show reduced vibration levels**

Figure 11 shows the spectrum of the

piping after modification and operating both gas engine driven compressors operated simultaneously at part load (~50% each). This relatively easy and quick fix allowed the end-user to continue uninterrupted operation without shutting down the compressor or without need of additional capital investment. **■**
