Porosity in Deposited Material

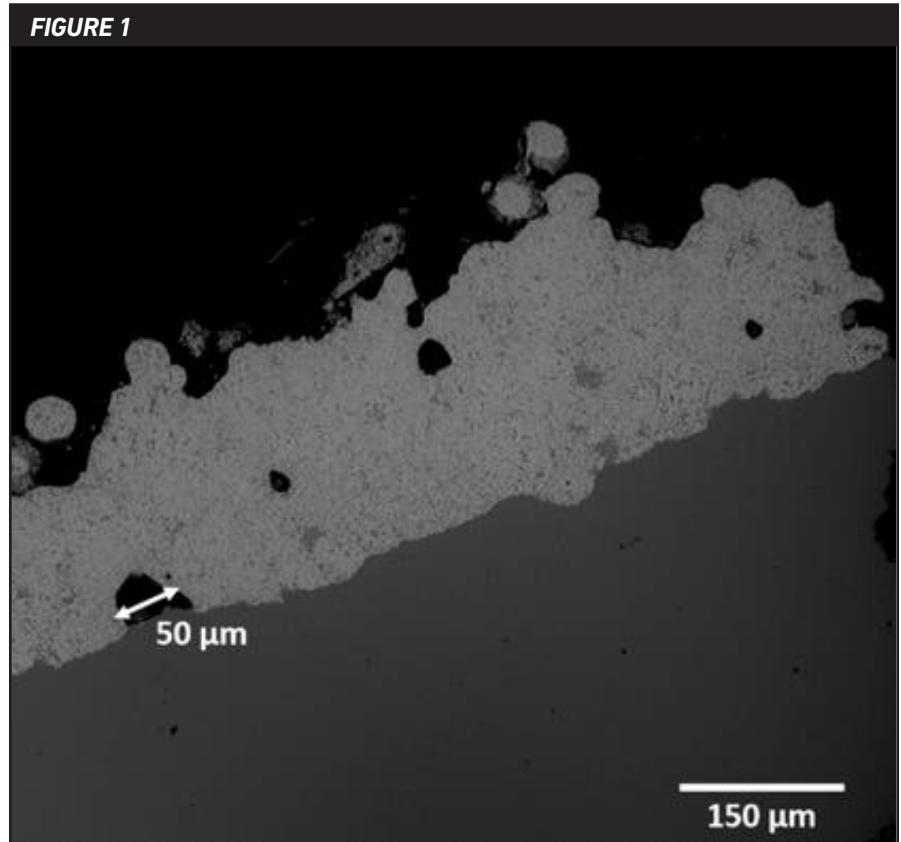
Figure 1. SEM micrograph of deposited layer-substrate interface

Microstructural analysis of samples of the deposited material were conducted to gain a better understanding of any potential processing issue. Once received, the samples were mounted, ground and polished to reveal the cross section. Figure 1 shows a Scanning Electron Microscope (SEM) image of the sample section which shows that the deposited layer is punctuated with large pores.

One understandable explanation is that the powder being included in the deposited layer is porous. The powder particles are between 20-53 microns in diameter and measurements of the pores reveal them to be 30-50 microns across, so are highly unlikely to be contained stably within a powder particle.

Since powder porosity would also not explain poor surface finish, the machine processing conditions were carefully investigated. A large retained sample of a previous batch of powder which was known to process satisfactorily was used in order to ensure a like for like comparison. After replacing a key component of the deposition system across all machines, the build quality was restored to output products that passed the stringent quality controls. It was confirmed that component deterioration across the machines was the root cause.
