Flight 93 Structural Fire

Serious Accident Investigation
Factual Report
October 3, 2014

SERIOUS ACCIDENT INVESTIGATION FACTUAL REPORT

Accident Name: Headquarters Structural Fire
Description: Structural Fire
Location: Flight 93 National Memorial
Date: October 3, 2014

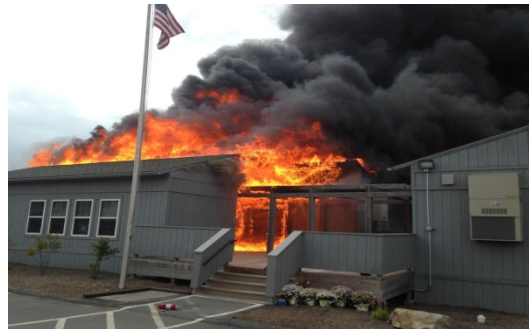
Figure 5 Fire progressing at Headquarters and curatorial offices

Ranger 1 was unable to extinguish the fire due to how hot the fire was burning and the strong winds pushing the fire toward the structures. All employees evacuated the complex and waited for the fire department to arrive. The first fire apparatus responded at 3:17 PM and arrived on scene at 3:23 PM.

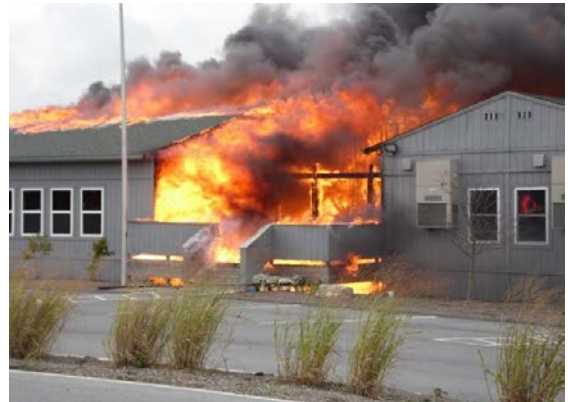
Figure 6 Liquefied decking spreading fire under the building

The MSDS for Tandeck lists the melting point at 250° F. As a comparison, paraffin wax used in candle making has a melting point of around 150° F. This low melting point is why the product behaved more like a fuel fire than it did a fire in typical construction materials. Once the melting point was reached the product turned back into its liquid form. It took the addition of very little heat to bring the liquid petroleum to its flash point of 645° F. The flash point is the temperature at which the liquid begins to vaporize and form an ignitable mixture in air. When products reach their flash point they need the addition of a flame source to begin to burn. One of the properties that makes this HPDE product so volatile is that it not only has a flash point of 645° F, but an autoignition temperature of 645° F. An autoignition temperature is defined as the temperature at which a substance will spontaneously ignite without an external source. The analysis shows that once we apply enough heat to the product to produce a combustible mixture in air, there is enough heat for it to ignite without applying a flame. As a comparison the autoignition temperature of gasoline is around 500° F.

The scientific data combined with what was learned from the fire at FLNI explains why this fire burned with such intensity. The wood substructure of the deck would quickly and easily produce enough heat to turn the HDPE into a pool of petroleum liquid. This liquid would quickly reach both its flash point and autoignition temperature creating a situation where the entire deck was quickly on fire and impinging on the lightweight wood construction of the buildings. This would be similar to what is known as area ignition in a wildland fire or flashover in a structure fire.

- Determinations must be made to identify where plasticized wood decking should be removed from existing buildings
- Ensure proper guidelines exist for use of plasticized lumber in new projects

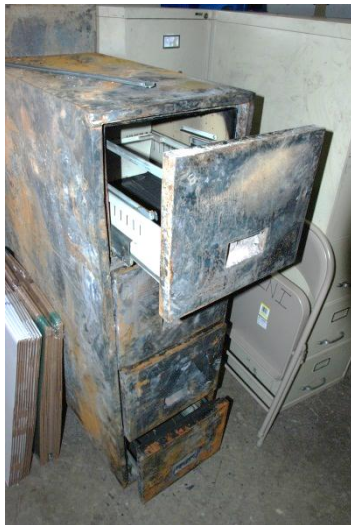
Figure 7 Filing cabinet recovered from FLNI HQs. Intact interior shows successful resistance to the effects of fire

Finding 6: The Accession ledger, the legal record of collections ownership, was not properly stored in a UL listed fire resistant filing cabinet, and therefore was destroyed.

The accession ledger is a legal document that identifies the source for every object in a park's museum collection. It contains the sequential log of transactions that prove NPS ownership of museum collections and temporary custody for incoming loans. All material in the park's museum collection must be part of an accession in the accession ledger. Legal custody of material is not completed until the information has been entered in the accession ledger. The accession ledger is one of the most important museum record-keeping documents for accountability and must be stored in a secure room inside a fire resistant file cabinet with a lock. Access to the accession ledger must be monitored and controlled. During the interview with the park curator it was revealed that the accession ledger was left on her desk and access to that space was inaccessible due to an ongoing deck staining project.

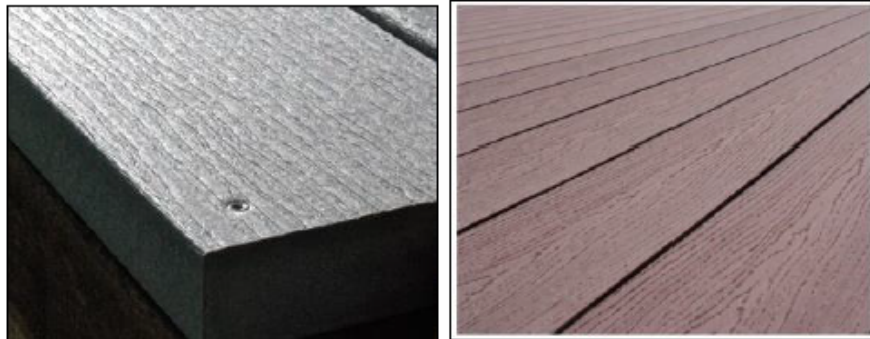
Examples of HPDE-based decking materials.

The plasticized lumber decking used at FLNI was primarily composed of high-density polyethylene (HDPE) plastic. This type of material is sold under several trade names and is available from a variety of manufacturers. HDPE-based building materials have a relatively low melting point, typically close to 250F degrees. Once ignited, the solid plastic quickly liquefies allowing it to spread rapidly. Unlike traditional building materials, the melted plastic behaves like a flammable liquid, burning rapidly and generating heavy smoke.

- If HDPE-based materials are found in any of the above locations, the park/facility must evaluate potential risks and take corrective action. Corrective actions may include relocation/removal of heat sources, removal of HPDE-based materials, modification of occupant emergency (evacuation) plans, and/or employee notification.
- For any HPDE-based decking installed inside a building, the park/facility must notify their Regional Structural Fire Manager to determine appropriate corrective actions.
- Parks with engine companies should review their response procedures for locations where HPDE-based decking materials are present. Additionally, parks that utilize local emergency services, should inform their local fire department if HDPE-based materials may be present in or near buildings.

NPS is in the process of ensuring guidelines exist for use of plasticized lumber in new projects. Additional guidance/policy will be provided when available.

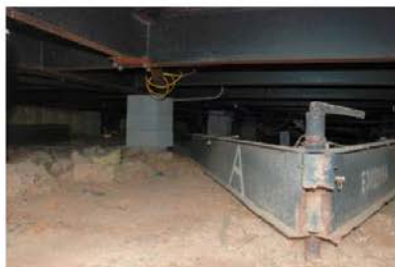
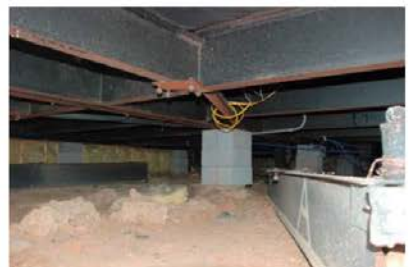
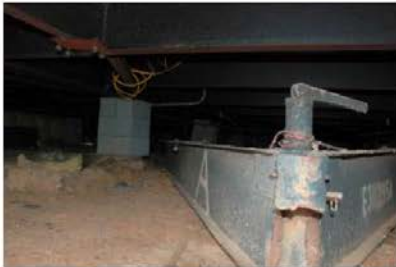
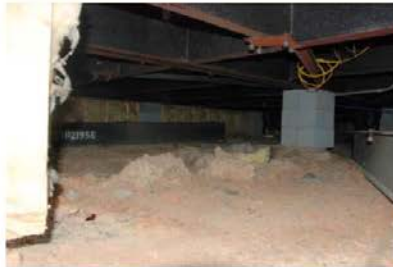
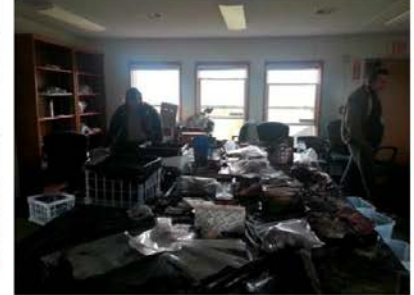
DSC_0020, 20141009, Don Boucher, 40° 4'2" N 78°53'16" W, East, Inspection of remaining structure foundation.

DSC_0021, 20141009, Don Boucher, 40° 4'2" N 78°53'16" W, East, Inspection of remaining structure foundation.

DSC_0022, 20141009, Don Boucher, 40° 4'2" N 78°53'16" W, East, Inspection of remaining structure foundation.

DSC_0023, 20141009, Don Boucher, 40° 4'2" N 78°53'16" W, East, Inspection of remaining structure foundation.

DSC_0024, 20141009, Don Boucher, 40° 4'2" N 78°53'16" W, East, Inspection of remaining structure foundation.
