## **INSPECTION PHOTOS NO.**

## ROOF MASTERS

Job Address:
47622 Wisteria Lane

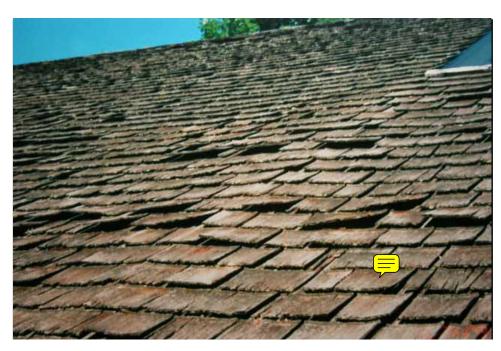
The main leak you are experiencing is a result of loose, missing and broken shingles in this area shown to the left. At this point in the life of your roof, 26 years old, we recommend a complete re-roof. You will not have to worry about this problem happening again for the life of the new roof. If you choose Lamarite composite slate shingles, the expected roof life will be 50 years!

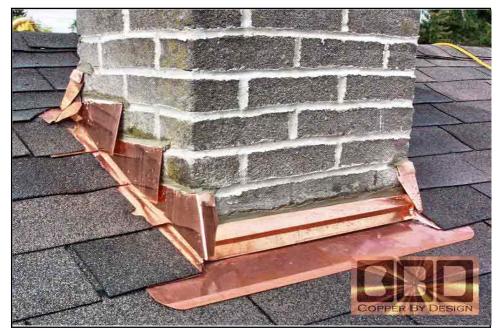
The second leak you have is a result of improper flashing done around your chimney as it penetrates the roof. As part of your re-roof, WE will insure that ALL flashing is replaced and correctly installed everywhere on your roof. You will not have to worry about this problem happening again for the life of the new roof. The picture to the right shows the type of copper flashing we will install around your chimney.
