Katrina - Revisited

WHITE PAPER • OCTOBER 2015

by Jerry Beall Technical & Product Specialist for FiberTite Roofing Systems

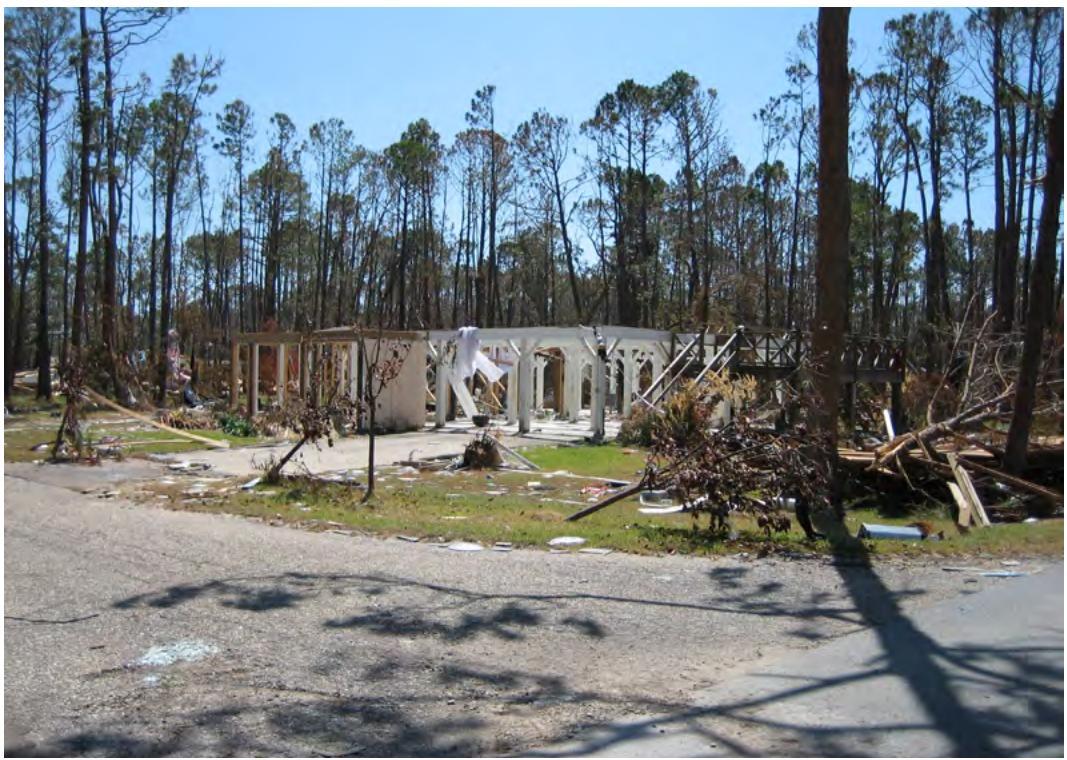
The previous picture is what was left from a house built on stilts. I can't tell you the exactly where this is because street signs and roads for that matter were few and far between. I knew where I was but all my senses disagreed.

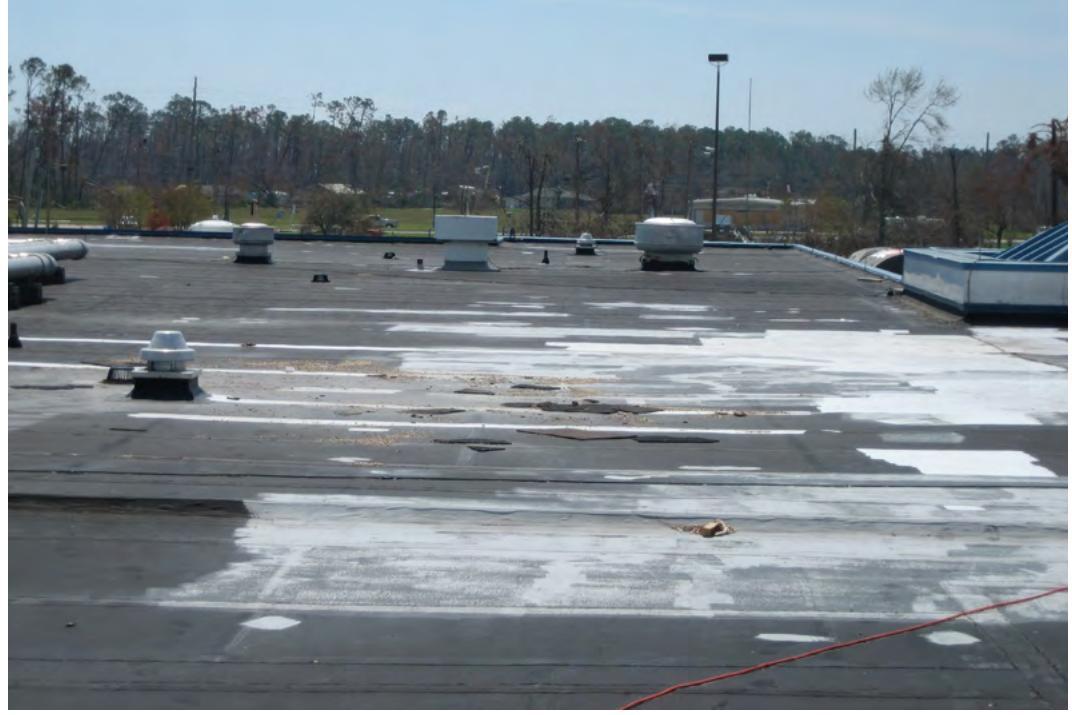
Hospital; Mechanically Fastened EPDM.

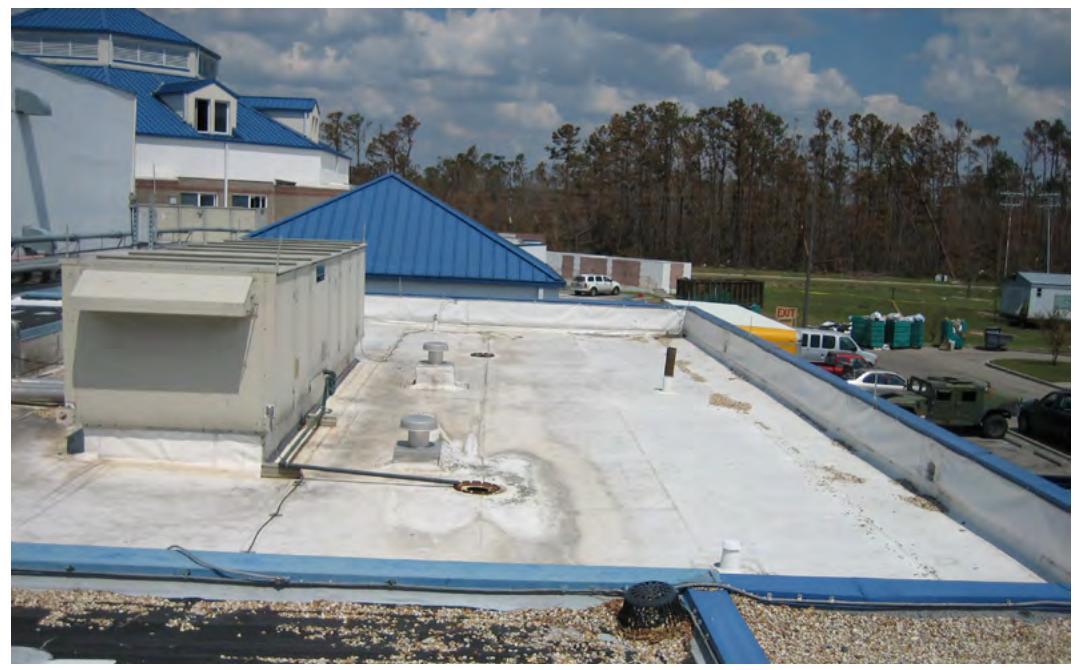
Hospital; Mechanically fastened vinyl roof system.

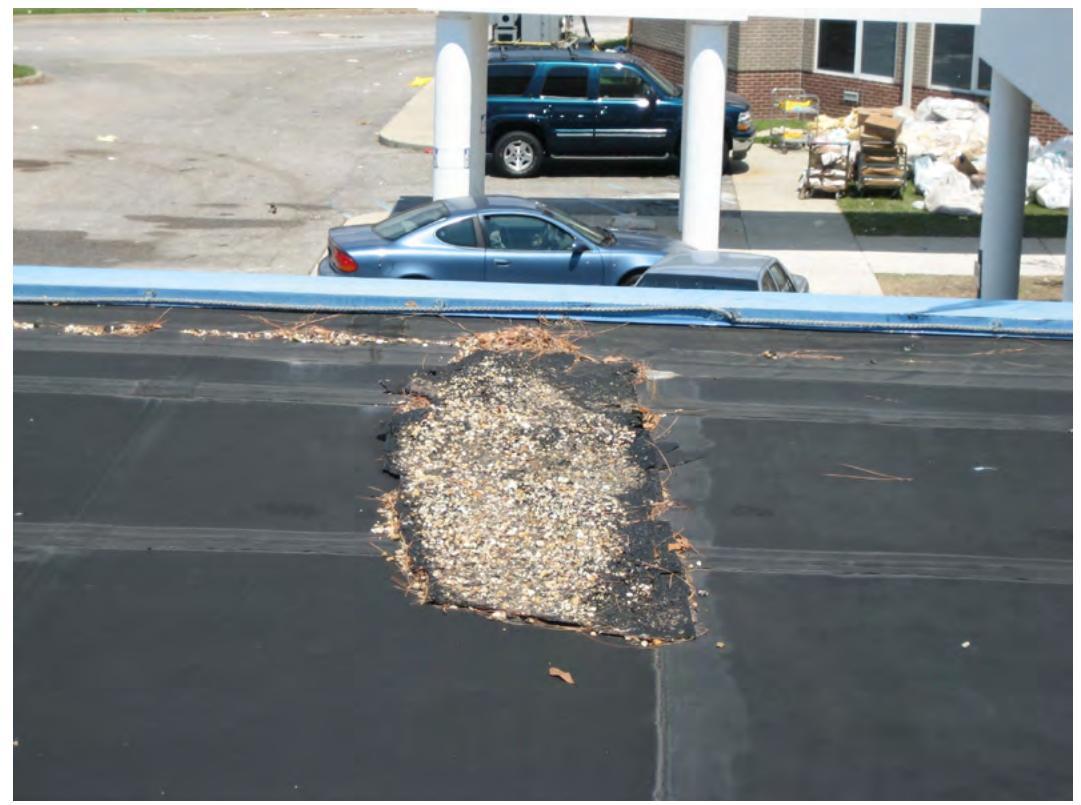
Debris from a built up roof system with no apparent source.

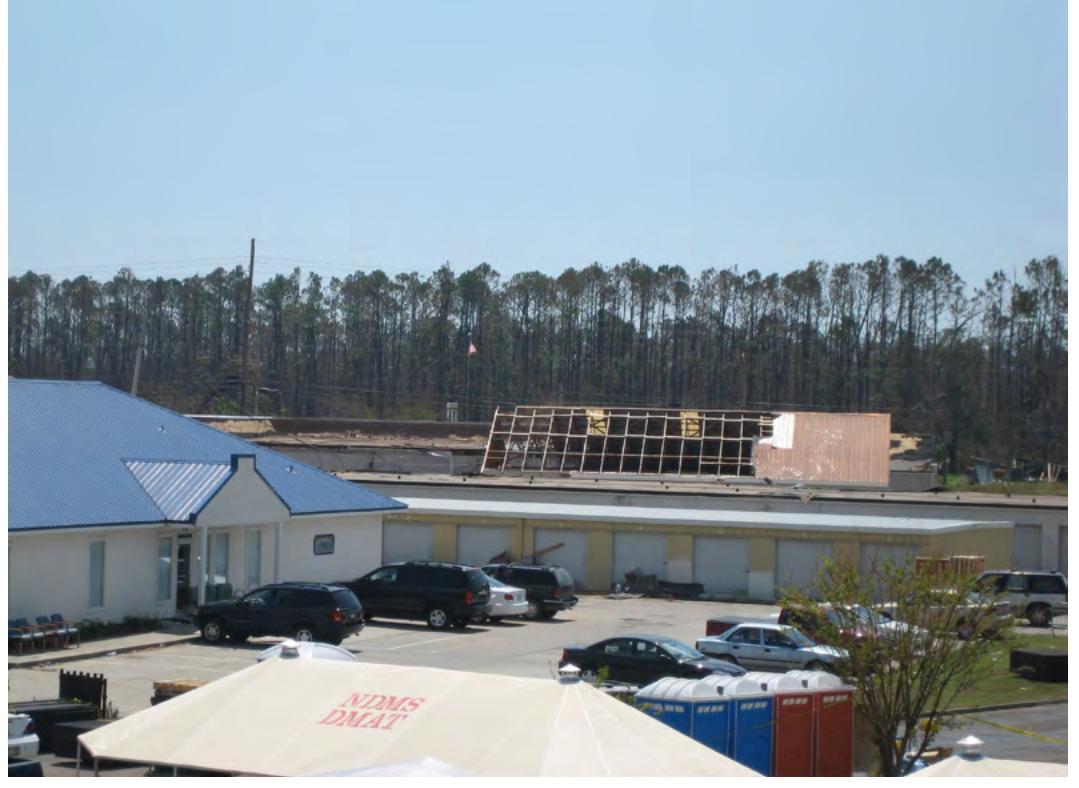
Small Strip Center off to the south east that was the source of the debris on the hospital roof.

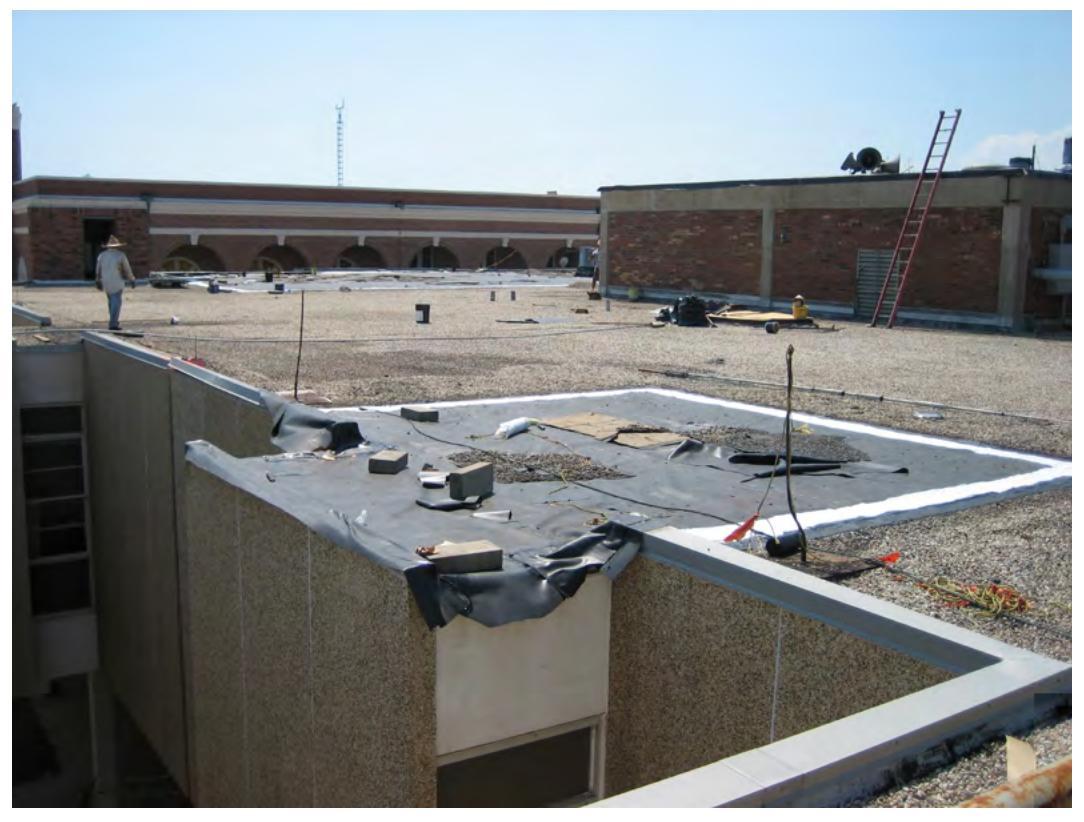
Wood blocking, associated with the recover, was 'nailed" at approximately 2 feet on center. When the blocking lifted, the recover system peeled. Crews were on site installing temporary EPDM repairs.

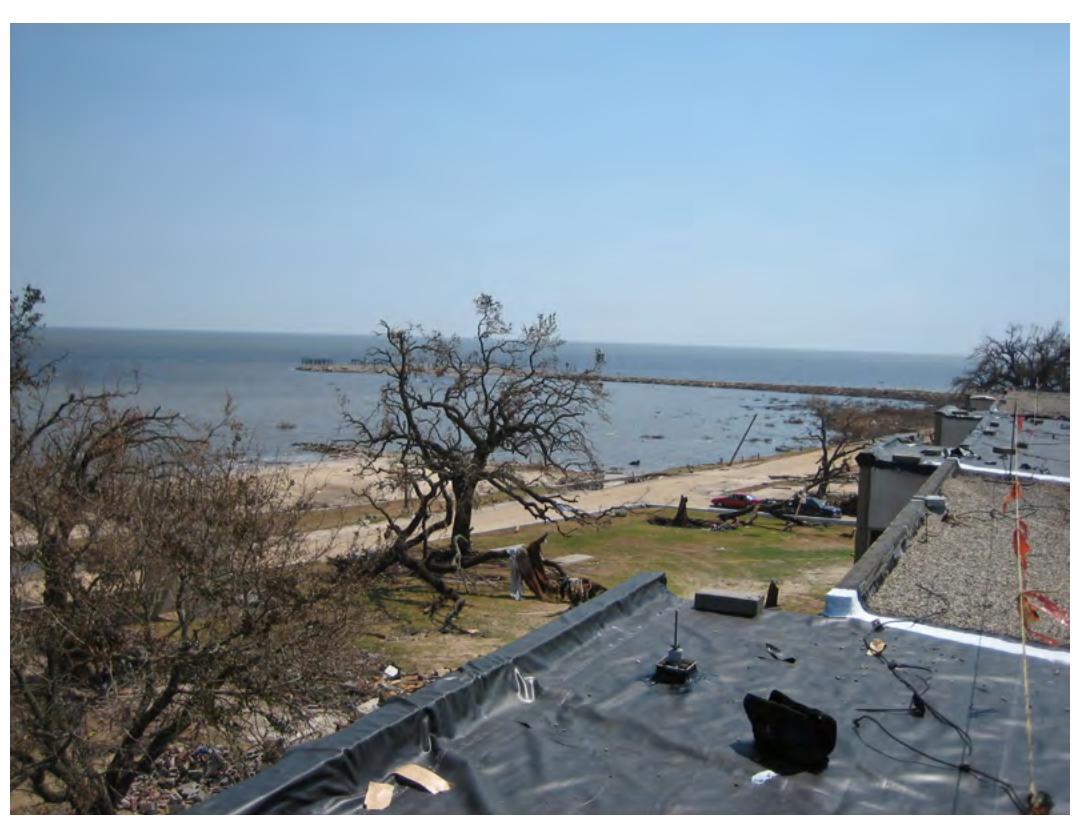
Damage along the eastern side at out cropped areas.

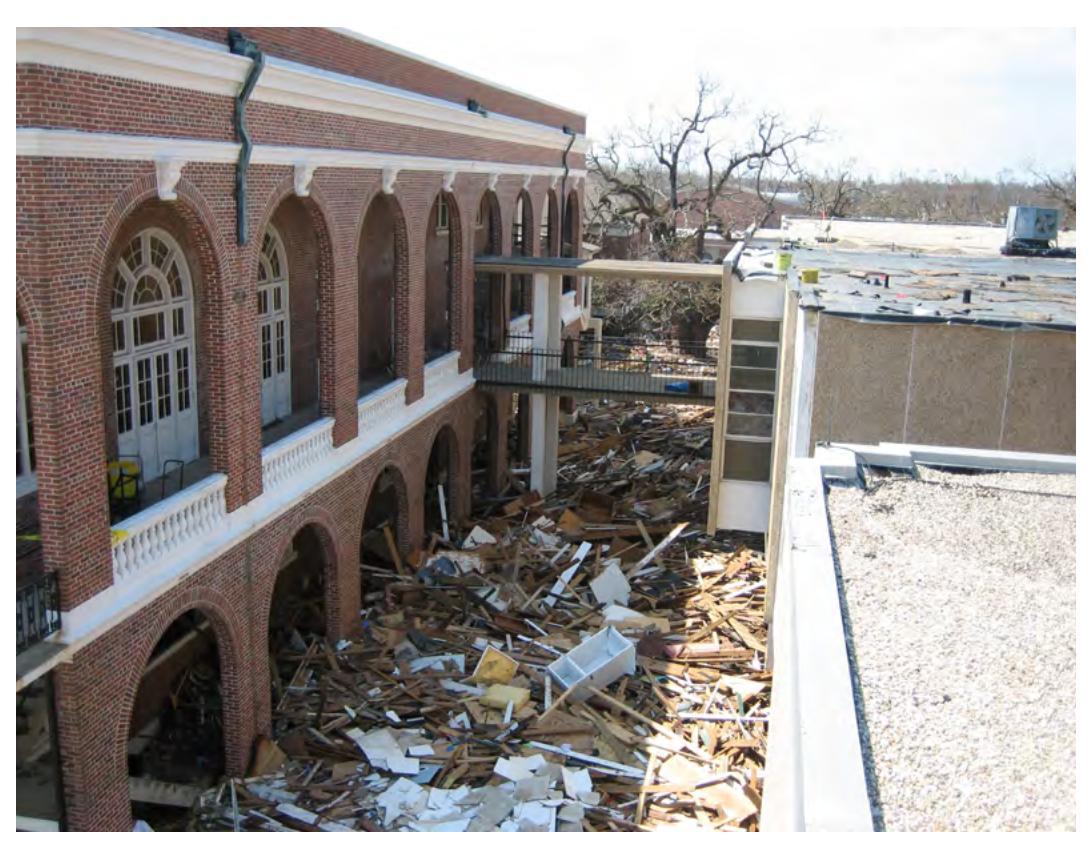
Here too the school suffered complete destruction of the lower level from the storm surge with apparent flooding on the second floor.

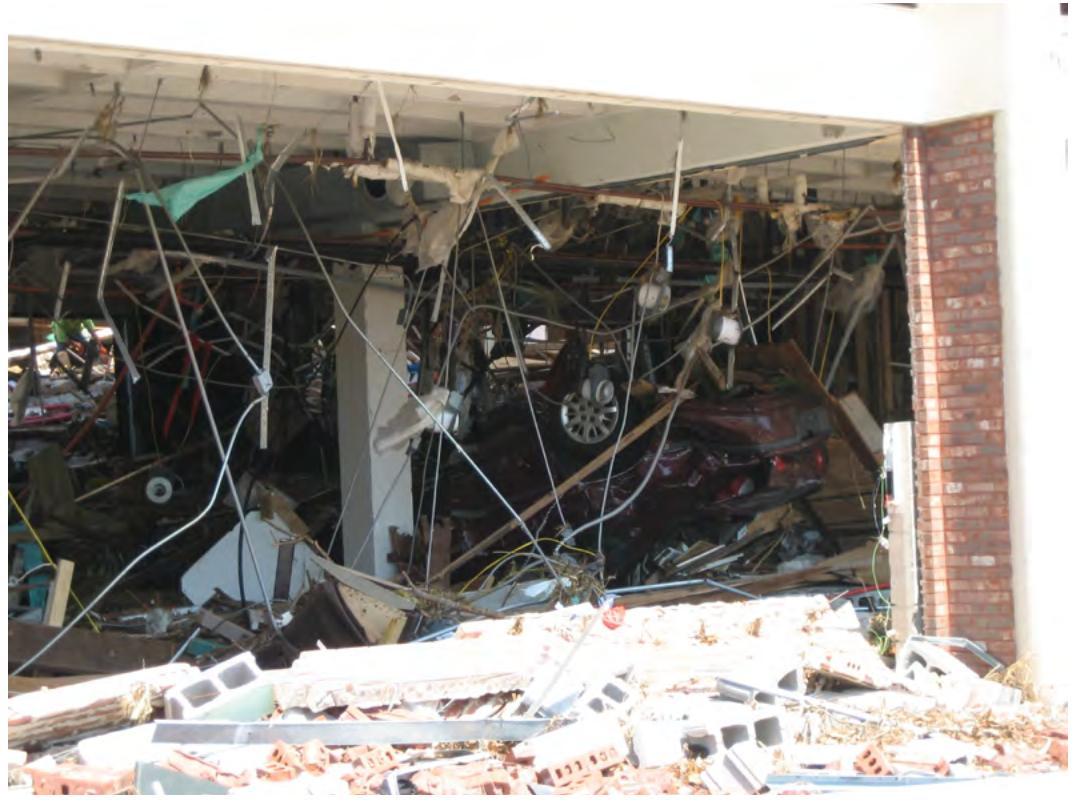
The storm surge showed no mercy to anyone or anything caught in its wake.

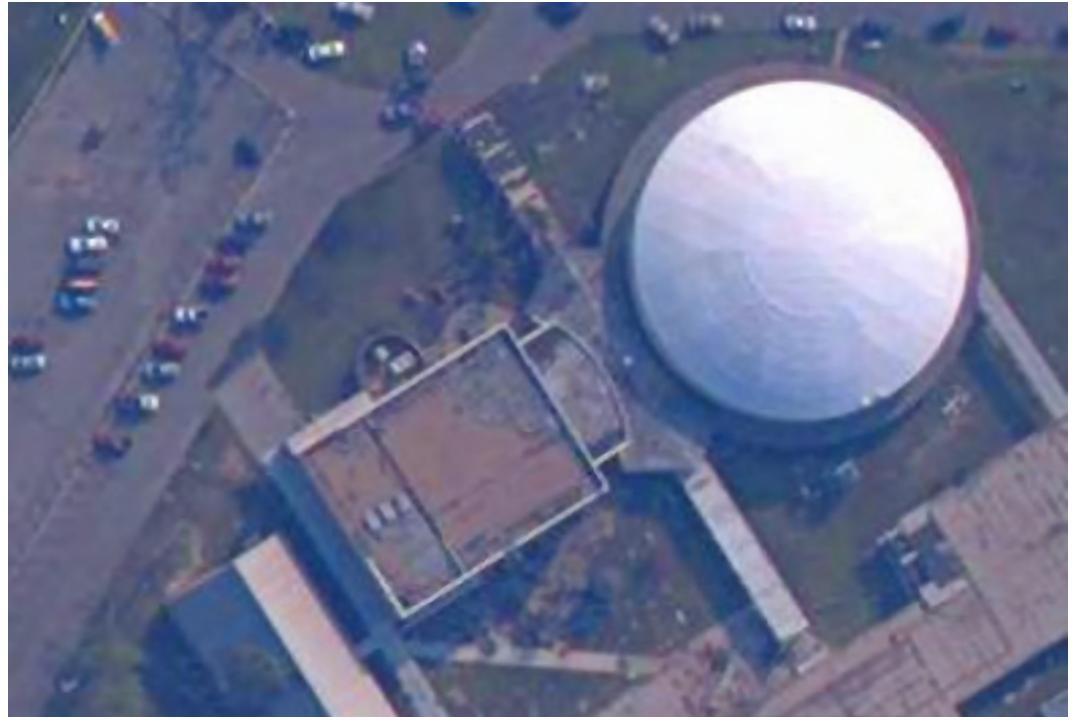
The sprayed polyurethane roof on the dome led us to this school. The auditorium, rectangular building to the left of the dome, turned out to be a classic example of building pressurization and no back up to prevent the peeling back of the built up roof.

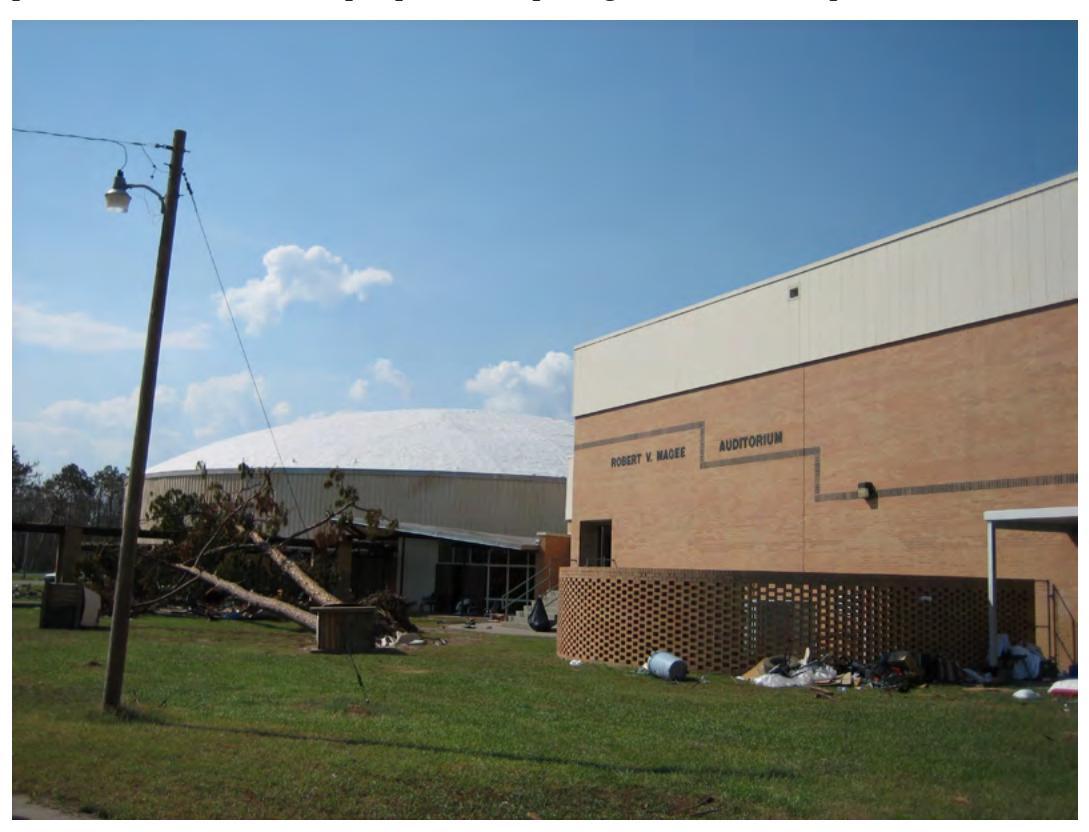
Our collabsable ladder was not going to help us here. We also noticed that the rolling freight door at the southeast corner of the building had been blown in. Directly above at the parapet line we could see missing metal.

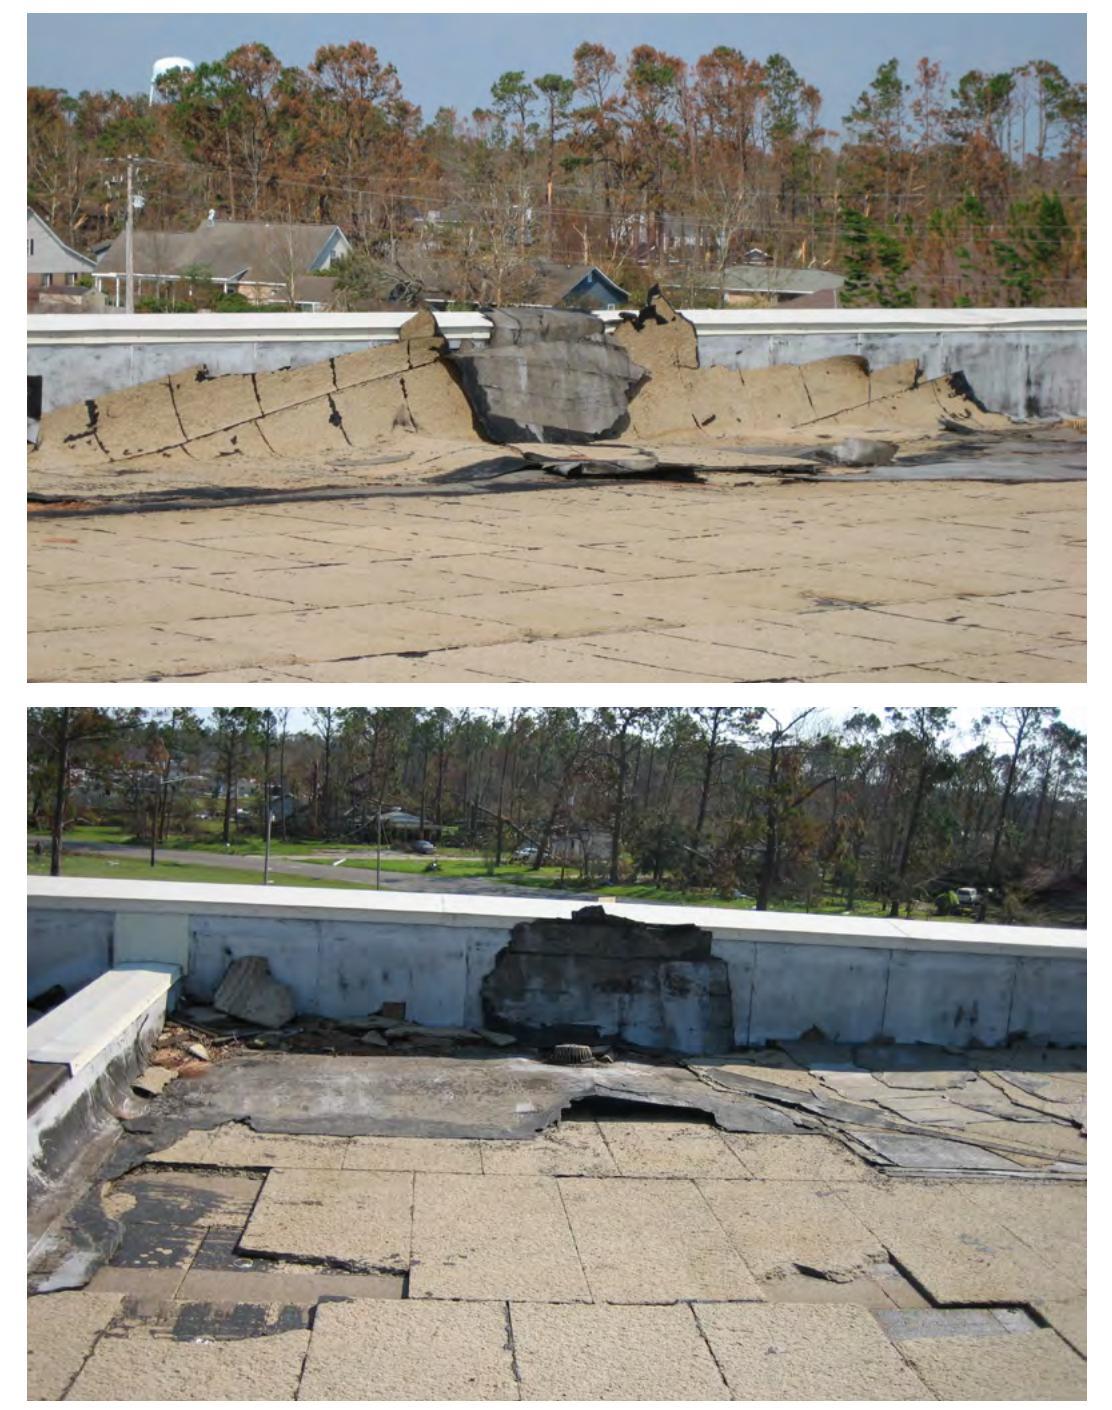
But a few of its associates were present, detached but present none the less.

The construction started with a steel deck, a mechanically fastened base layer of perlite using only 2 fasteners per 2' x 4' insulation board. Yet the mechanically fastened insulation was barely disturbed. An additional layer of perlite was adhered to the first layer with a ribbon applied, asphaltic adhesive. The roof cover was a smooth surface, multi-ply bur.

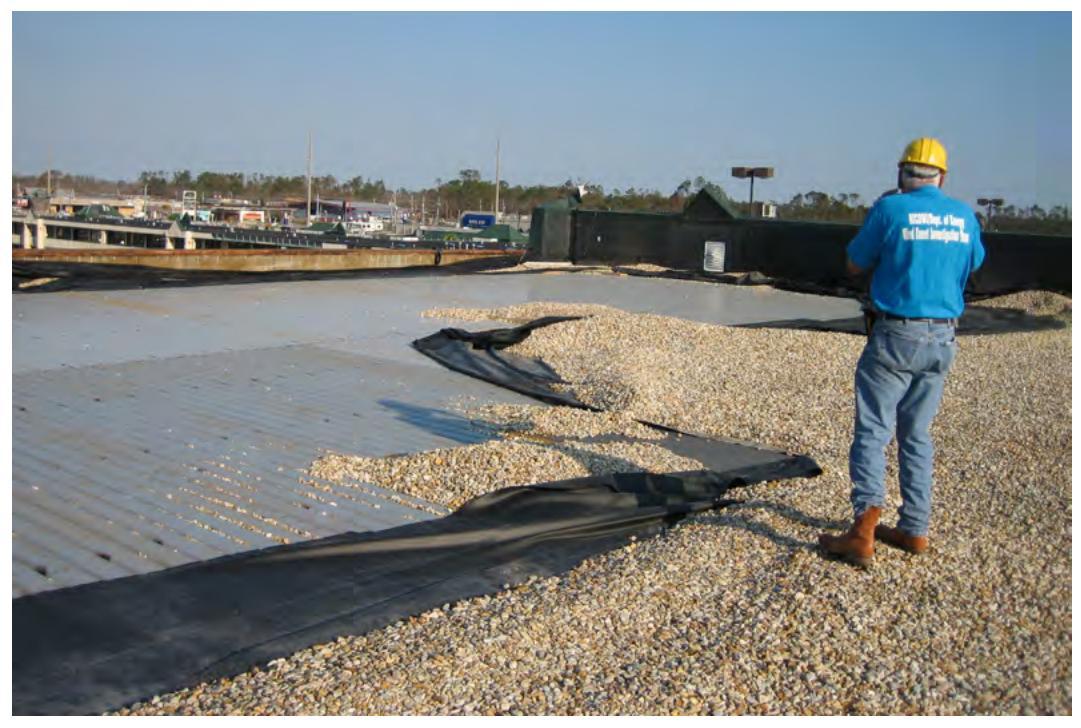
Here, the weight of the ballast created a "peel stop" but not until a significant portion of the deck had been exposed.

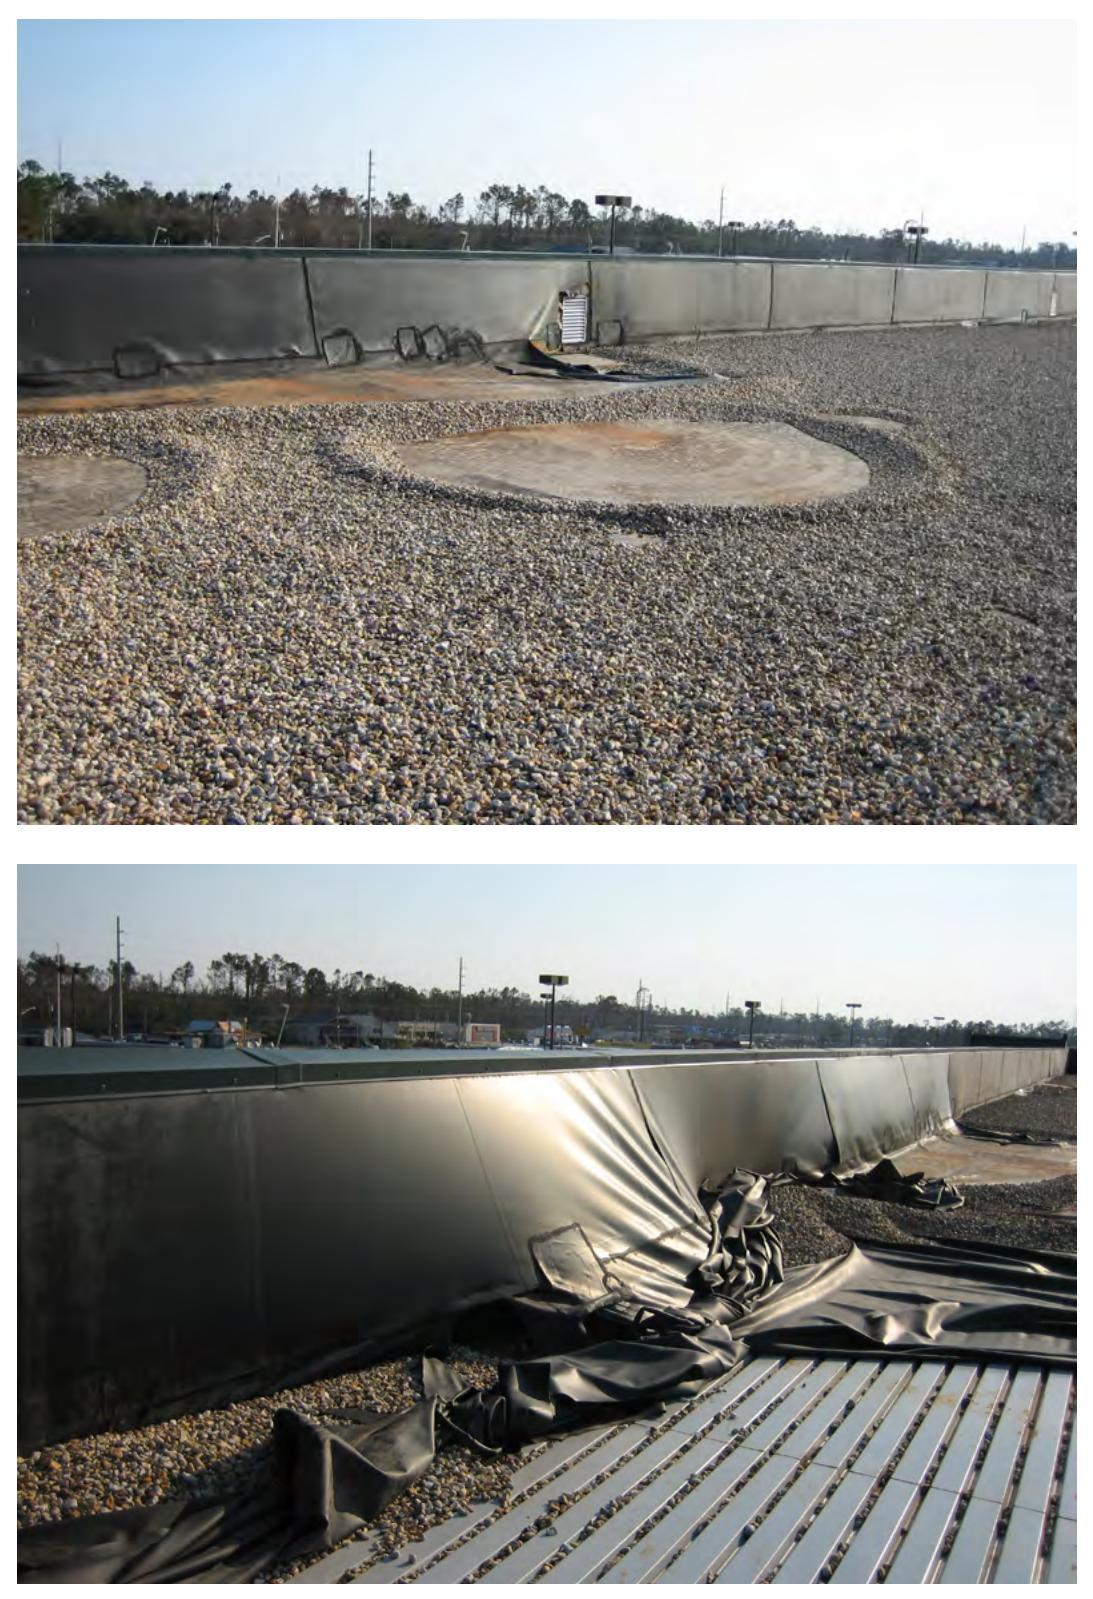
The store front windows were blown out. Pressurization along with the probability that scour was already present in the corner initiated the blow back.

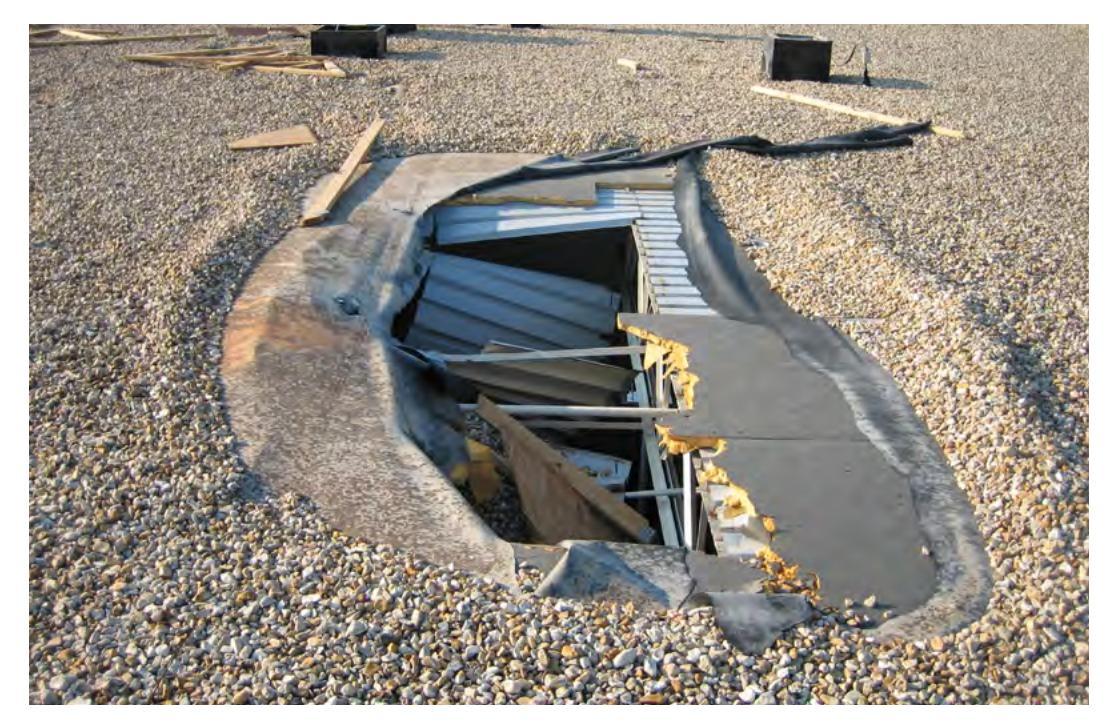
This store also had a mansard that wrapped its south east corner. This is where it landed when it came loose.

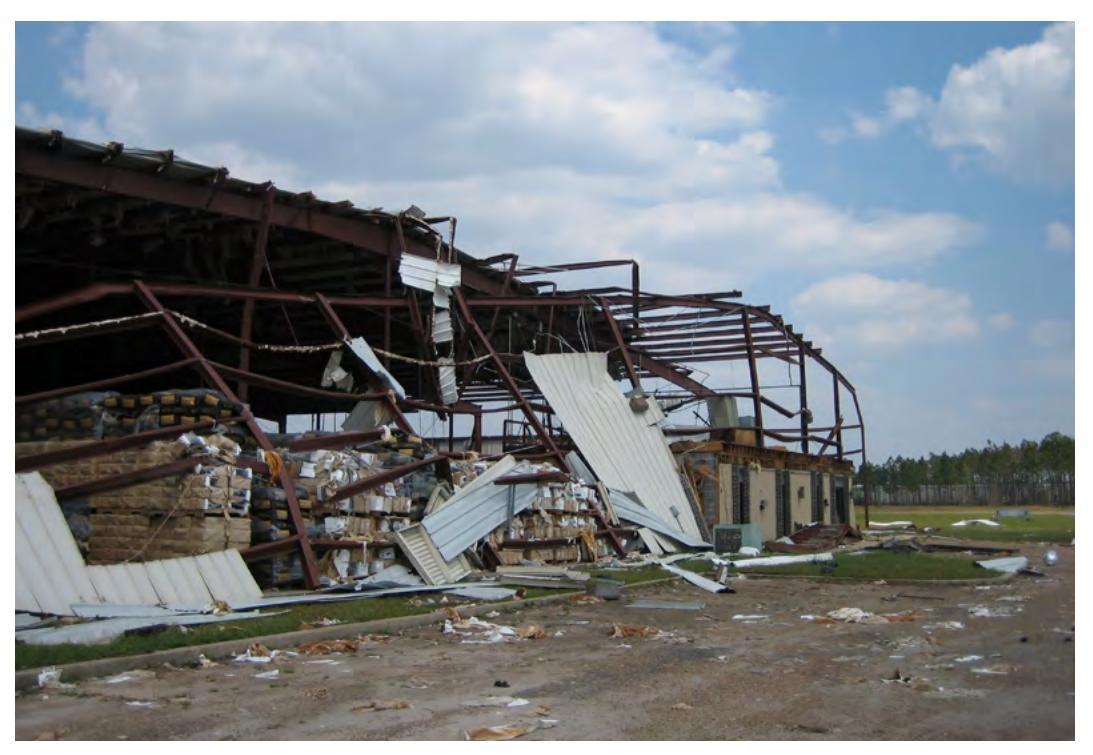
This was definitely a case of significant wind.

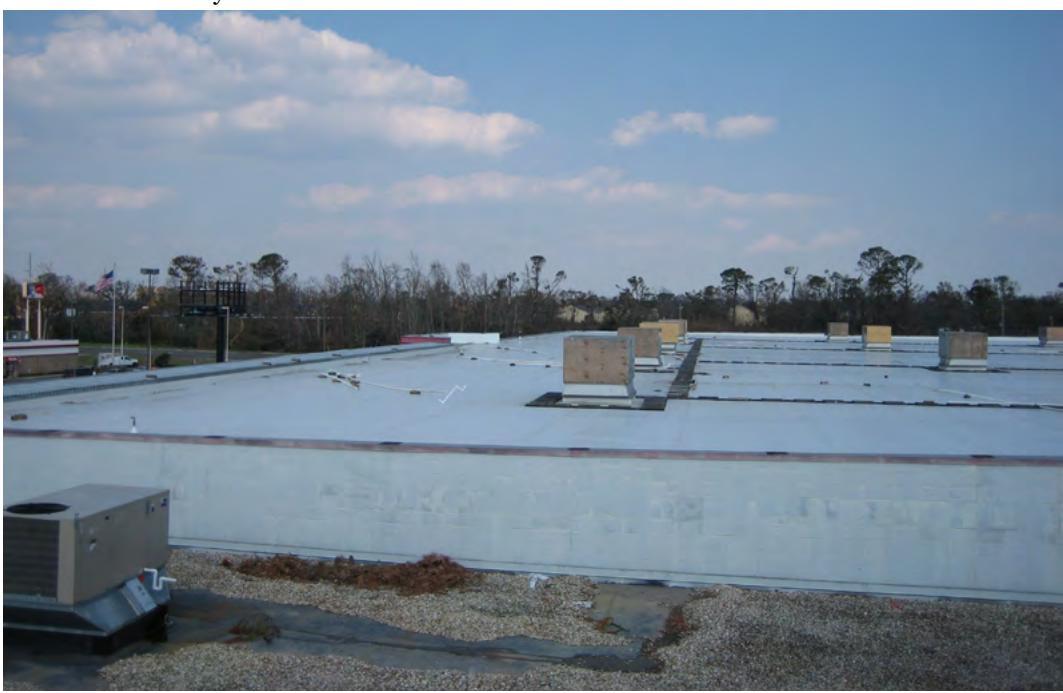
This building "K-Mart" was also in the Long Beach area. It is a mechanically fastened 10' TPO.

Flying debris left a few scars here and there but we couldn't find a loose fastener. It was a similar finding on this mechanically fastened vinyl roof in Bay St. Louis.
