QUALITROL CASE STUDY:

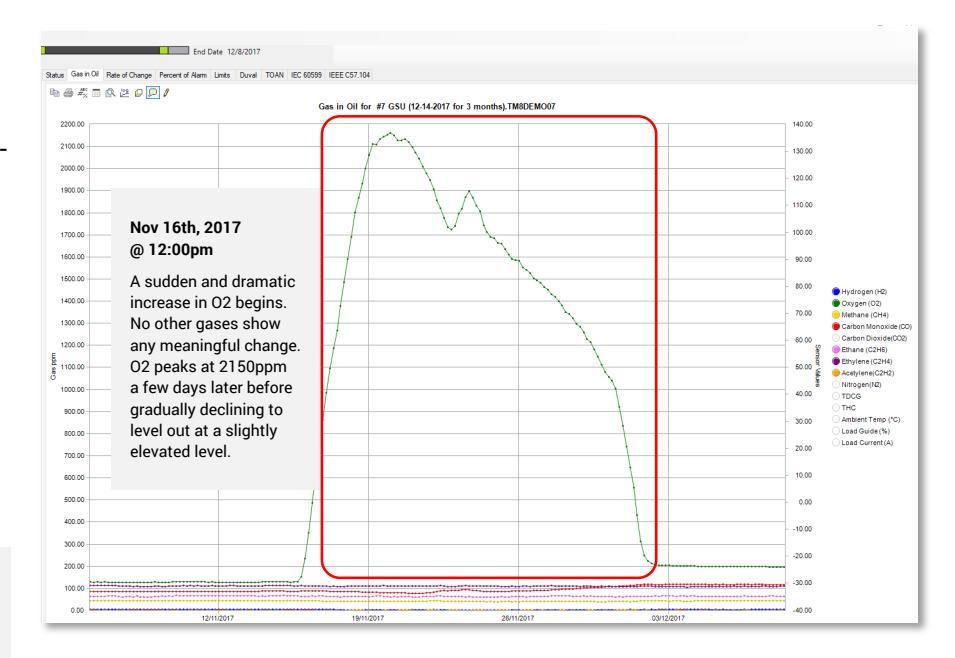
A Qualitrol Serveron TM8 mutli-gas DGA device was monitoring an old (30+ years) 3phase 230kV shell-form nitrogen (N) blanketed GSU. At midday on November 16, 2017, the TM8 alarmed for increasing concentration of Oxygen (O2), which had been stable at 130ppm for an extended period. Over the course of the following 3 days O2 concentration continued to increase, peaking at 2,150ppm before gradually declining back to a stable 200ppm.

Reviewing the data around the time of the increase in O2 concentrations using Serveron TM View software, no fault is detected using any of the established diagnostic methods.

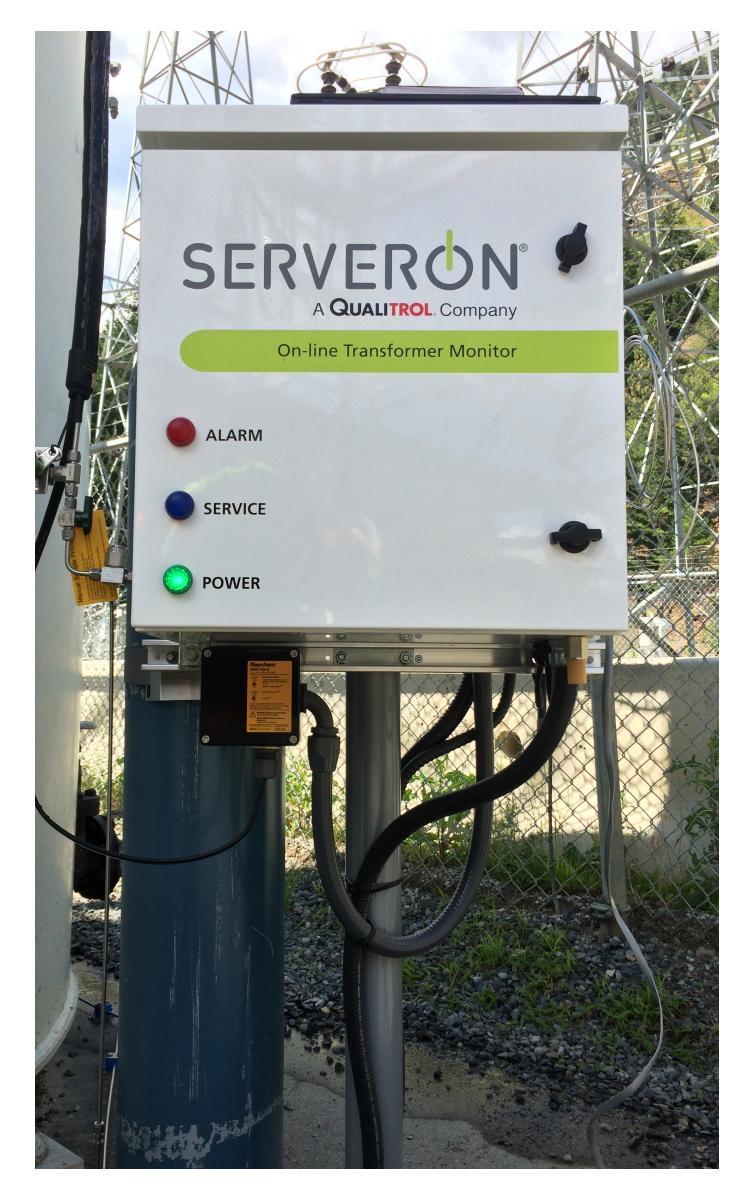
The sudden O2 increase, with no associated change in any other gas indicated that the O2 originated from the atmosphere. Qualitrol experts suggested that the transformer may have had an atmospheric air injection and requested the operator to investigate. Upon a physical examination of the transformer it was noticed that there was a leaky manhole cover gasket and that the pressure of the nitrogen blanket was close to atmosphere. It was determined that a partial vacuum occurred in the transformer during a cool down that resulted in atmospheric air being sucked into the transformer.

O2 can facilitate oxidation in the transformer and thus shorten the life of the paper. However, the big concern with a transformer sucking atmospheric air in is that inevitably, it also brings moisture into the transformer.

"N2 pressure does not prevent entrance of water--only a good gasket seal does."
