Issue

Spotlight: A Risk-Based Approach for Combustible Dust Hazard Mitigation

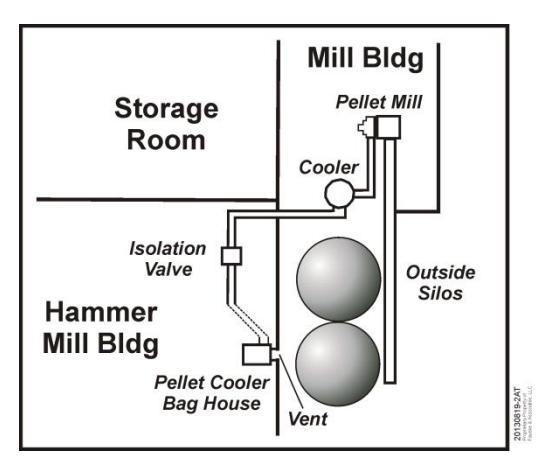
Figure 1. Pellet Cooler Bag House House (Post-repair)

A fire and combustible dust explosion occurred at a wood pellet manufacturing plant. A smoldering nest started in the pellet cooler and the local fire department was notified. As fire fighters prepared to extinguish the pellet cooler fire, a hot ember travelled through the ducting to the pellet cooler bag house and initiated a combustible dust deflagration. The deflagration ruptured the bag house explosion vent, resulting in a fire that propagated through the 6 foot duct through the wall and onto the side of a nearby corrugated steel silo located 8 feet away from the building. The flames spread up the side of the silo containing dried-wood particulate and through vents on the underside of its cone-shaped roof, causing hot embers to enter the silo and start another fire.
