Nuclear Materials and Energy 000 (2016) 1-17

Safety insights from forensics evaluations at Daiichi

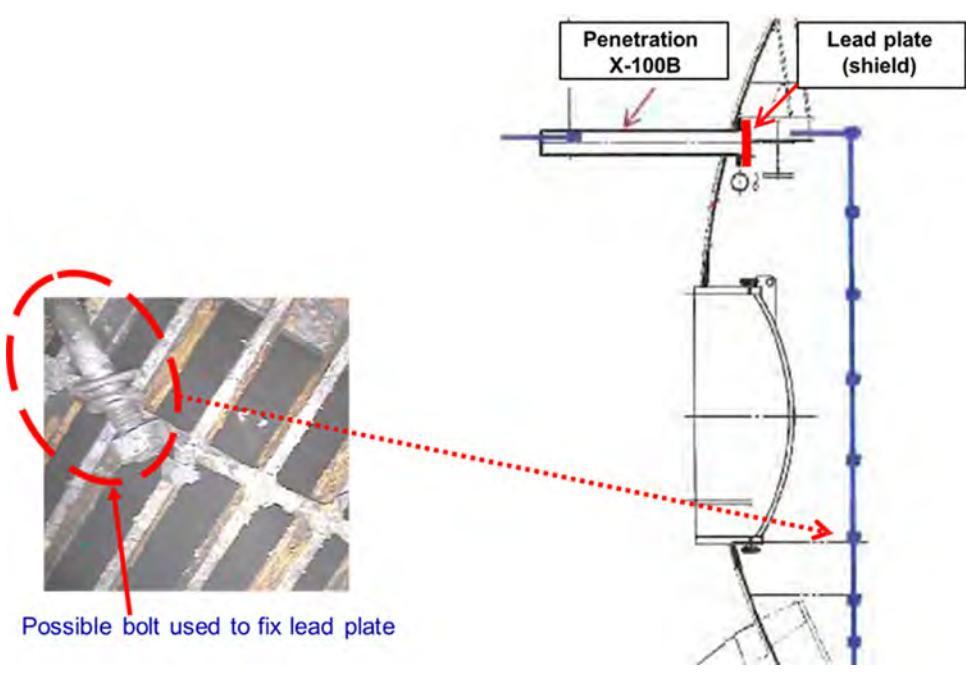
Fig. 1. Visual images within 1F1 X-100B penetration. (Courtesy of TEPCO [6]).

2.3.1.1 *IF1*. Pressure data [3] from 1F1 indicate that peak PCV pressures were as high as 0.84 MPa/122 psia on March 12, 2011. Temperature data were not available until March 21, 2011. The calculated saturation temperature for this measured peak pressure (neglecting any release of high temperature steam or hydrogen from the vessel) is 172 °C/342 °F. However, as shown in Fig. 1, examinations within the X-100B penetration of 1F1 revealed that the lead shield cover plate was missing. In order for this lead plate to have melted, gas temperatures inside the drywell exceeded 328 °C/622 °F, the melting point for lead.

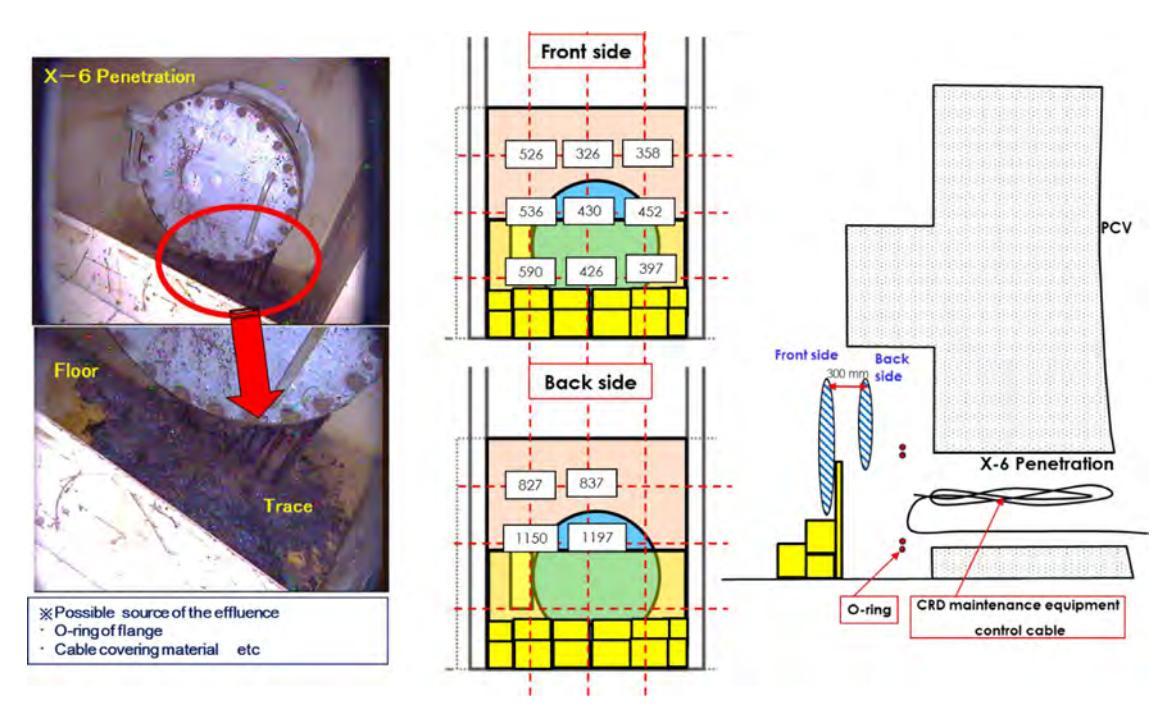
Fig. 2. Photographs and radiation surveys (in mSv/hr) near 1F2 X-6 penetration (values measured in 13 locations). (Courtesy of TEPCO [23,24]).

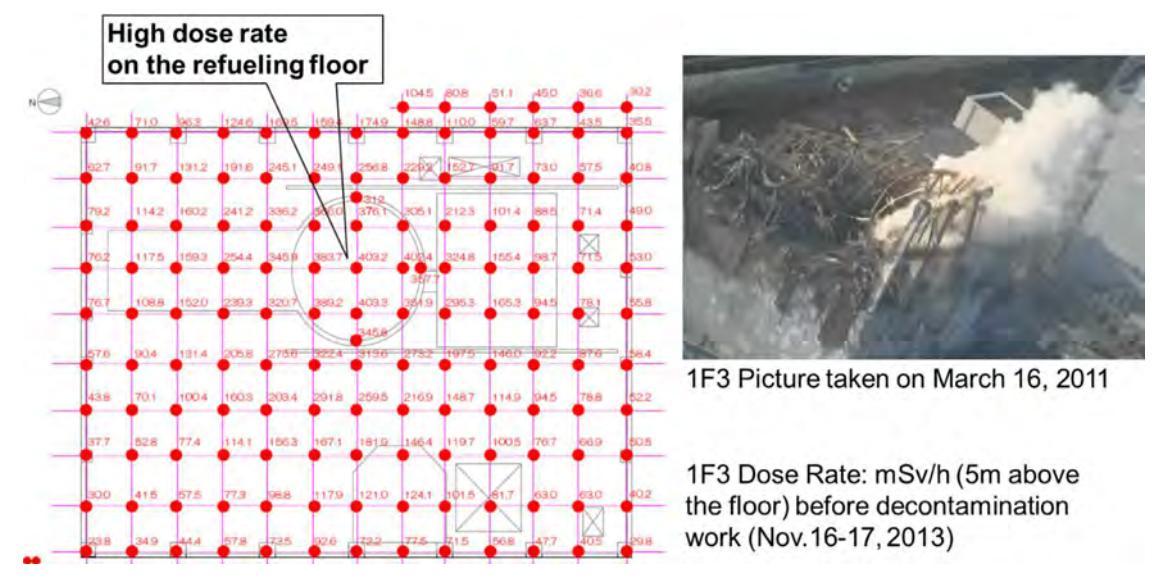
2.3.1.3. 1F3. Insights about 1F3 leakage come from photos and dose surveys. As shown in Fig. 3, steam appears to be escaping at locations near the drywell head, and higher dose rates were measured near the drywell head. Both of these observations are consistent with a failure of the drywell head, perhaps due to drywell bolt expansion or seal degradation from high temperatures and pressures within the PCV. Plant data [3] indicate that 1F3 pressures were as high as 0.75 MPa/109 psia on March 13, 2011. Temperature data were not available until March 20, 2011. The saturation temperature for the measured peak pressure, neglecting any release of high temperature steam or hydrogen from the vessel, is 168 °C/334 °F. The combined pressure and temperature challenges are postulated to have stretched the drywell head bolts and al-

lowed leakage through that pathway. However, the degree of damage to the head gasket is not known at this time. Photos showing leakage from MSIV expansion joints and radiological surveys from the equipment hatch penetration indicate that 1F3 developed multiple leakage locations.

Fig. 3. 1F3 radiation survey (value in mSv/hr measured on November 16-17, 2013 at 5 m above the floor at points shown on grid) and photograph taken on March 16, 2011 (Courtesy of TEPCO [6, 8]).

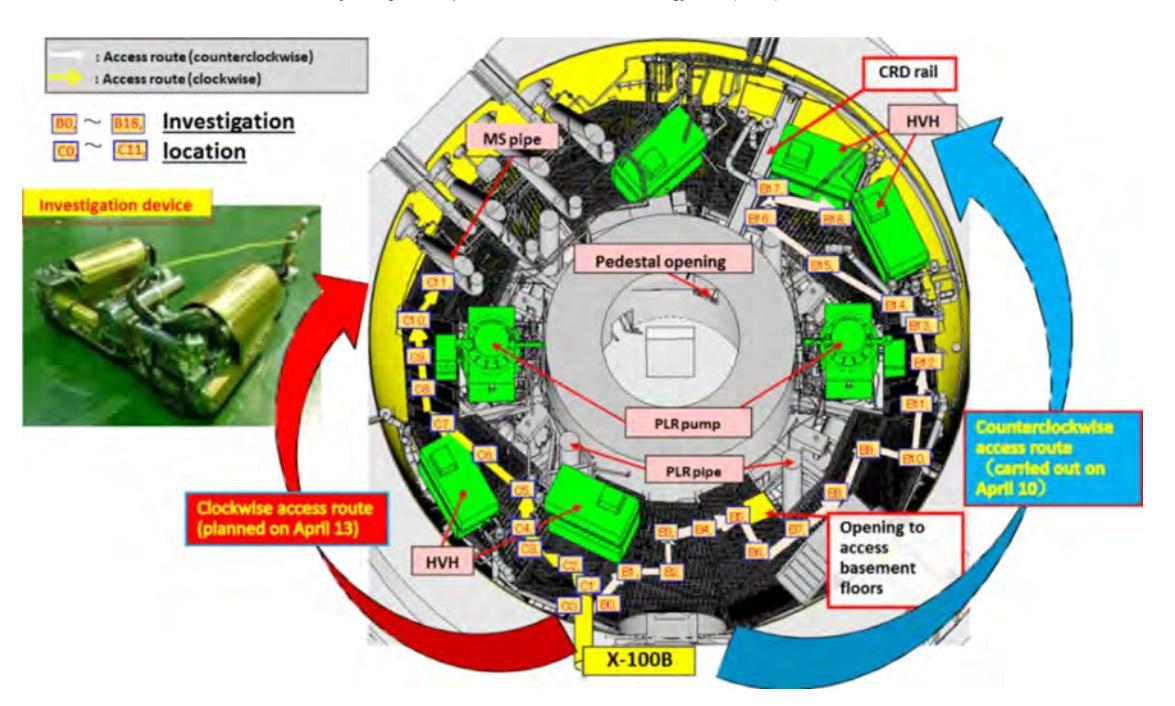
Fig. 6. Location of X-100B in 1F1 PCV and robotic examination paths completed on April 10, 2015. (Courtesy of TEPCO [55]).

Other valuable information obtained by TEPCO regarding conditions inside the PCV for 1F1 has been obtained by robotics examinations through a containment penetration; i.e., the 'X-100B' penetration; see Fig. 6 [55]. Prior to the accident, this penetration was shielded on the interior of the PCV to reduce the radiation level in the reactor building. As discussed in Section 2.3.1.1, the first piece of information gathered when this penetration was opened was that the lead shielding had melted during the accident. Lead melts at 328 °C/ 622 °F; temperatures this high in the PCV atmosphere are hard to rationalize unless one postulates vessel failure and core debris discharge into the pedestal region.

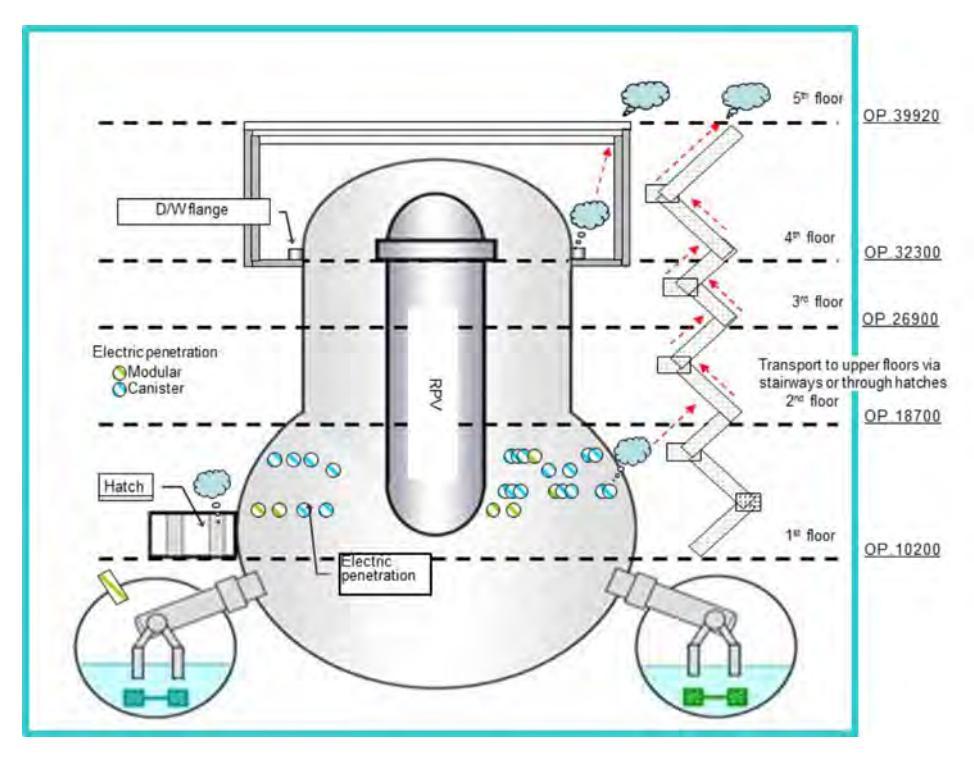
Fig. 10. Inferred hydrogen leakage paths. (Courtesy of TEPCO, [61]).

The upper part of the 1F1 reactor building above the operating floor (the 5th floor) experienced an apparent hydrogen explosion on March 12, 2011 at 3:36 pm approximately 25 hours after the seismic event [59]. It is believed that this hydrogen was primarily due to reactions between steam and fuel Zircaloy cladding. The exact pathway through which the hydrogen flowed is unknown, but available information suggest that it leaked into the building through degraded seals on the head of the PCV, the hatch equipment, and other penetrations (see Fig. 10).

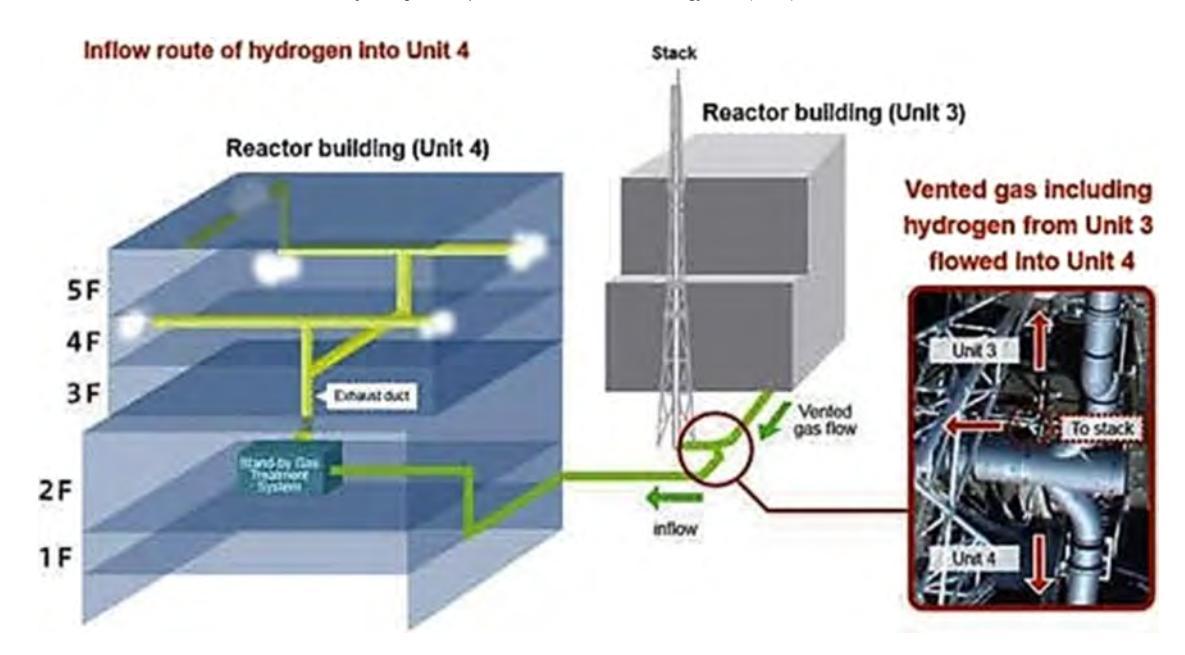
Fig. 11. Hydrogen transport path from 1F3 to 1F4. (Courtesy of TEPCO, [58]).

These findings are consistent with the hypothesis that the ventilation flow from 1F3 travelled into the 2nd floor of 1F4 and then into other areas of the 1F4 reactor building via pipes and the SGTS ducts.¹

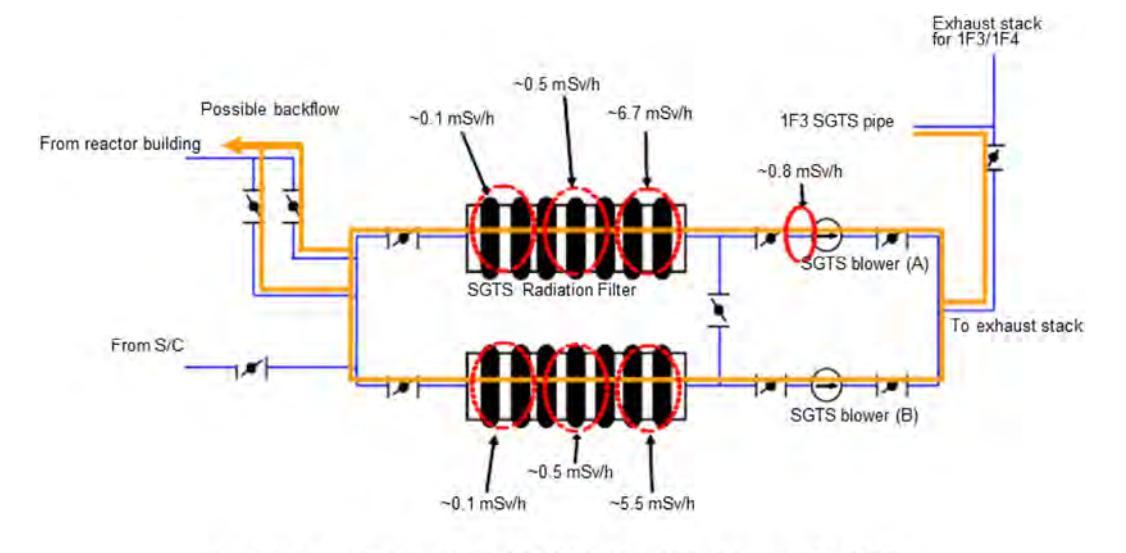
Fig. 12. 1F4 SGTS radiation measurement results. (Courtesy of TEPCO, [61]).

- Examinations of the filter train of the standby gas treatment system (SGTS) at 1F4. Measurements indicate that the concentration of radioactive materials accumulated at the outlet was higher than at the inlet. This implies that contaminated gas flowed into the 1F4 SGTS piping from the outlet, which is reversed from the expected gas flow direction (see Fig. 12).
- Field investigations near the 1F4 SGTS duct on the 4th floor. Damage to the 4th floor (along with the floors above and below this floor) and remaining pieces of the SGTS exhaust duct work support the concept that the explosion originated at this location (see Fig. 13).
- Examinations of the fuel in spent fuel pool for 1F4. At the time of the accident, the 1F4 reactor had been completely defueled with the fuel placed in the spent fuel pool for planned work on RPV internals. Thus, the only credible source of hydrogen

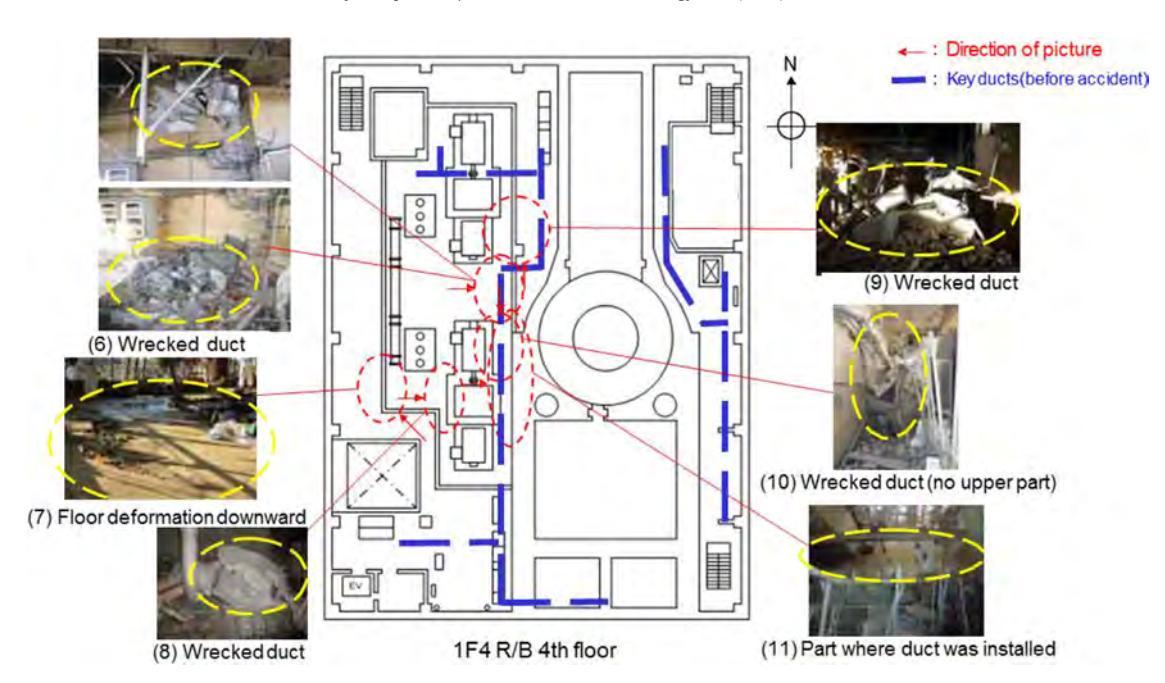
The 1F4 explosion in the reactor building is estimated to have occurred on March 15, 2011 at 6:14 am [59]. There were no videos capturing the explosion when it occurred. Unlike 1F1, the structure of 1F4 is a reinforced concrete structure with higher design limits with respect to pressure loadings. Most of the roof slab and walls were blown off leaving only the frame structure consisting of pillars and beams [57]. Most walls on the 4th floor and some walls on the 3rd floor were damaged.

Fig. 13. Field investigation of the 1F4 4th floor (Courtesy of TEPCO, [61]).

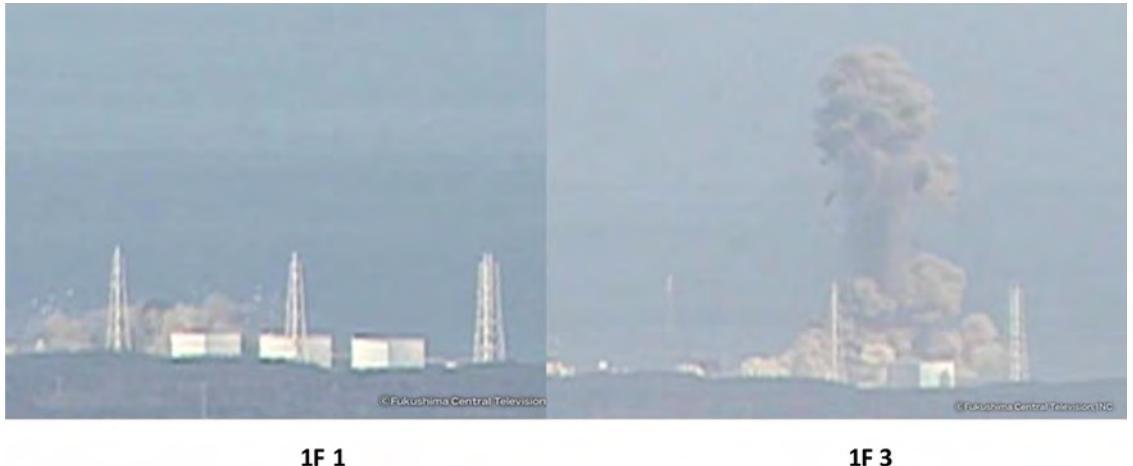
Fig. 14. Snapshots comparing 1F1 and 1F3 explosion characteristics (Courtesy of FCT, [66]).

US and Japan expert evaluations of information related to hydrogen combustion [62,63,64,65], indicate that the hydrogen explosion at the 1F3 reactor building was very different from the explosion of 1F1. As shown in Fig. 14, the explosion at 1F1 was directed horizontally from the top floor of the reactor building. The explosion "smoke" (product gas) was white indicating that the "smoke" was a condensed water vapor which is a by-product of hydrogen combustion. The building roof and side panels were blown away, but concrete pillars remained intact with little damage. The explosions at 1F3 were quite different in appearance and much more energetic. There appeared to be at least two explosions. The first was less energetic and directed horizontally (similar to that of 1F1). The color of the explosion "smoke" appears white and orange. The second was directed vertically with an almost perfect spherical fireball appearing above the building and shooting up very high into the sky (about 3 times the vent stack height). Large chunks of materials appeared to be carried with the fireball. Unlike the explosion at 1F1, available 1F3 images indicate that concrete pillars on the building top floor were highly damaged and the product gas of the explosion appears to be a darker color, raising questions, such as: whether a significant amount of reactor building concrete dust was generated from the explosion; or if dust was generated within the drywell due to Molten Core Concrete Interaction (MCCI).

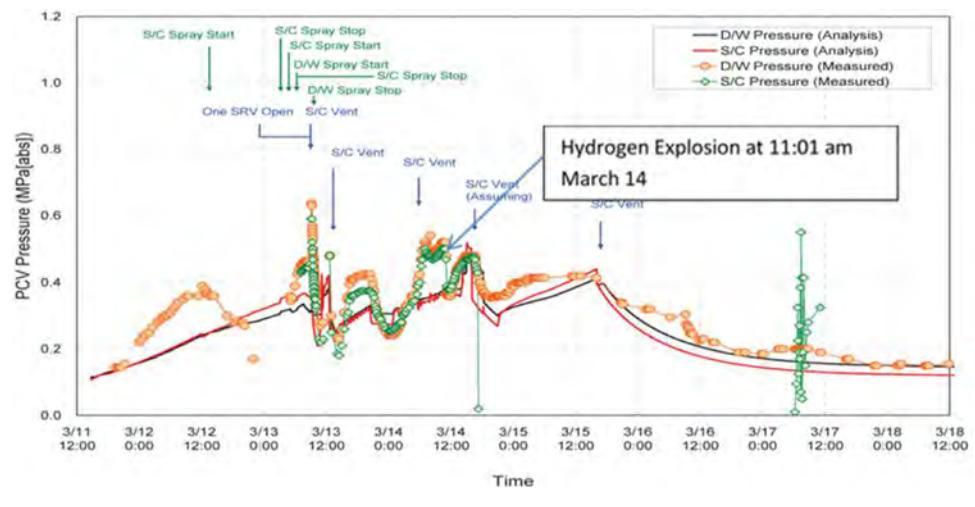
The time of the 1F3 explosion, 11:01 am, March 14, 2011 was near the time when the 1F3 PCV pressure instantaneously dropped from 0.53 to 0.36 MPa (Fig. 15). The instantaneous drop in pressure is believed to correspond to drywell upper head seal failure. This PCV failure would release a hydrogen-steam gaseous mixture into the 5th floor of the reactor building. These hot vent gases could have ignited hydrogen gas that had leaked earlier and accumulated on the 5th floor of the reactor building. Ignition of this hydrogen resulted in the first explosion whose burning mechanism was similar to the 1F1 explosion. Failure of the 1F3 drywell upper head seal then provided a large, continuous supply of hydrogen gas from inside the drywell through the failed head seal. This fuel jet entrained surrounding air as it moved upward and burned as a large fireball emanating from the reactor building into the sky.

Fig. 15. 1F3 PCV pressure: the rapid drop coincides with 1F3 explosion time (Courtesy of TEPCO, [65]).
