2017 Volkswagen Atlas

Weak Key Fob - Failure to Recognize

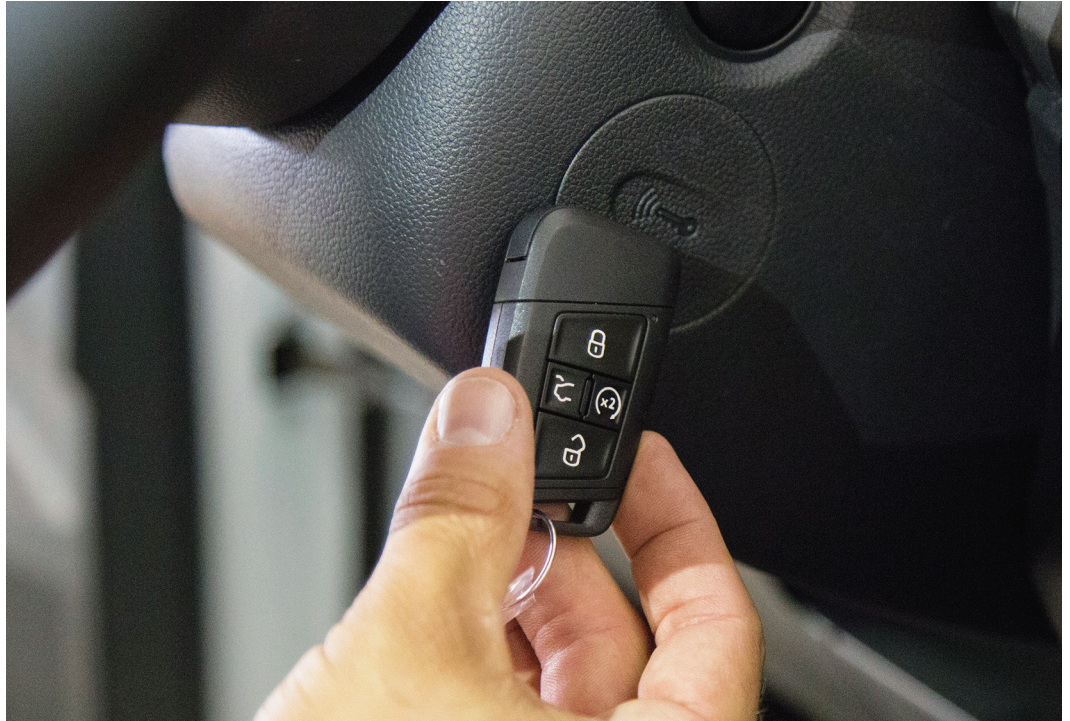
When an Atlas proximity key fob battery becomes weak, the vehicle may have difficulty acknowledging its presence and not start.

The designated area in the Atlas is on the right side of the steering column.

Holding the fob near the designated area will aid in starting the vehicle.

Immediately replace the weak key fob battery.
