McLaren 570S

Weak Key Fob -
Failure to Recognize

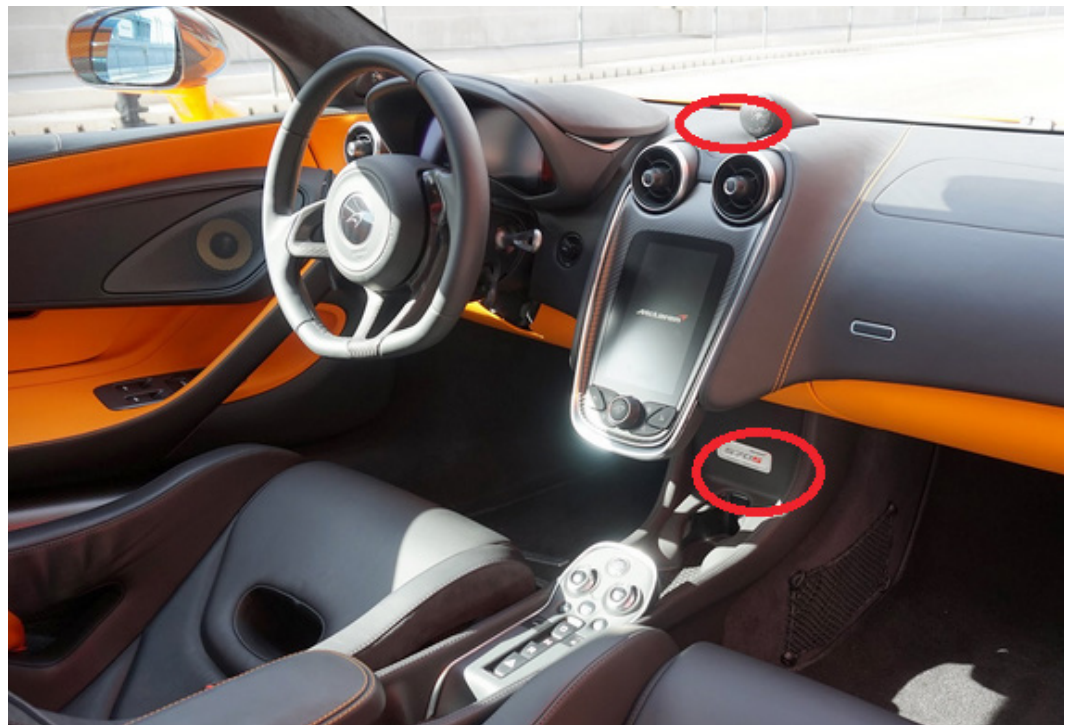
When a McLaren proximity key fob battery becomes weak, the vehicle may have difficulty acknowledging its presence and not start.

The designated areas in this model are indicated above, circled in red.

Holding the fob near the designated areas will aid in key recognition and help start the vehicle.

Immediately replace the weak key fob battery.
