## McLaren 570S

Weak Key Fob -  
Failure to Recognize

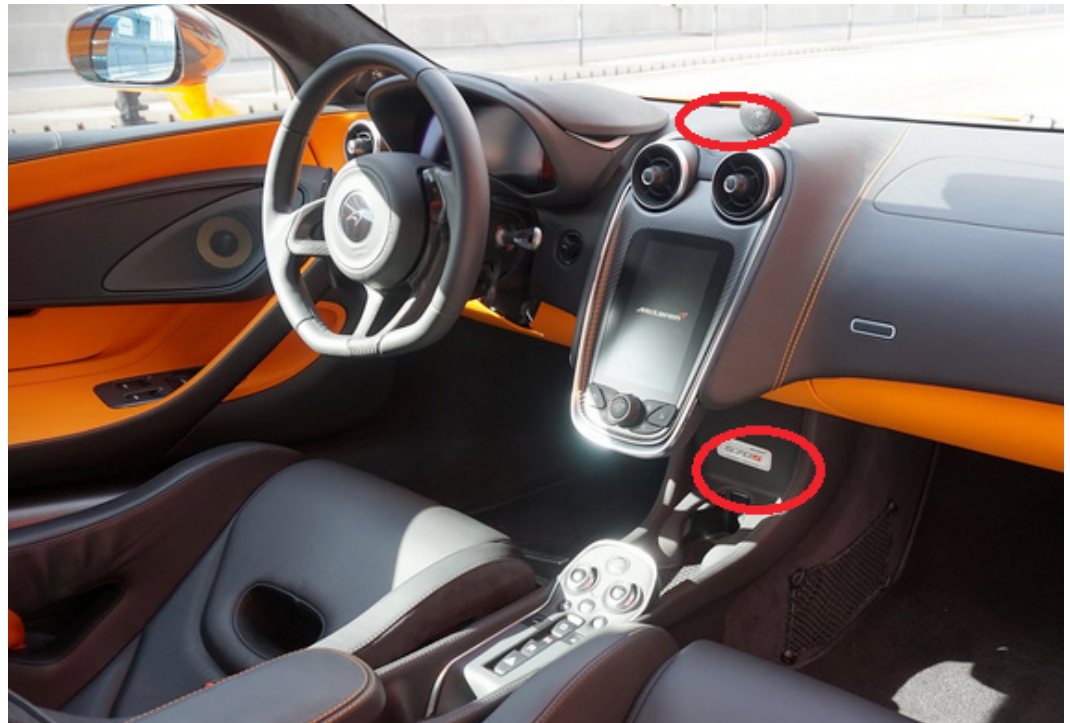
When a McLaren proximity key fob battery becomes weak, the vehicle may have difficulty acknowledging its presence and not start.

The designated areas in this model are indicated above, circled in red.

Holding the fob near the designated areas will aid in key recognition and help start the vehicle.

Immediately replace the weak key fob battery.
