## Shrinkage and Corner Cracks in Concrete

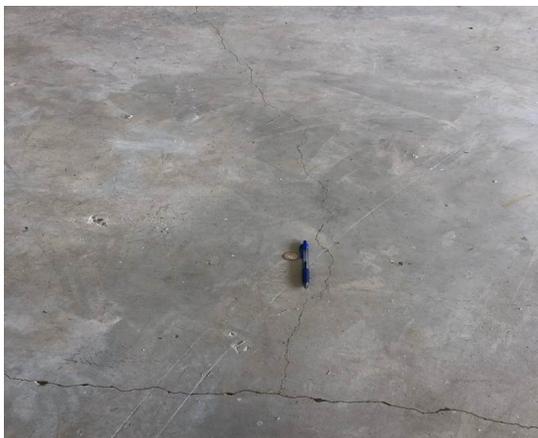
During the concrete curing process, plastic shrinkage cracks can occur in a foundation. See photo on bottom left. Concrete shrinks as it cures. The surface of the slab-on-grade foundation cures faster than the concrete below the surface of the foundation and the surface layer of concrete becomes less plastic. Shrinkage cracks are usually limited to the upper surface of the slab and are typically 1/16" or less in width. Although the cracks are noticeable in the surface of the slab, they are not a structural concern due to the function of a post-tension reinforced slab-on-grade. The tendons, when stressed to design specification, induce compression forces into the concrete. The cable tension causes the two surfaces of a crack to fit tightly and will not separate unless the flexure stress exceeds design. These are referred to as hairline cracks.

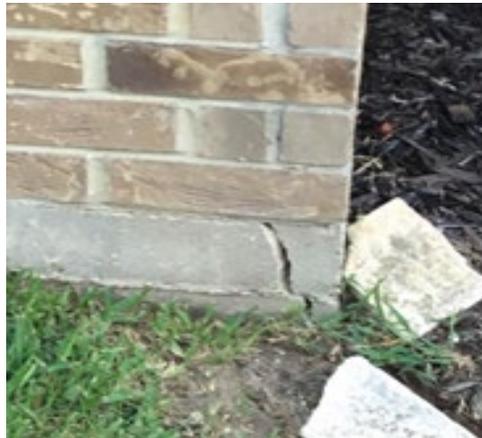
Corner cracks on slab-on-grade foundations are a common occurrence on homes with brick veneer applied to the exterior walls. See photo on bottom right. This phenomenon occurs as the result of differential thermal expansion between the brick and the concrete foundation.

During construction a plastic membrane moisture barrier is placed behind and under the brick veneer to direct any moisture out through the moisture vents placed in the bottom course of brick. This plastic moisture barrier also provides a slip surface that allows the brick to move independent of the foundation during solar heating and cooling of the brick. Unfortunately, the plastic is not always extended over the surface of the outside corner of the brick ledge of the foundation. Thus, the brick mortar bonds to the foundation at the corner well enough to cause a fracture crack to form at the exterior corner(s) of the foundation.

Although corner cracks are unsightly, they are not indicative of a structural failure in the foundation. Cosmetic repairs can be attempted but the crack will probably reoccur. With or without these corner cracks, the foundation remains capable of performing its primary function of properly supporting the home.
