#### Case Study:

Rebuilding of haul roads damaged by moving a dragline at South32 Wolvekrans Colliery

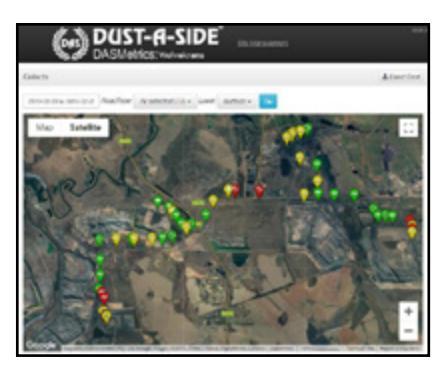
### Road defects before the dragline was moved:

There are few red dots, signifying minimal defects on the road.

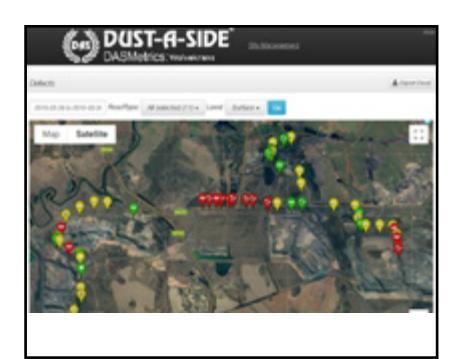
### Road defects during the move of the dragline:

As can be seen, there are many more red dots soon after or during the movement of the dragline.

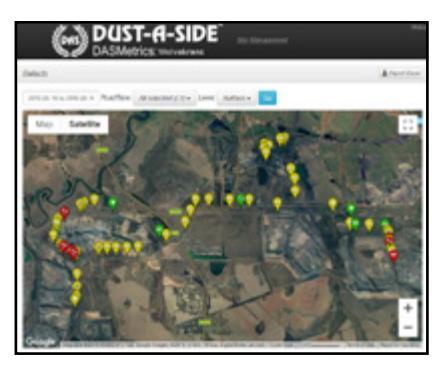
Road defects after dragline damage was repaired:

Red dots are once again minimal after repair work
