RH Effects on Wood Flooring

By David Stutzman, AIA, CSI, CCS, SCIP, LEED AP

Issue

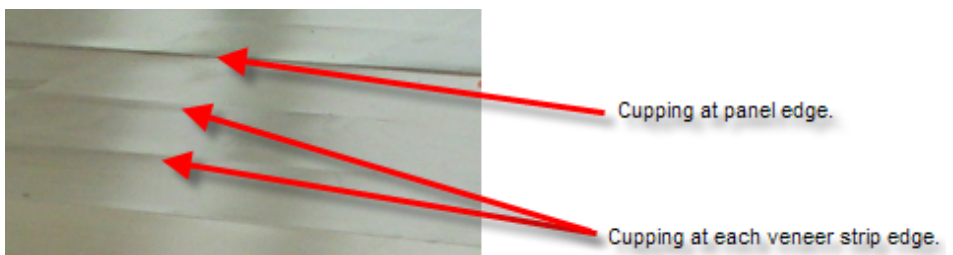
- Cupping
- Side joint separation
- Veneer delamination

Cupping occurs when the flooring moisture content is unbalanced through the flooring thickness. The condition is caused by the exposed surface drying or by the concealed surface absorbing moisture, possibly from the concrete slab. The condition can be temporary. If the flooring moisture content is returned to an as

installed equilibrium condition, the cupping effect will be reduced, maybe eliminated. When the surface veneer delaminates from the backing the flooring must be replaced. Moisture affects the dimension across the wood grain most. The dimension along the length is affected little by changes in moisture content. Solid maple has a thermal expansion coefficient of 2.7×10^{-6} inches/inch/degree F. Assuming a 40 foot long flooring installation and a 40 degree temperature differential, the wood will expand only 0.05 inches. So temperature has minimal effect. Changing the moisture content from green (saturated condition) to oven dry will cause solid maple to shrink across the grain, 3-5 percent for quarter sawn veneer and 7-10 percent for plain sawn veneer. There is little dimensional change when the wood moisture content is greater than the fiber saturation point (25 to 30 percent moisture content). As a composite, engineered maple flooring will exhibit shrinkage values less than solid lumber content before being manufactured into flooring. Reducing the moisture content in the wood before manufacturing helps minimize dimensional changes as a result of drying when the wood achieves equilibrium with the surrounding environment after installation.

Therefore the wood when properly handled, transported, and delivered to the site should be dimensionally stable. The observed conditions indicate that the moisture content in the wood veneer changed dramatically after the flooring was manufactured. The wood equilibrium moisture content (EMC) is a function of relative humidity and temperature of the surrounding air. As a rule of thumb, a relative humidity of 30 percent gives an EMC of 6 percent and a relative humidity of 65 percent gives an EMC of 12 percent, irrespective of temperature. These ranges are within the maximum moisture content range for milling wood, and they correspond to the recommended relative humidity range for installing engineered wood floors. Observed relative humidity was less than 20 percent. If the flooring was at equilibrium at 20%, the EMC would be 4.5, less than recommended lower limit. The cupping is likely the result of the excessively low EMC.

Specify that HVAC systems must be operational and maintaining the facility at design conditions before starting wood flooring installation. Ensure the systems continue to maintain conditions after installation. Require wood products to be delivered to the site and stored with environmental conditions the same as the final construction. Allow time to achieve equilibrium before installation. Size the expansion space at the perimeter of the floor installation to accommodate seasonal dimensional changes from variations in moisture content. The expansion space must be continuous and large enough to accommodate the movement for the size room in which the flooring is installed.
