The Creepy Pond

Getting to the Root of the Problem

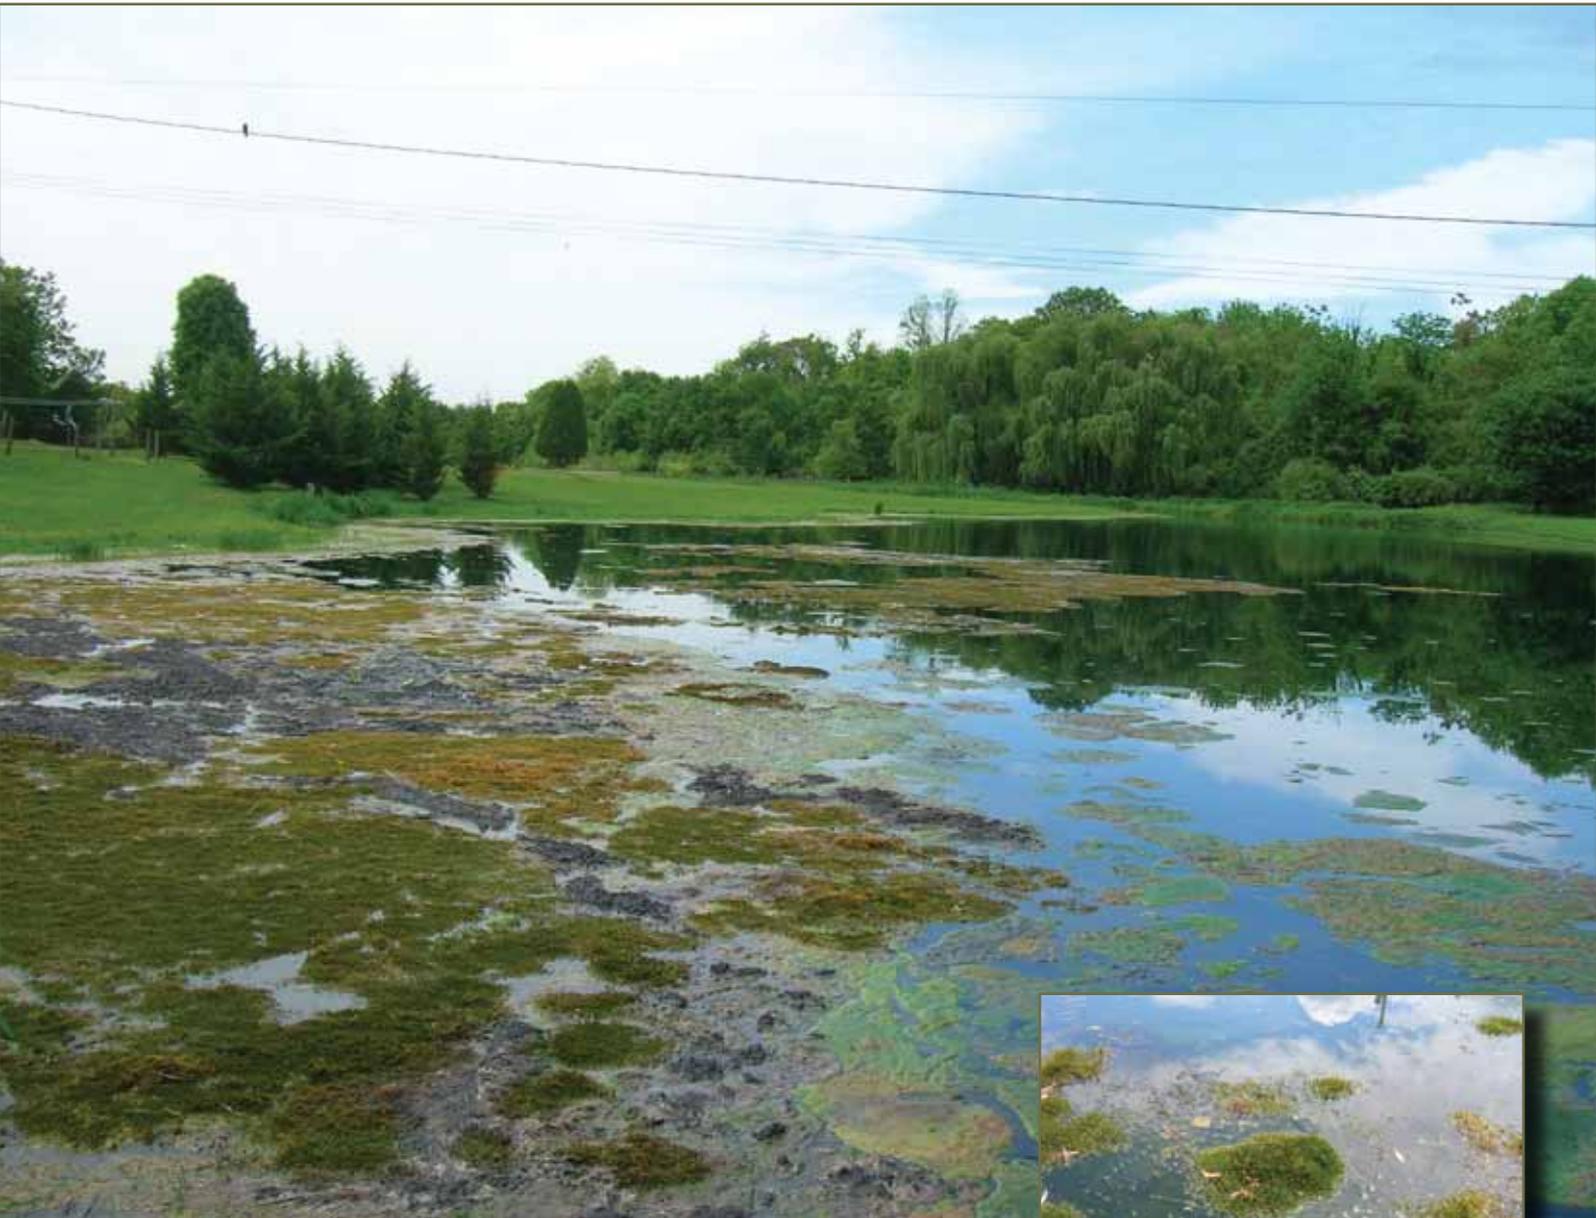
Mats of liverwort and filamentous algae. Inset: Liverwort growth began on the bottom near the springs, and the mats would eventually break free to float on the surface.

At this point, we were only three months into our contract and had expended over half of our annual budget. But we diligently continued treating the pond, striving to get ahead of the issues and to keep the clients happy. Fortunately, the duckweed did not proliferate beyond a few patches that were easily controlled with foliar treatments. Liverwort is very difficult to kill, however, we were able to main-

tain satisfactory control with liquid hydrogen dioxide and diquat. By mid-season, we were able to achieve adequate control of all of the herbaceous nuisance species.

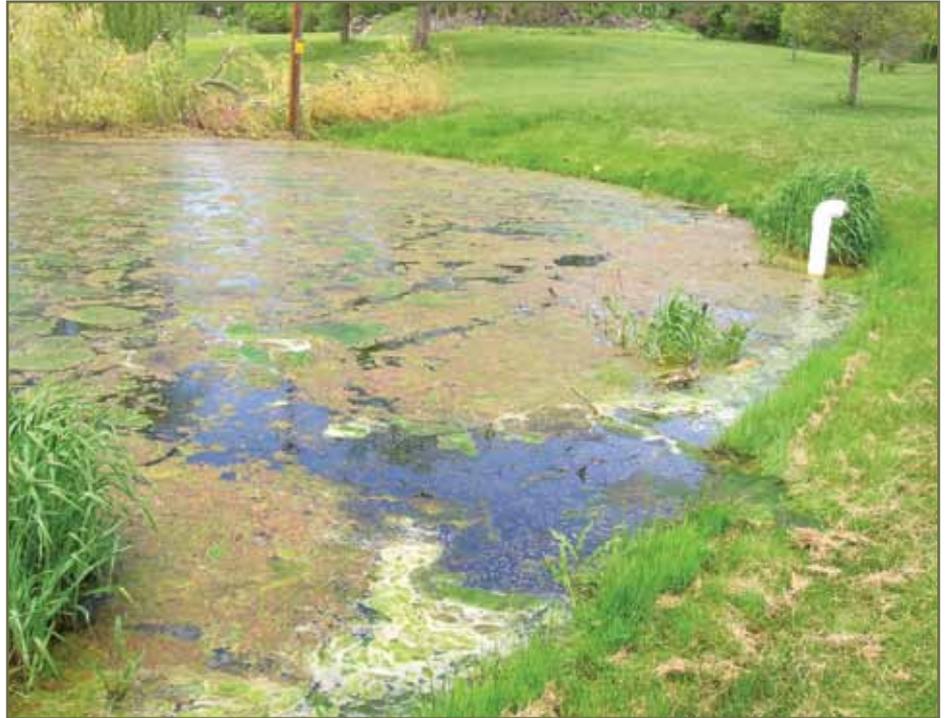
Decaying mats of filamentous algae persisted after treatment.

The algae, though, were a constant and persistent battle for the entire season. There were thick mats of filamentous algae that often filled the entire water column. The decaying biomass of algae and liverwort accumulated on the weir after treatments because of the high flow, often causing the water level to rise above normal pool. There was also a very strange pink

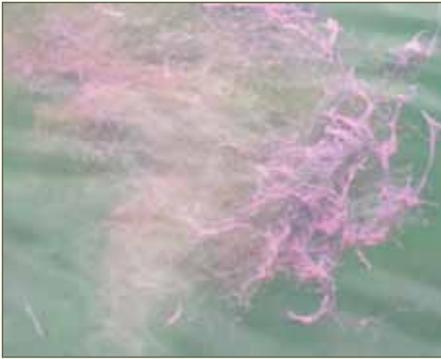
The mysterious "pink slime" was identified as a photosynthetic cyanobacteria.

There was also a very strange pink "slime," that looked a lot like viscous strands of Pepto Bismol, which appeared throughout the pond later in the summer.

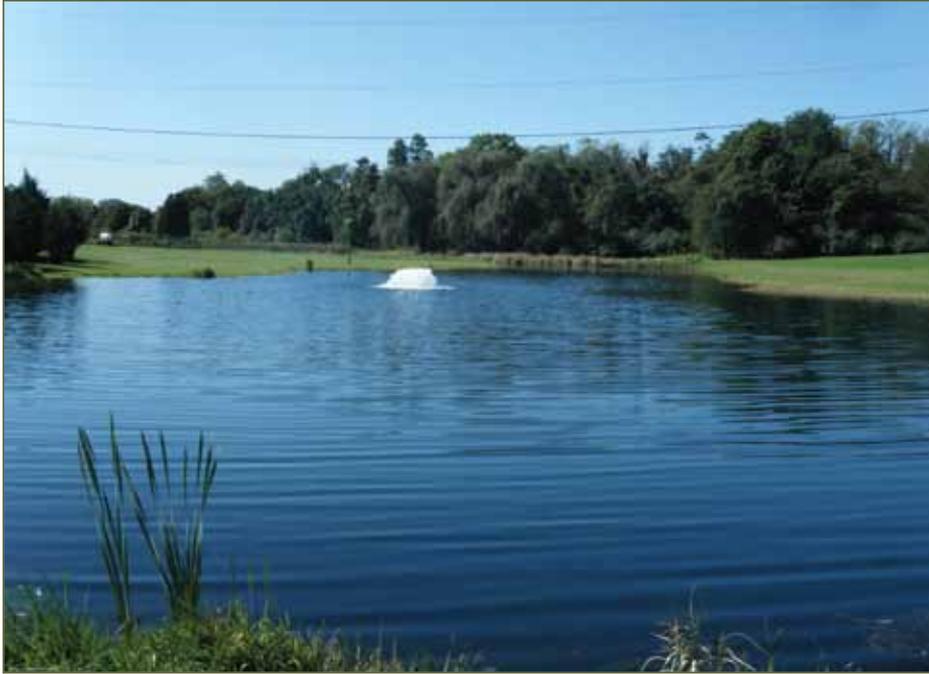
View of the pond after algaecide treatment and Phoslock application.

ments of 1.2 – 2.4 gallons per acre-foot were recommended. For nutrient management, it was recommended that we apply 370 pounds of the phosphorus binder Phoslock to remediate the free reactive phosphorus in the water column and an additional 2,330 pounds to remediate what is in the sediment.

Because our annual budget for the contract was fixed and the client did not want to allocate additional funds, we were unable to implement the entire recommended phosphorus remediation. However, we did perform the water column remediation anticipating that it would significantly improve the water quality and offset some of our herbicide costs. In mid-June, we performed an initial max-rate algaecide treatment with the recommended product followed one week later by the application of 400 pounds of the phosphorus binder.

The results were dramatic. While we still had to treat the pond for algae during almost every maintenance visit, we were able to control the mats before they reached the surface. The pond looked consistently better throughout the season, which made our clients very happy. The phosphorus level was measured again in early July of 2011 and it was found to be down to 100 ppb. It was still high, but was on the low end of the hypereutrophic scale rather than “off the charts”. Best of all for us, the contract was profitable for the first time in 2011. By treating the root of the problem
