# GOLD EMBRITTLEMENT IN LEADFREE SOLDER

## ABSTRACT

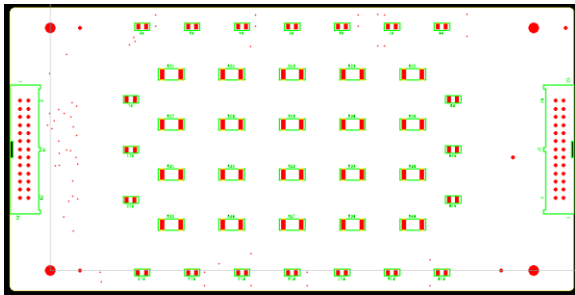
Test samples consisted of 2512 and 1206 ceramic chip resistors assembled to printed circuit boards with varying thicknesses of gold plating. A schematic of the test coupon is shown in Figure 1.

Figure 1: Test coupon

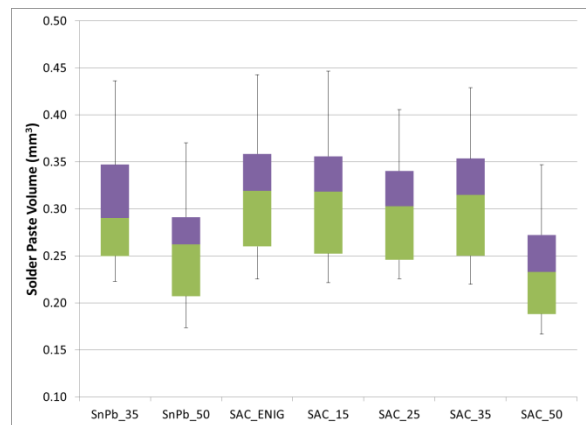
To accurately capture actual gold content in the solder, three dimensional (3D) solder paste measurement was performed on all of the assemblies prior to reflow. The measured solder paste volume deposited on the pads after stencil print is displayed in Figure 3 for bond pads under the 1206 component and Figure 4 for bond pads under the 2512 component.

Figure 3: Measured solder paste volume under 1206 resistor

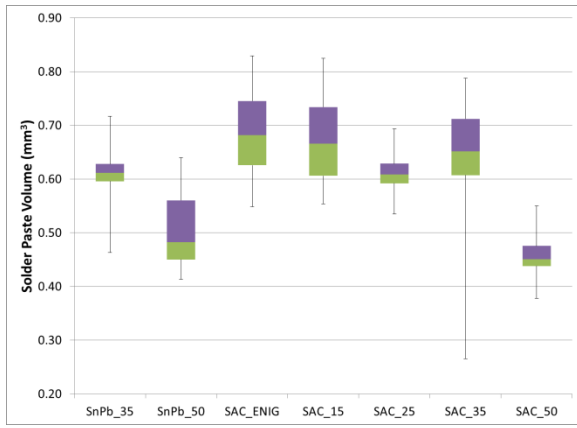
Figure 4: Measured solder paste volume under 2512 resistor

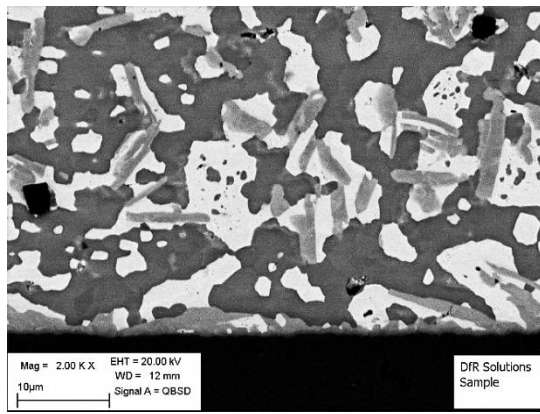
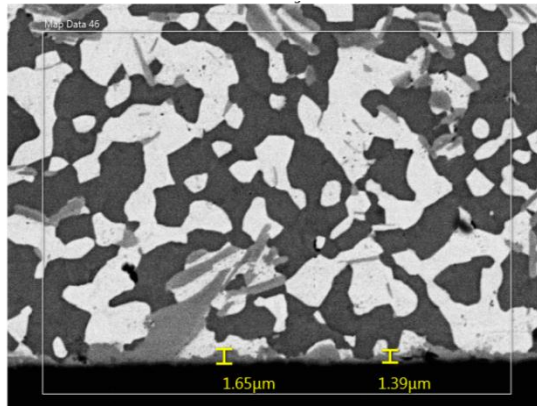
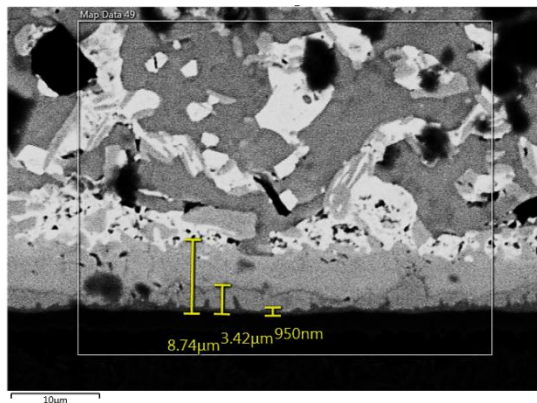
The first images are of the baseline SnPb solder samples with the highest percentage of gold content (6.0 wt%) . The observed morphology after 0 hours of aging, seen in Figure 5, is in line with prior studies that show large  $\text{AuSn}_4$  platelets growing into the Pb-rich phases with high gold content.

After 168 hours of aging at 125C, there is some phase coarsening in the bulk solder, but the  $\text{AuSn}_4$  intermetallic platelets remain about the same size. At the board-solder interface, a layer of  $\text{AuSn}_4$  intermetallics, approximately 1.5 microns thick, can be observed.

After exposure to 125C for 1000 hours at 125C, a significant amount of gold has migrated to the board-solder interface and formed an  $\text{AuSn}_4$  layer close to 10 microns in thickness. An intermittent layer of Pb-rich phase has formed above the  $\text{AuSn}_4$  due to the consumption of tin.

Figure 5 (2000x): Electron micrographs of SnPb Solder with 6.0wt% Gold and Aged for 0 (top), 168 (middle) and 1000 (bottom) hours at 125C

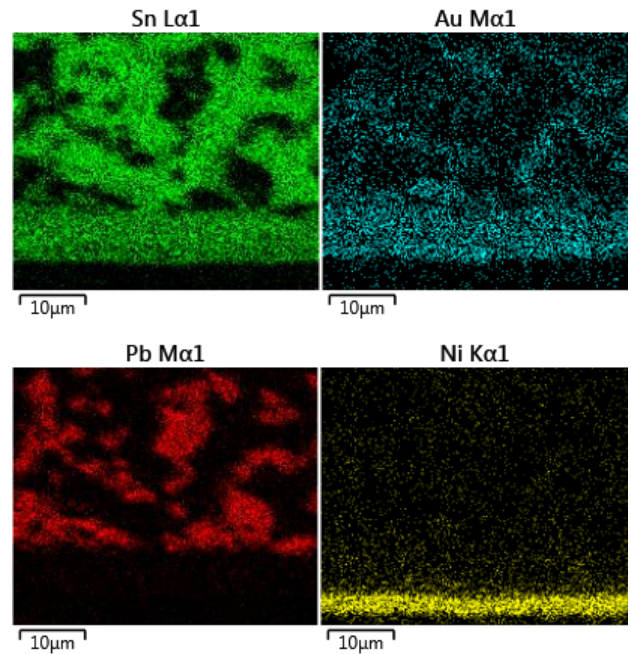
An X-ray map of the SnPb solder with 6.0wt% gold and aged for 1000 hours at 125C shown in Figure 6.

Figure 6: Distribution of Sn, Au, Pb, and Ni in SnPb solder with 6.0wt% Gold and Aged for 1000 hrs at 125C

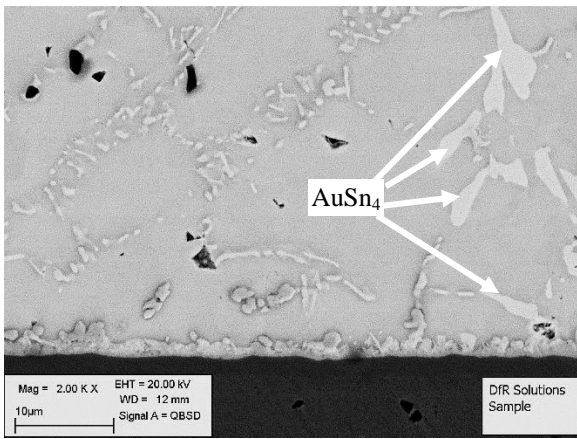
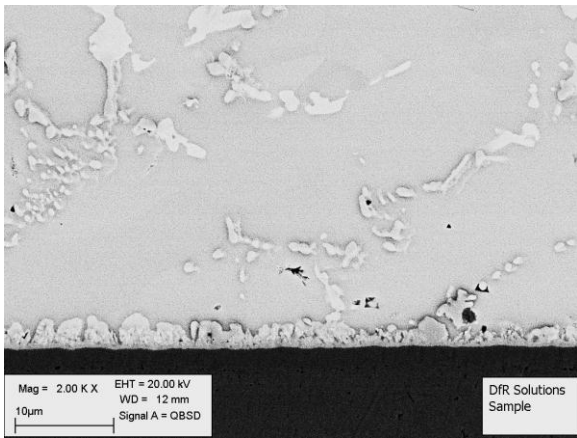
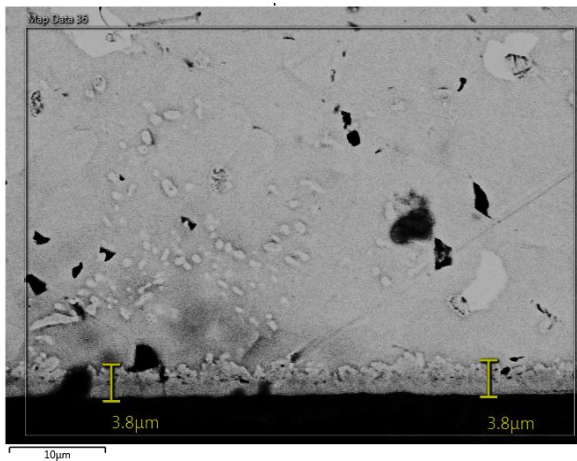
Similar phenomena can be observed with gold content in SAC305 solder. The image of SAC305 solder with 2.0 wt% gold after 0 hours of aging shows a distribution of SnAg and AuSn<sub>4</sub> intermetallics in a tin-rich phase. At the board-solder interface, there is a tin-nickel intermetallic layer, approximately 1 to 1.5 microns thick, with sporadic formations of AuSn<sub>4</sub>.

After aging at 168 hours, the discrete AuSn<sub>4</sub> intermetallics at the board-solder interface have increased in thickness, but have not formed a continuous layer. Some coarsening of the SnAg and AuSn<sub>4</sub> intermetallics in the bulk solder can also be observed.

After exposure to 125C for 1000 hours, the AuSn<sub>4</sub> intermetallics at the board-solder interface have formed a continuous layer. This layer is not uniform and shows extensive variation in thickness compared to the tin-nickel intermetallic layer beneath it. The extent of this layer can be seen in the bottom image in Figure 7 and the X-ray map displayed in Figure 8. The X-ray map also displays an unexpected layer of copper in the area of the AuSn<sub>4</sub> intermetallic layer.

Figure 7: Electron micrographs of SAC305 Solder with 2.0wt% Gold and Aged for 0 (top), 168 (middle) and 1000 (bottom) hours at 125C

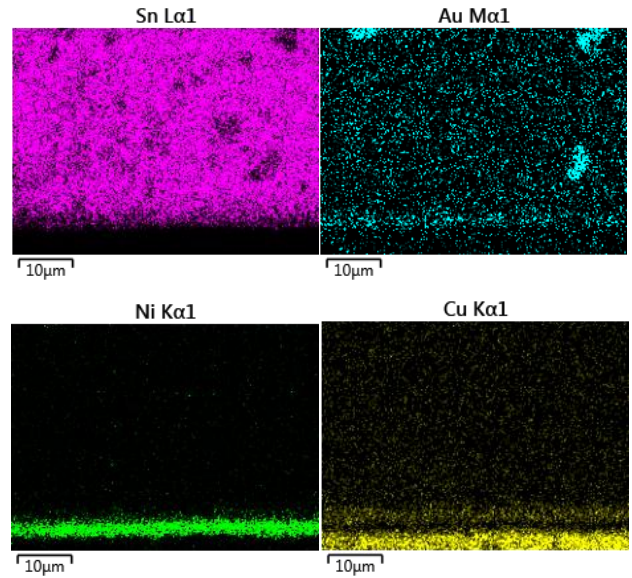
Figure 8: Distribution of Sn, Au, Ni, and Cu in SAC305 Solder with 2.0wt% Gold and Aged for 1000 hours at 125C

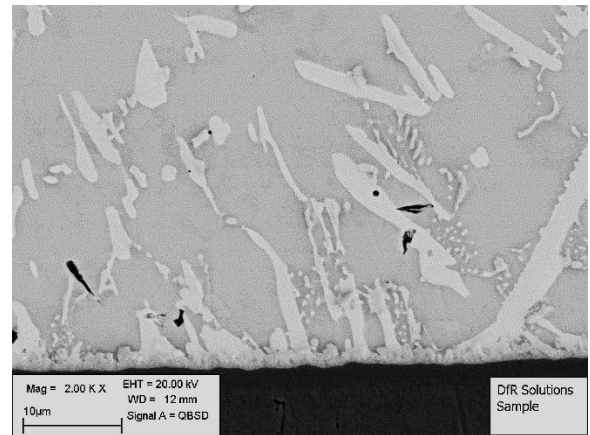
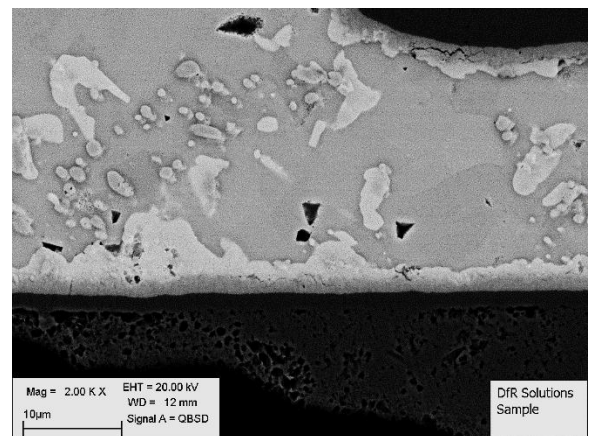
Figure 9: Electron micrographs of SAC305 Solder with 7.5wt% Gold and Aged for 0 (top) and 1000 (bottom) hours at 125C

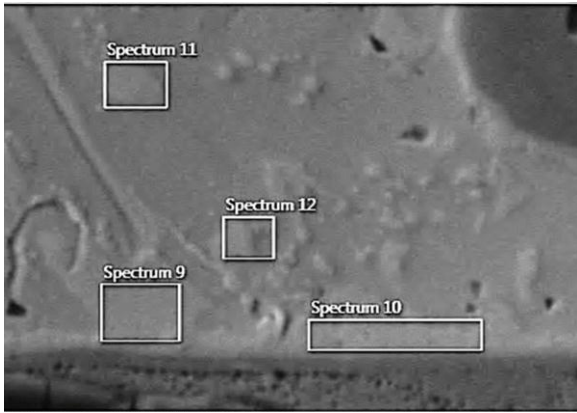
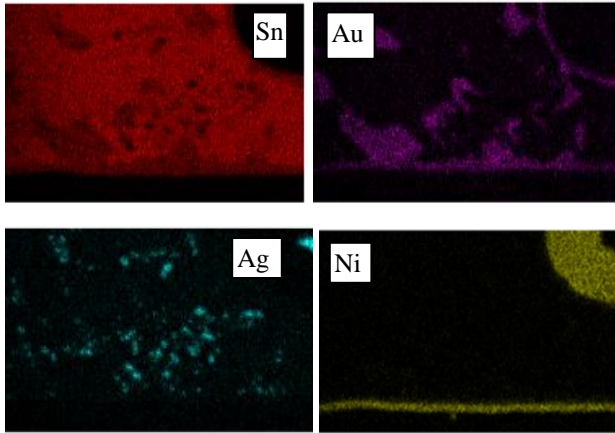
Figure 10: Distribution of Sn, Au, Ag, and Ni in SAC305 with 7.5wt% Gold and Aged for 1000 hours at 125C

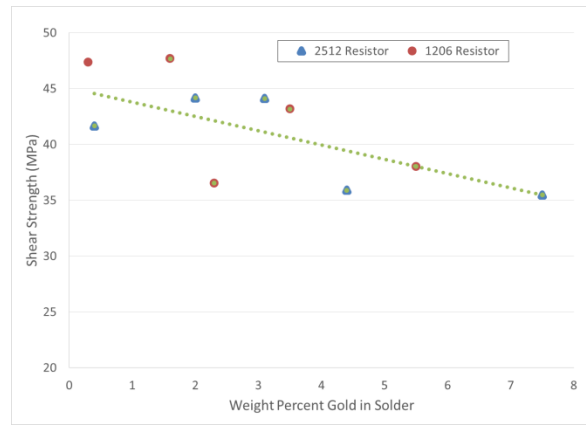
Low speed shear was performed to determine if gold content induced measurable changes in solder strength. The test was performed using the die shear tool at a speed of 2.5 mm/s and a shear height 0.2mm. Shear force measurements were normalized by bond pad dimensions to acquire shear strength values for both 2512 and 1206 resistors. The results as a function of weight percent gold and aging times are displayed in Figure 11 through Figure 13. The dotted green lines are a linear extrapolation of the data.

Figure 11: Low Speed Shear Test Results, SAC305 – 0 hr Aging

It is this duality of failure locations, fracture of the intermetallic in the bulk and separation along a gold-rich layer at the interface, that may explain the shear strength trends observed in Figure 11 through Figure 13. Shear strengths at time zero are dominated by the amount of  $\text{AuSn}_4$  within the bulk SAC305 solder. Initial aging of the SAC305 solder allows the gold in the immediate vicinity of the interface to diffuse towards the  $\text{SnNi}$  intermetallic. This migration weakens the interface and the surrounding solder (discussed as a denuded region in the paragraph below). For SAC305 solder with low gold content, the interfacial region becomes the weak link. For SAC305 with high gold content, the bulk solder with fractured  $\text{SnAu}_4$  intermetallics remains the failure site.

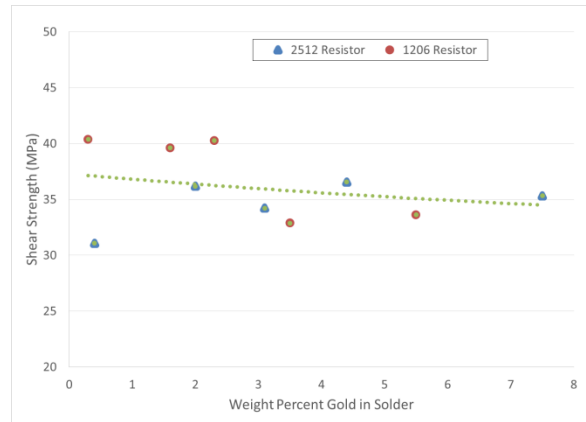
Figure 12: Low Speed Shear Test Results, SAC305 – 168 hr Aging

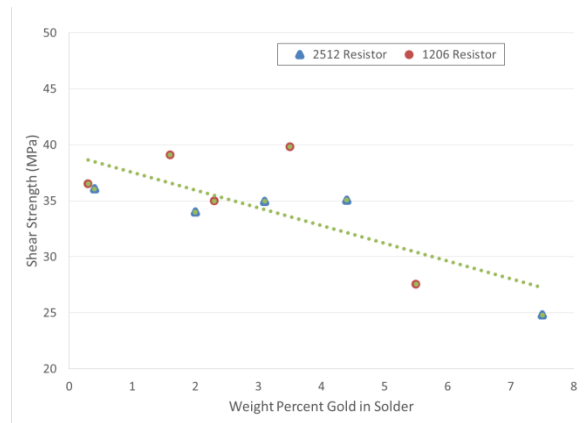
Figure 13: Low Speed Shear Test Results, SAC305 – 1000 hr Aging

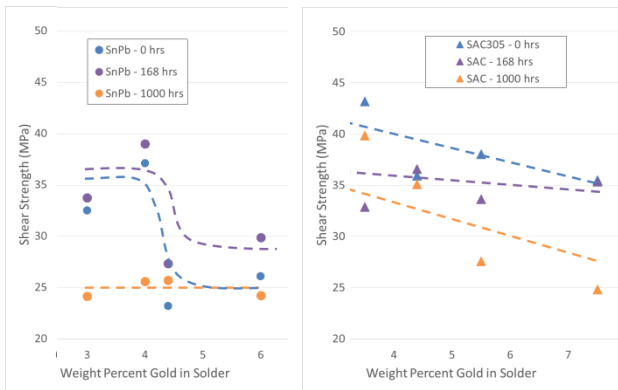
A comparison of the change in solder shear strength as a function of solder alloy is shown in Figure 14. The SnPb samples that are unaged or aged for 168 hours seem to display a substantial drop in shear strength at around four (4) weight percent gold. After 1000 hours of aging, all SnPb samples above three (3) weight percent gold show much lower shear strength. In contrast, the SAC305 samples seem to show a gradual reduction in strength as a

function of weight percent gold, with no defined transition from high to low shear strength.

Figure 14: Low Speed Shear Test Results – SnPb (left) and SAC305 (right)

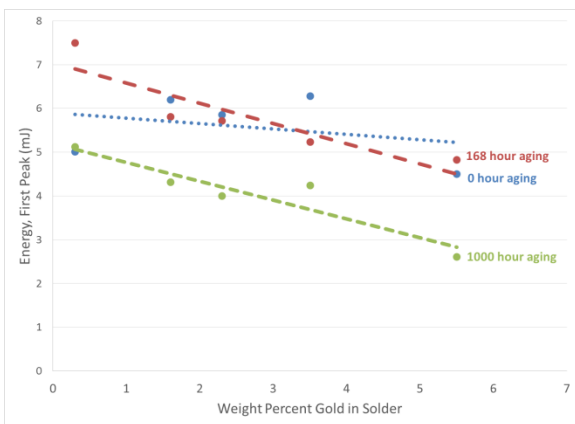
A variety of techniques were used to post process the data from the high speed testing to compensate for different failure modes. The energy that just captures the first fracture (first peak) is shown in Figure 15. The total energy dissipated during the impact results are shown in Figure 16. The dashed lines are linear extrapolations of the results.

Figure 15: High Speed Shear Test Results, SAC305 – First Peak Energy

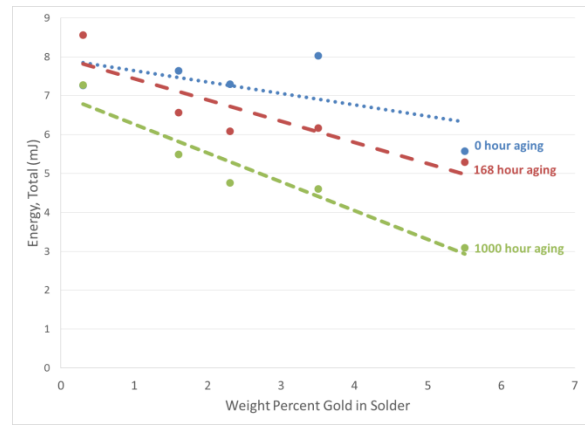
Figure 16: High Speed Shear Test Results, SAC305 – Total Energy

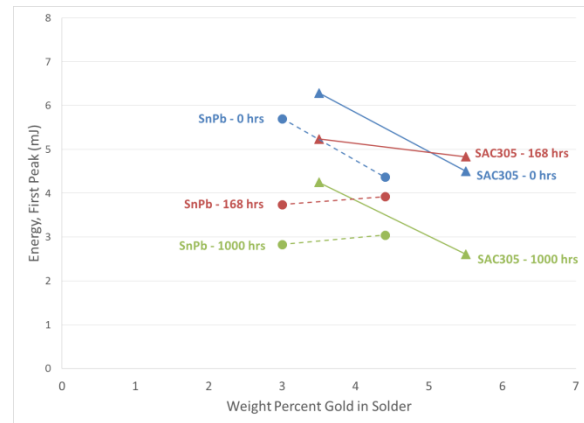
A comparison of change in impact energy as a function of solder alloy is shown in Figure 17 and Figure 18.

Figure 17: High Speed Shear Test Results, SnPb and SAC305 – First Peak Energy

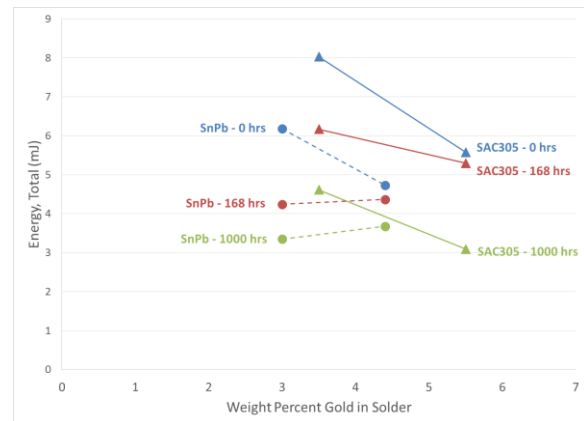
Figure 18: High Speed Shear Test Results, SnPb and SAC305 – Total Energy

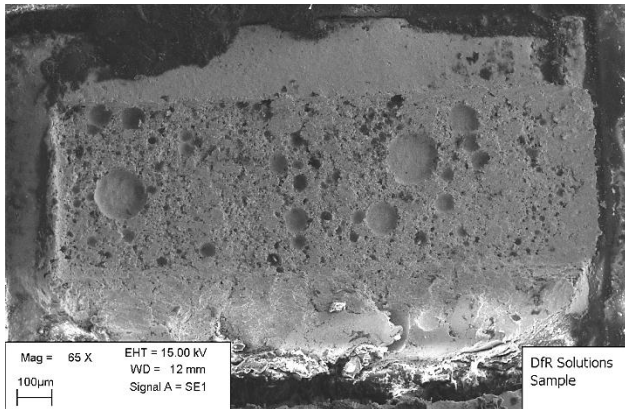
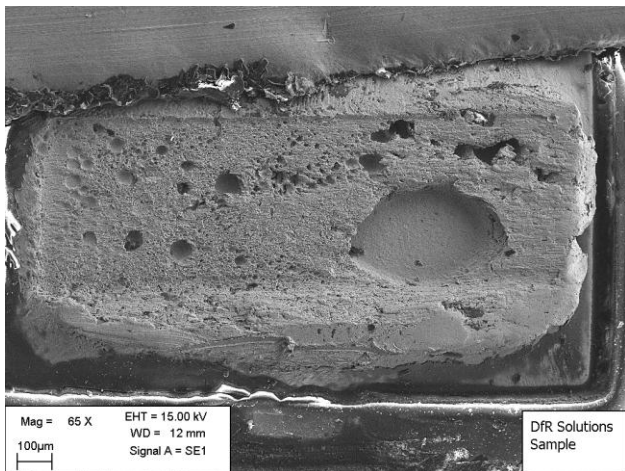
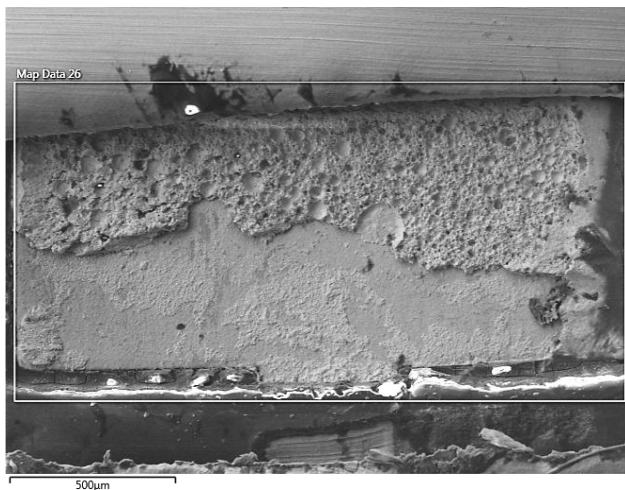
For SnPb solder with 4.4wt% gold and no aging, seen in Figure 19, the failure can be seen to be ductile in nature and the fracture surface propagates through the bulk solder. A similar behavior is seen after 168 hours of aging, also seen in Figure 19.

Figure 19: High Speed (Impact) Fracture Surfaces of SnPb Solder with 4.4wt% Gold and Aged for 0 (top), 168 (middle), and 1000 (bottom) hours at 125C

Once aging times increase to 1000 hours, we see the transition from ductile to brittle failure. The lower portion of the fracture surface in Figure 19 / bottom shows a smoother surface, suggesting fracture at an intermetallic layer. This is confirmed through elemental mapping (see Figure 21), which shows the crack alternating between the interface between the SnNi and AuSn<sub>4</sub> intermetallic layers and the interface between the AuSn<sub>4</sub> intermetallic and the bulk SnPb solder.

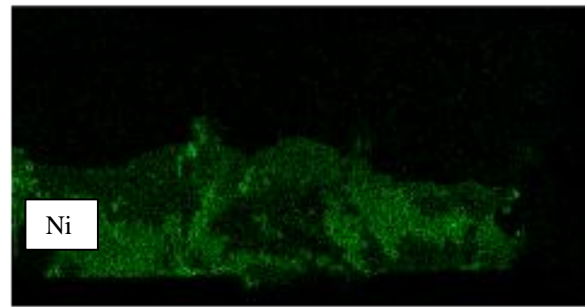
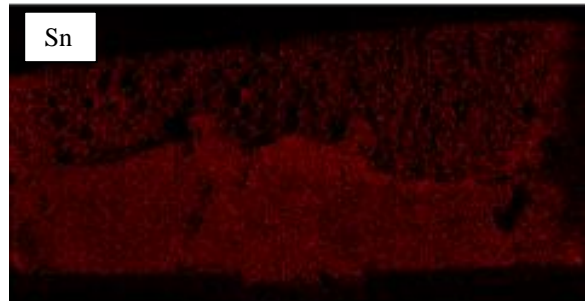
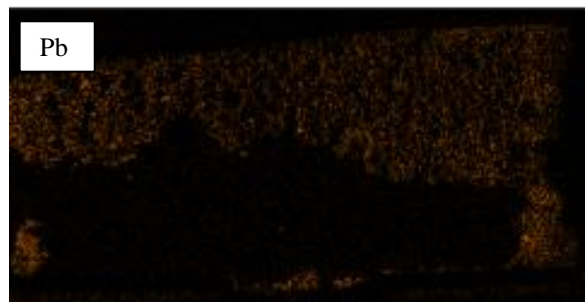
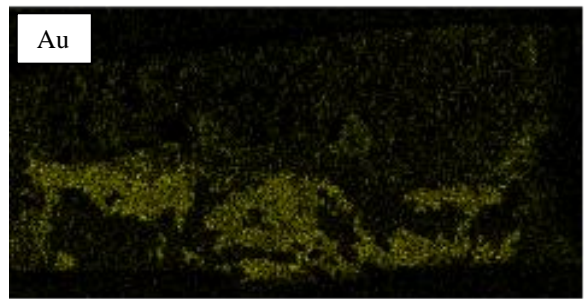
Figure 20: Elemental map of SnPb solder with 4.4wt% Gold and Aged for 1000 hrs at 125C

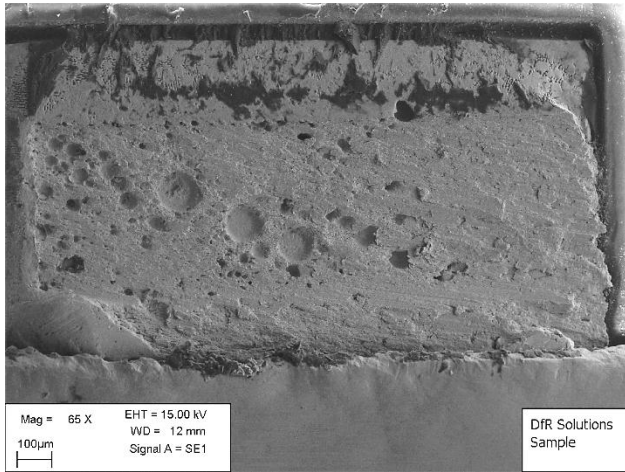
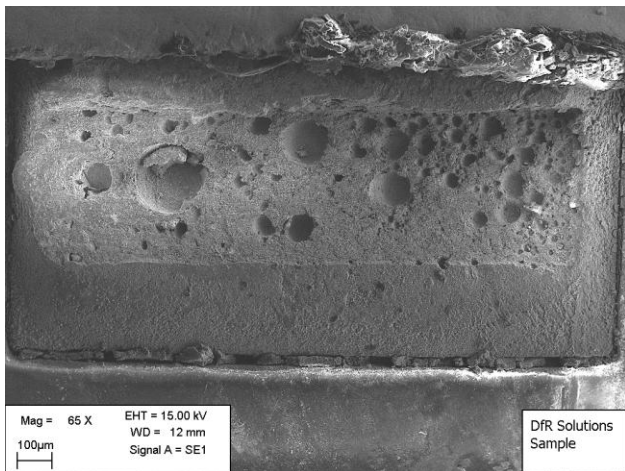
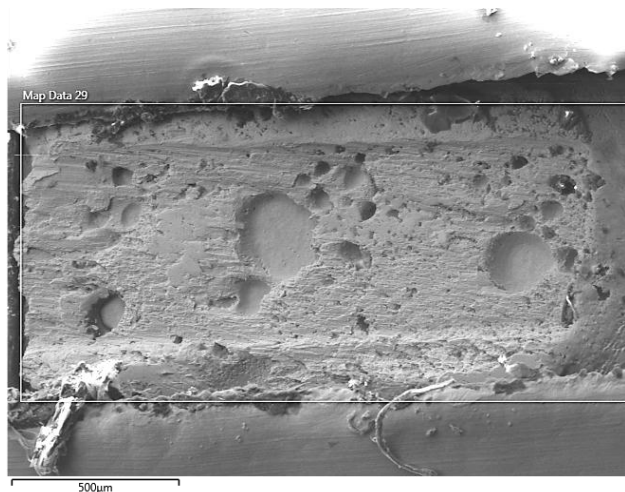
SAC305 solder with 1.6wt% displays ductile behavior for all three aging conditions. This is confirmed through the X-ray map displayed in Figure 22, which reveals a fracture surface dominated by tin (Sn), with trace amounts

Figure 21: High Speed (Impact) Fracture Surfaces of SAC305 Solder with 1.6wt% Gold and Aged for 0 (top), 168 (middle) and 1000 (bottom) hours at 125C

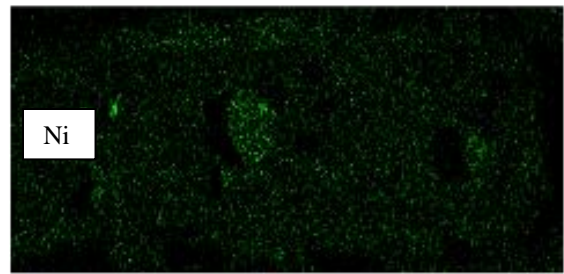
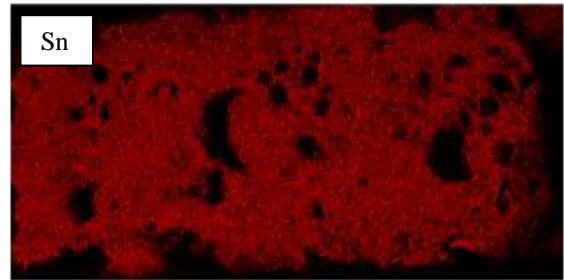
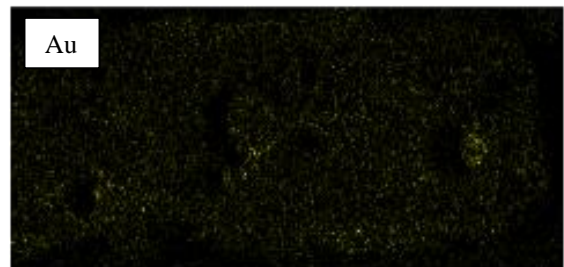
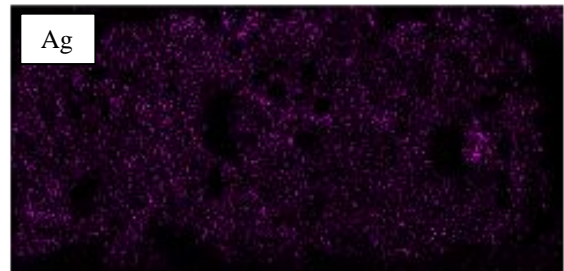
of nickel (Ni), gold (Au), and silver (Ag). These results are expected for fracture through the bulk solder.

Figure 22: Elemental map of SAC305 solder with 1.6wt% Gold and Aged for 1000 hrs at 125C

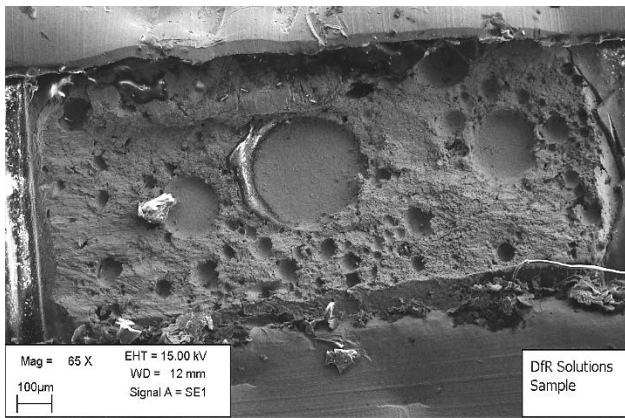
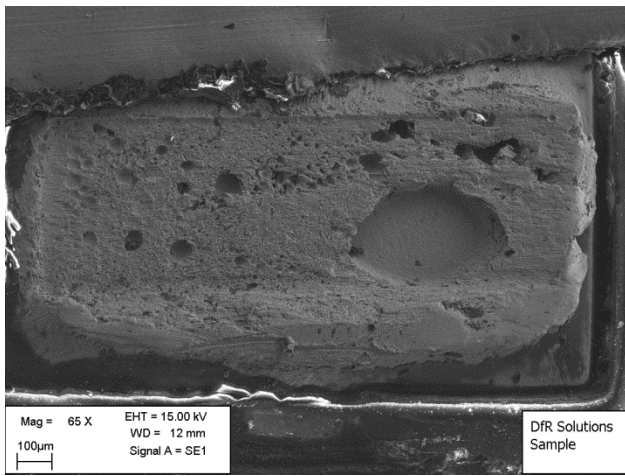
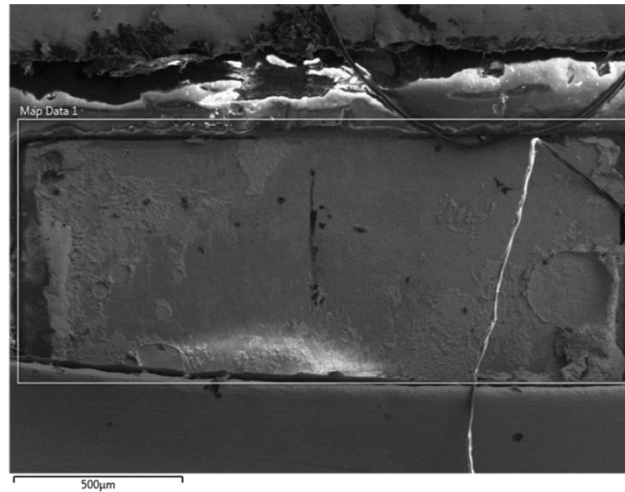
For SAC305 solder with higher amounts of gold (5.5wt%) and 0 hours aging, seen in Figure 23, the failure is ductile in nature and the fracture surface propagates through the bulk solder. A similar behavior is observed after 168 hours of aging.

After 1000 hours of aging, the fracture behavior has transitioned to a brittle mechanism. The fracture surface is smoother when compared to 0 and 168 hours of aging.

Figure 23: High Speed (Impact) Fracture Surfaces of SAC305 Solder with 5.5wt% Gold and Aged for 0 (top) and 1000 (bottom) hours at 125C

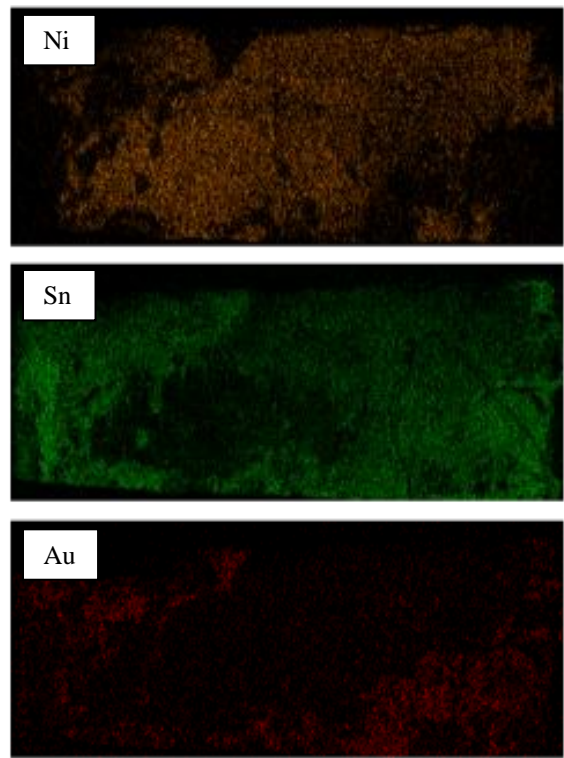
Reviewing the elemental maps in Figure 24, the crack path is seen to have primarily propagated between the AuSn<sub>4</sub> and the SnNi intermetallic layers. In some areas, crack seems to have deviated into the interface between the SnNi intermetallic and the underlying nickel plating.

Figure 24: Elemental map of SAC305 solder with 5.5wt% Gold and Aged for 1000 hrs at 125C

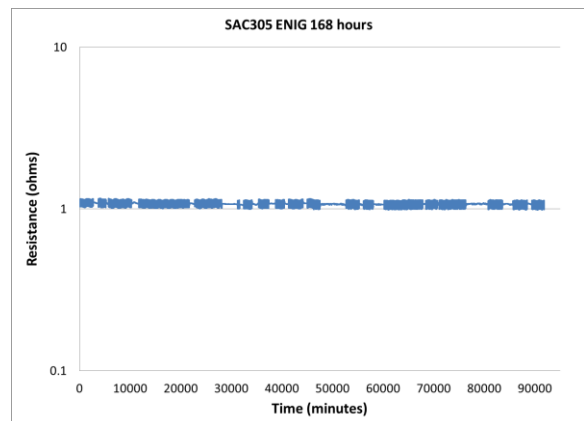
Resistance was monitored using an Agilent 34970A Data Acquisition Switch Unit with three (3) 40 channel single-ended multiplexer modules. Resistance was captured every 70 seconds. Nominal resistance was approximately one (1) to two (ohms) as seen in Figure 25.

Figure 25: Resistance vs. Time, Thermal Cycling of SAC305 with 0.4% Gold and Aged for 168 hours at 125C

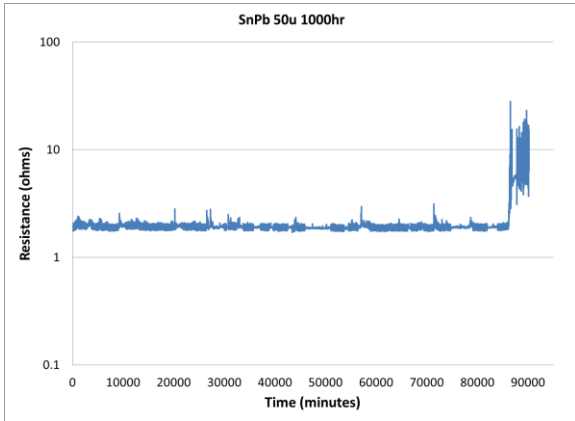
To minimize false detection error, the failure criteria was defined as when resistance increased by 10 times (10X) the range of variation in resistance [7]. Using this approach avoided false detection errors and response to variations driven by channels, wiring, and board level connections. Examples of the resistance variation are shown in Figure 26 and Figure 27.

Figure 26: Resistance vs. Time, Thermal Cycling of SnPb with 6.0% Gold and Aged for 1000 hours at 125C

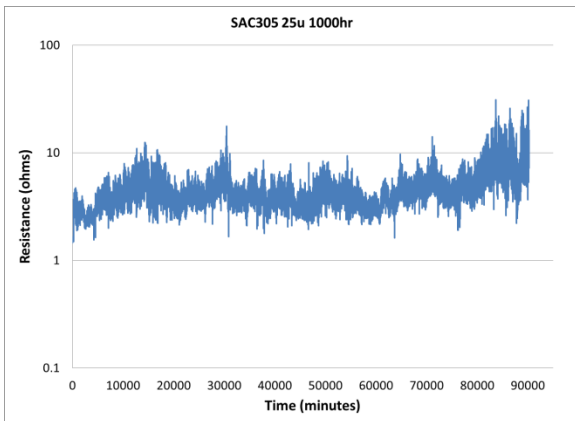
Figure 27: Resistance vs. Time, Thermal Cycling of SAC305 with 3.1% Gold and Aged for 1000 hours at 125C

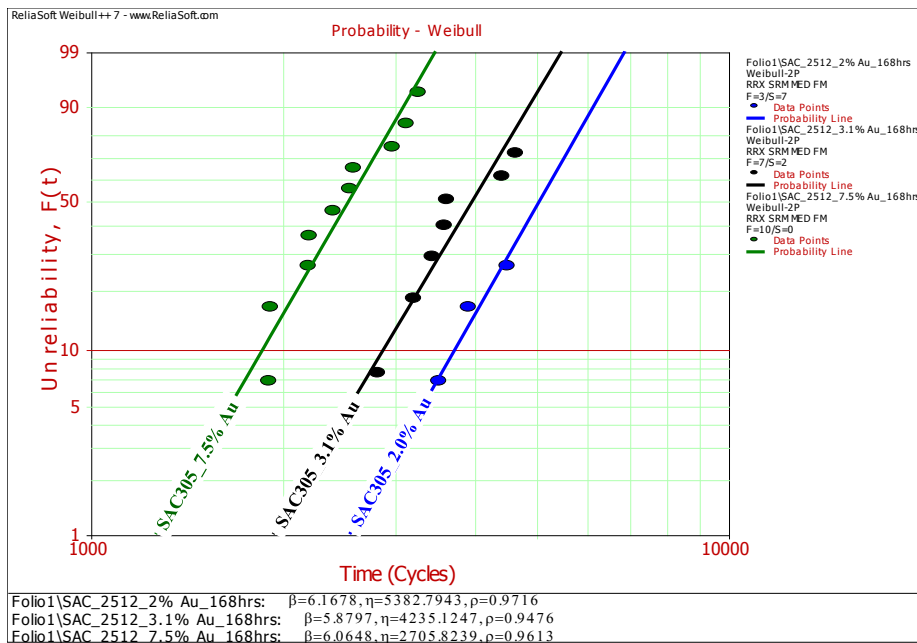
A Weibull plot of thermal cycling failures as a function of gold content, after 168 hours of aging, is shown in Figure 28. There seems to be a strong influence of gold content, with increasing gold content resulting in measurable reduction in time to failure.

Figure 28: Weibull plots of thermal cycling failures (0 to 100C) as a function of gold content (2512 Resistors, Aged for 168 hours at 125C)

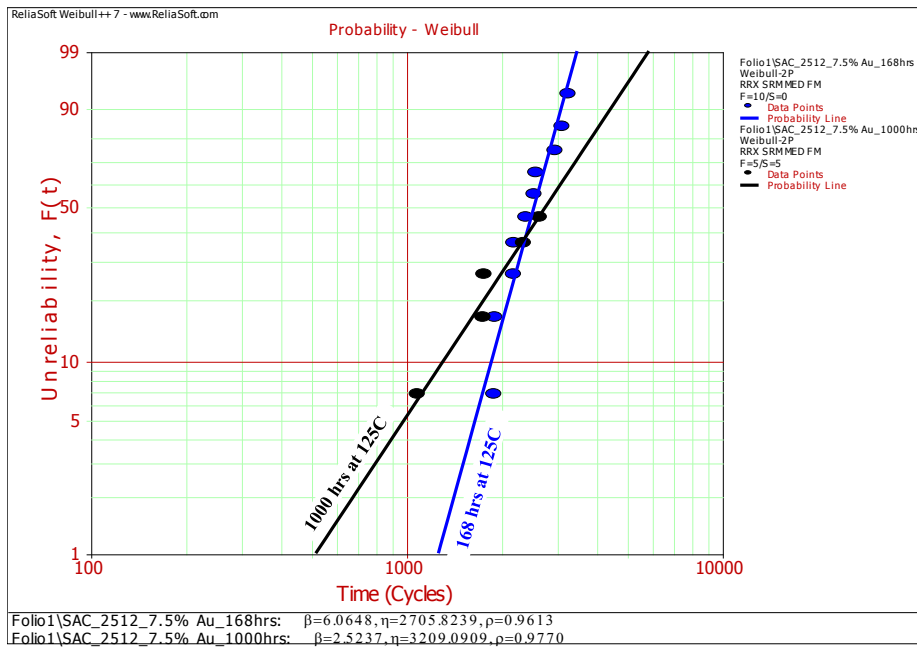
Weibull plots showing the influence of aging time (168 vs. 1000 hours) and solder alloy (SAC305 vs. SnPb) are shown in Figure 29 and Figure 30.

Figure 29: Weibull plots of thermal cycling failures (0 to 100C) as a function of aging time (2512 Resistors, SAC305 with 7.5% Gold)

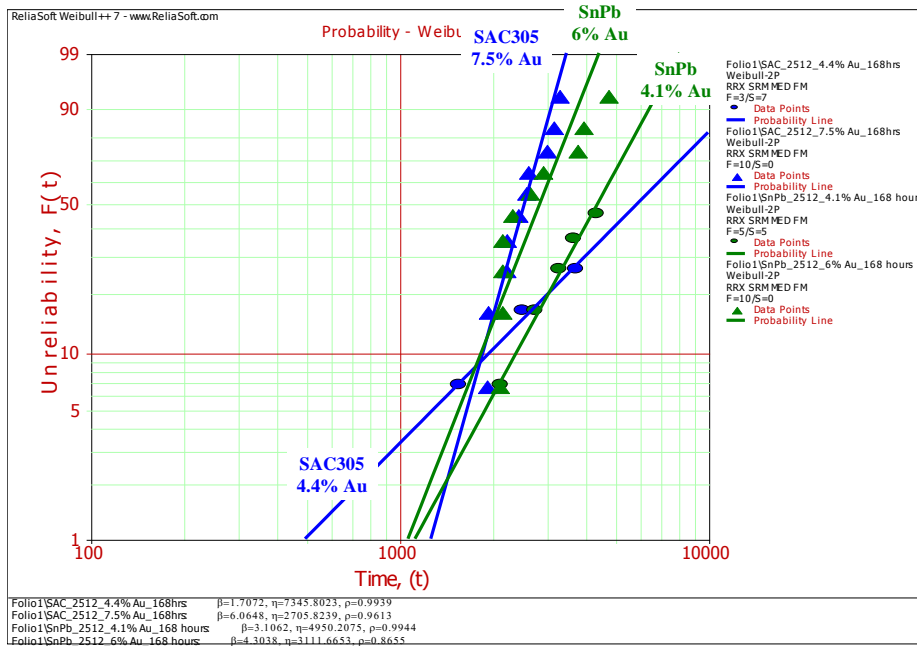
Figure 30: Weibull plots of thermal cycling failures as a function of solder alloy (2512 Resistors, Aged for 168 hours at 125C)

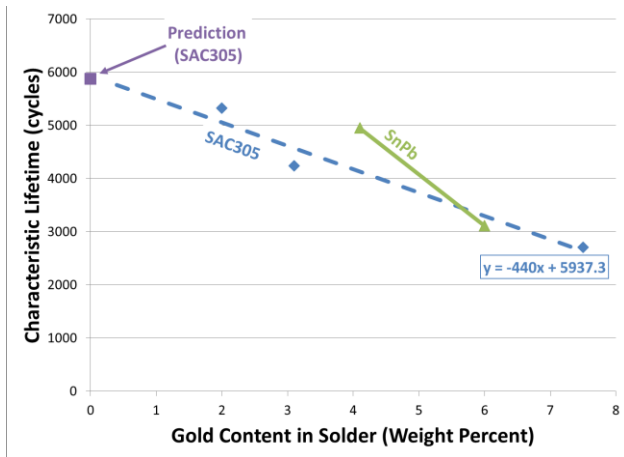
A plot of time to failure under temperature cycling as a function of gold content can be seen in Figure 31. All samples in Figure 31 were aged for 168 hours. A clear trend can be observed, with increasing gold content decreasing characteristic lifetimes by approximately 500 cycles / 1% Au for SAC305 solder.
