Instability, Metastability or Failure: Assessing the Reliability of 28nm FPGA Technology

Edward Wyrwas
DfR Solutions, LLC
(301) 474-0607
ewyrwas@dfrsolutions.com

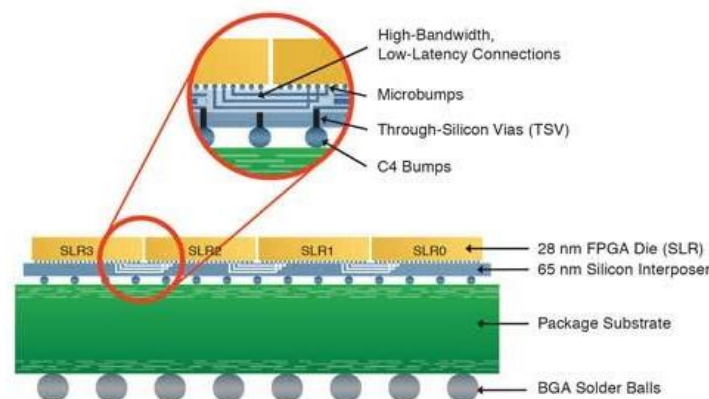
Figure 1 - Xilinx Virtex 7 3D Package Technology

Although these FPGAs are said to be unprecedented in performance, their state-of-the-art 3D packages (see Figure 1) and 28nm feature sizes lack the empirical test data necessary for designers to make critical reliability decisions on whether this new technology is a suitable replacement for the Virtex 5 FPGAs. DfR Solutions will investigate the reliability of the Xilinx -7 Series 28nm products in this qualification activity.

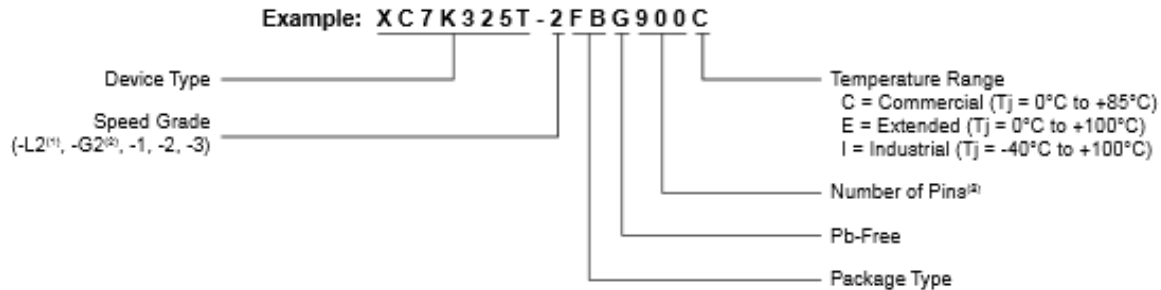
Figure 3 - Component Part Number Grading

The 7-Series component classification from Xilinx shows that this FPGA, X7CA200T-2FBG676C, has a commercial grade temperature range:

- T_J = 0°C to +85°C
- Test environments: -25°C to +140°C

It is worth noting that the grading distinction most likely comes from a wafer level test which sorts the individual die by speed and an undisclosed performance parameter that has temperature dependence. Therefore, considering variability, guard banding and other process margins, the die has an optimal temperature range between extended and industrial.

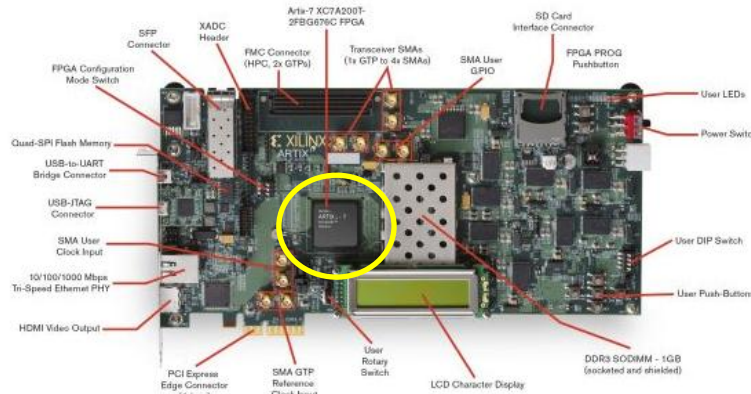
Figure 4 - Artix-7 Evaluation Board

The card's layout (Figure 4) permits minimum modification to its thermal stack up. A chiller and water block style heat sink (Figure 5) were a cost effective solution to expose the FPGA itself and not the test computer to cold-side temperatures. Minimal changes to the evaluation card were necessary, i.e. adding an extension cable to the LCD display. Hot-side temperatures were achieved by treating the chamber environment as an elephant chamber with an overwhelming volume of controlled ambient air temperature.

Artix-7 FPGA AC701 Base Board

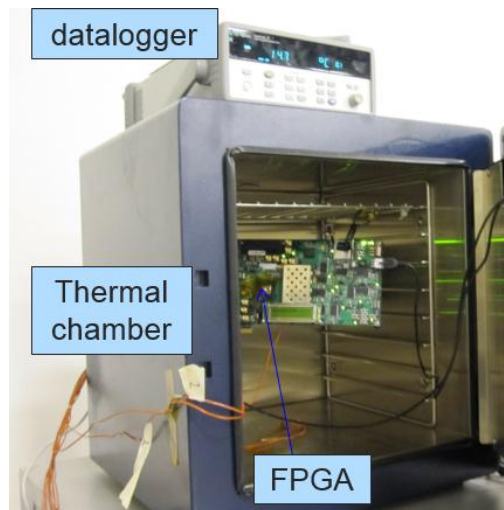
Figure 6 - Hot Side Step Stress Setup

A data logger recorded the die temperature in real time. Temperature was initially ramped at 5°C/min. At 90°C, the ramp rate was decreased to 1°C/min. The destructive limit of the FPGA was identified as 149°C at limited power dissipation (Figure 7).

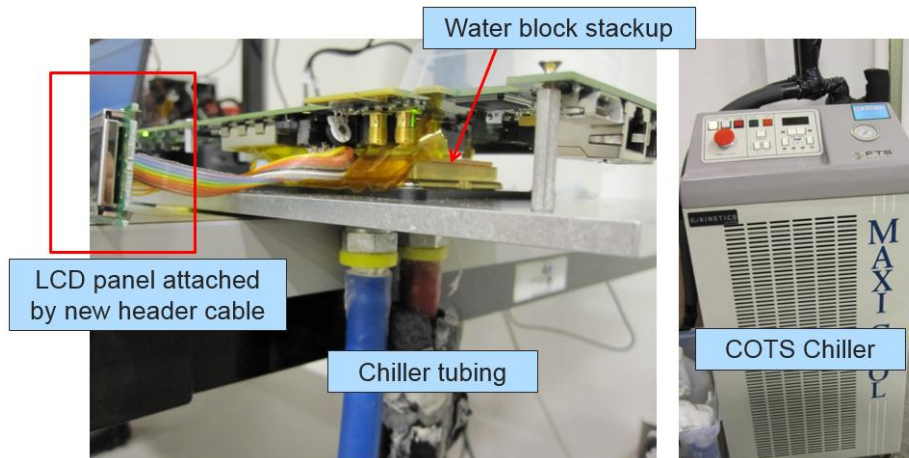
Figure 8 - Cold Side Configuration

The cold side setup was constructed using machined components and modifications to the evaluation card to fit it within the water block stack up. Figure 8 shows the evaluation card mounted on its new heat sink. Thermocouples were placed in the thermal compound of the heat sink stack up, the secondary side of the AC701 card (behind the FPGA), and on an auxiliary water block. Temperature was decreased at a rate of -5°C/min.

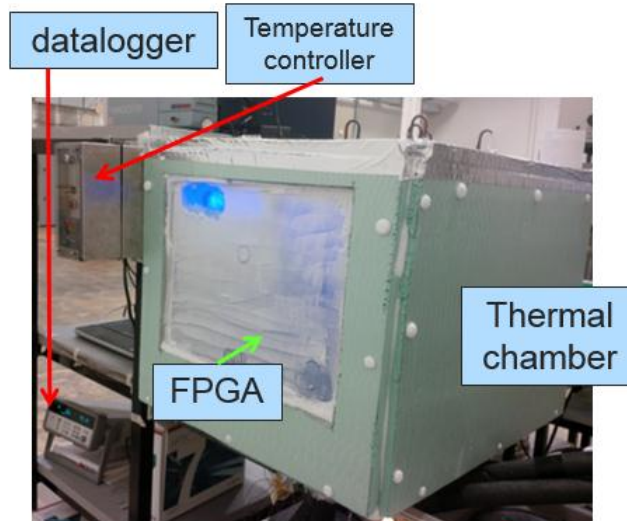
Figure 10 - LN2 Chamber around Cold Side Test Setup

To guarantee that the component was exposed to a low enough temperature, a liquid nitrogen chamber was built around the water block setup, Figure 10. The measured die temperature during test was -35°C.

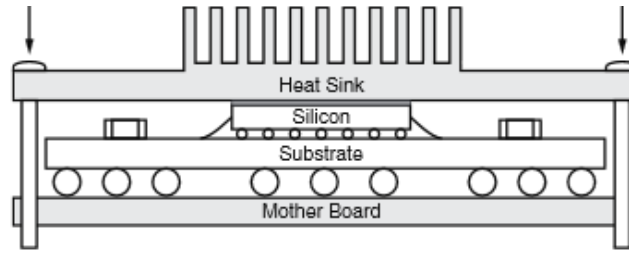
Figure 11 - Thermal Stack up Diagram

The thermal stack up was defined using Figure 11 - Figure 13. The heat sink, die and card were assessed for optimal heat transfer and leakage paths to determine whether additional measures were necessary to control the temperature exposure during the life test. The junction temperatures for the High Temperature Operating Life (HTOL) and Low Temperature Operating Life (LTOL) tests were calculated using the thermal resistance values at each interface and the power dissipation estimated by the Xilinx development software.

Thermal Layer	Variable	Value
Junction temperature	T_J	Calculated
Ambient Temperature	T_A	-25°C and 140°C
Junction-Ambient Thermal Resistance	θ_{ja}	13.0°C/W
Power Dissipation	P	<1W
Junction-Case Thermal Resistance	θ_{jc}	0.07°C/W
Case-Compound Thermal Resistance	θ_{cs}	0.043°C/W
Compound-Heatsink Thermal Resistance	θ_{sa}	0.21°C/W
Junction-Board Thermal Resistance	θ_{jb}	4.6°C/W

T_J	=	T_a	+	(Q_{ja}	*	(Q_{jc}	+	Q_{cs}	+	Q_{sa}	+	Q_{jb})	/	(Q_{ja}	+	Q_{jc}	+	Q_{cs}	+	Q_{sa}	+	Q_{jb})	*	P
hot	143.571		140	+	(13	*	(0.07	+	0.043	+	0.21	+	4.6)	/	(13	+	0.07	+	0.043	+	0.21	+	4.6)	*	1
cold	-21.429		-25	+	(13	*	(0.07	+	0.043	+	0.21	+	4.6)	/	(13	+	0.07	+	0.043	+	0.21	+	4.6)	*	1
	°C		°C			°C/W			°C/W		°C/W		°C/W		°C/W			°C/W		°C/W		°C/W		°C/W		°C/W		°C/W		W

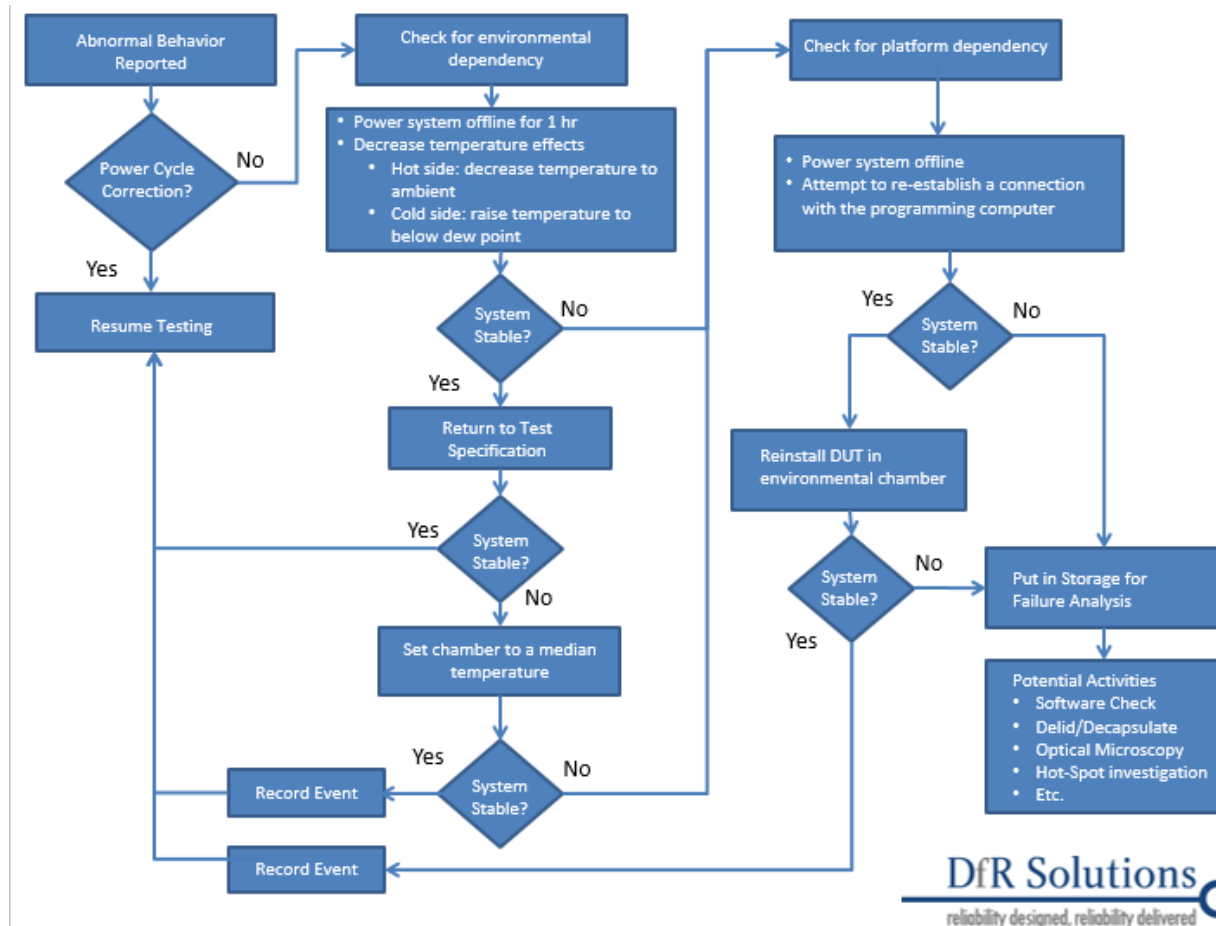
Figure 14 - Failure Confirmation Flow Chart for FPGA

In the event of an FPGA not sending the desired signal, a step-by-step procedure was followed to identify device failure versus system related anomalies. This procedure is defined in Figure 14.

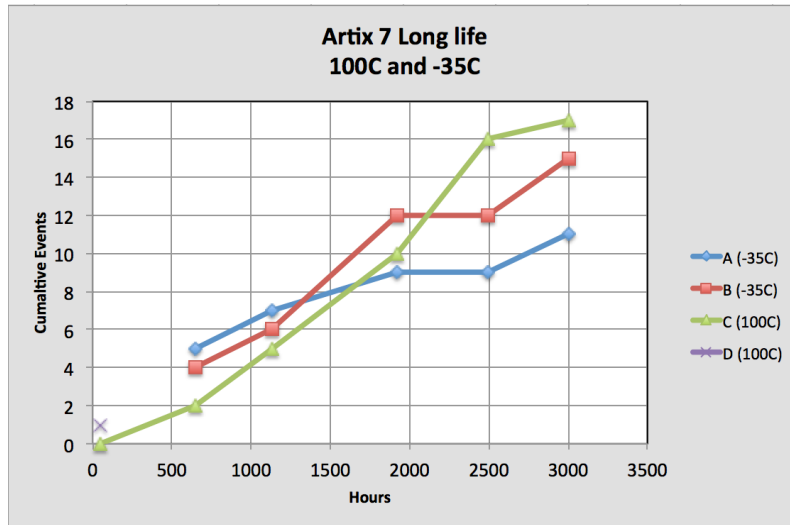
Figure 17 - Rate of Anomalous Events - All Systems

Time to Failure was recorded for both the hot side test systems. It is unclear whether failure would occur on the cold side test systems given a longer test duration as no definitive trending behavior was identified in the systems other than a relative rate of events (slope of events per time interval), Figure 17. Without failure analysis, we do not know what element within the FPGA failed.

We can conclude that things do in fact seem to be slowing down on the FPGA. While these events were corrected on subsequent signal generation iterations by the FPGA, their very nature should raise questions as to whether critical mission capabilities could be affected by such an event, even in a system with triple mode redundancy (TMR). We can speculate that real degradation is occurring, but also compensation and/or some type of error correction method is taking place since the FPGA recovers back to normal (the laptop receives the expected signal after the 2840mSec interval). This behavior is similar to the accumulation of defects that take place in dielectric breakdown, but rather than a breakdown event causing a failure, we're seeing a breakdown event followed by recovery. More so, the negative bias temperature instability (NBTI) mechanism causes degradation with similar behavior as seen from previous IC wearout work performed at DfR Solutions³. In the gate oxide region and along its interface allowing electrons and holes to become trapped and break Si-H interface bonds. NBTI is different from other failure mechanisms because it has a recovery process. This can cause a reduction in the rate of degradation where the amount of NBTI recovery is equal to the amount of degradation. When CMOS pairs are toggled, NBTI can be forced to recover by re-passivating those bonds. If we are truly seeing NBTI degradation, then an additional assessment of its effects on a more complex programming routine is necessary to determine how detrimental the slowdown effect is.
