Keeping the US Mail Moving

VIBRATION ANALYSIS ON A CONVEYOR DRIVE UNIT

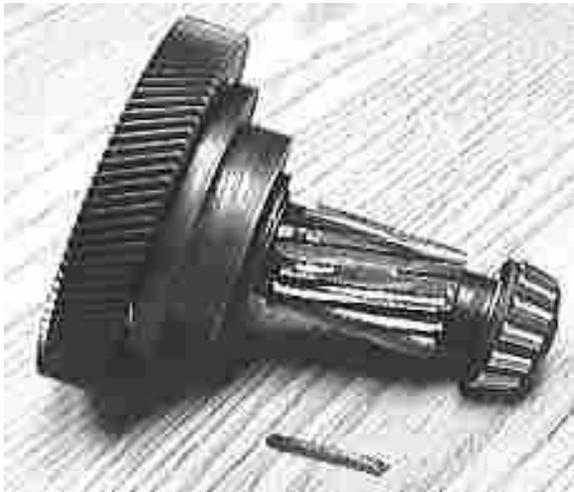
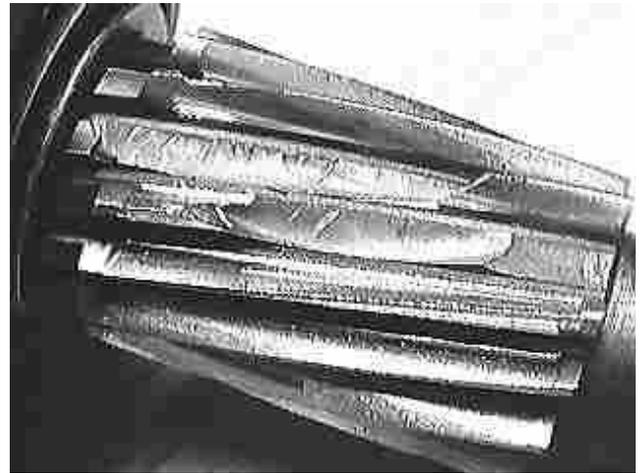
When the unit was replaced, the maintenance technicians disassembled the defective gearbox and found a broken tooth on the low speed pinion. The broken tooth was causing an impact each time it meshed with the gear on the output shaft. The tooth next to the broken tooth also had a severe crack and came off when handled by the analyst.

The photographs below show the intermediate shaft on the left and the broken teeth on the right.

Based on the findings of the disassembled gearbox, if left to run until complete failure, the low speed pinion would have continued its self-destruction and catastrophic failure would have probably been the result.

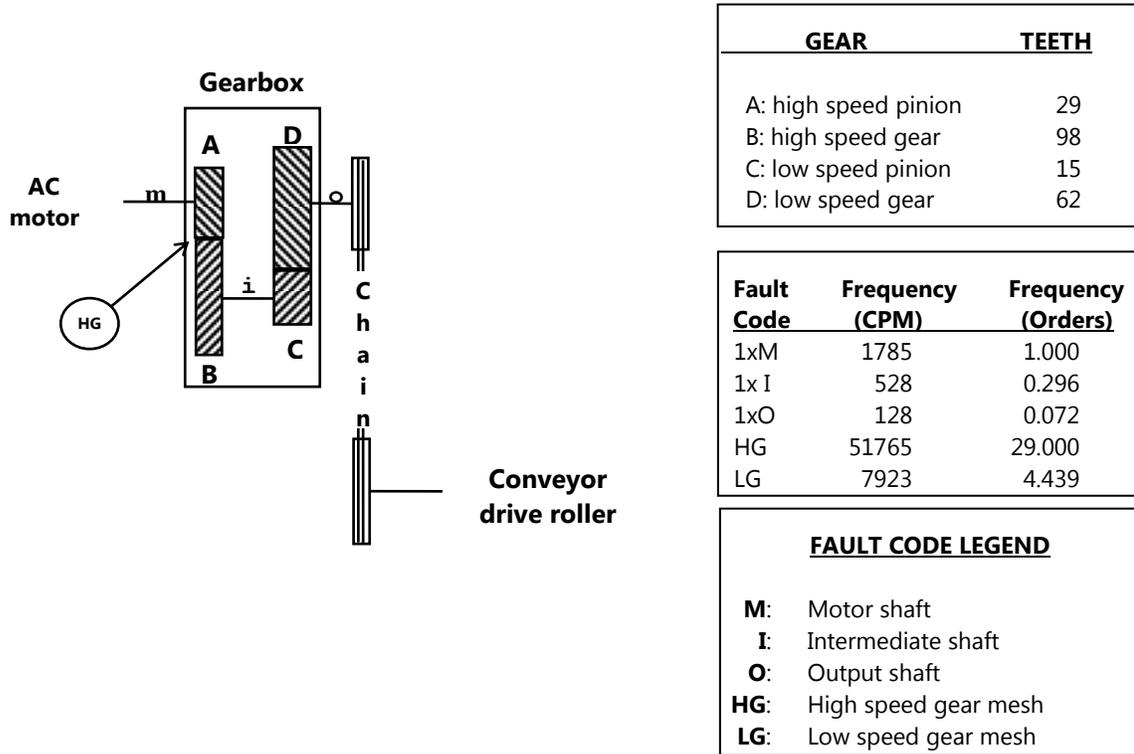
This case history displays some of the vibration data used in the diagnosis of the problem. A basic explanation of the internal configuration of the gearbox is included to help you understand the machine. The driver is a 4 pole AC induction motor operating at a speed of about 1785 cpm. The motor / gearbox is close coupled and the double reduction

gearbox has two gear meshes that are identified as high speed gear mesh (HG) and low speed gear mesh (LG). The shaft rate frequencies and gear mesh frequencies were calculated using the gear teeth ratios. See Figure 1 below.

Figure 1. Schematic of the B-14 conveyor drive and the primary forcing frequencies. The motor housing is bolted directly to the gearbox so that the prime mover is a close coupled unit. All shafts are in the horizontal plane.

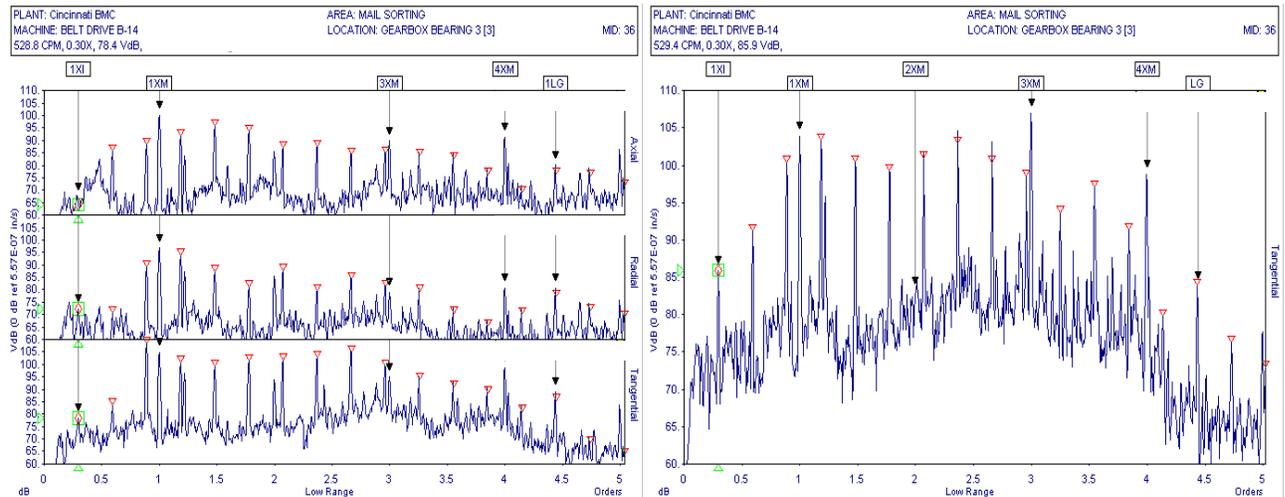
Figure 2 shows the first and last set of data taken on the faulty machine. The tangential spectrum shows a strong 1xI harmonic series. Note that all prominent peaks in the spectra are harmonics of either 1xM or 1xI.

Figure 2. Low range vibration data from October (on the left) and just before replacement in March (right). Note harmonic cursors at 1xI spacing.

The first vibration test showed a significant intermediate shaft rate (1xI) harmonic series in the spectra (figure 2). The strong 1xI harmonic series in the demod spectra (figure 4) confirms the intermediate shaft problem and actually shows the fault much more clearly. The shaft rate harmonic series with high amplitudes indicates looseness or impacting problem with the intermediate shaft or one of the components on the shaft. The maintenance technicians continued to monitor the machine on a monthly basis until a replacement was available and the conveyor could be taken out of service. Each monthly survey showed the strong 1xI harmonic series up to the point of replacement.

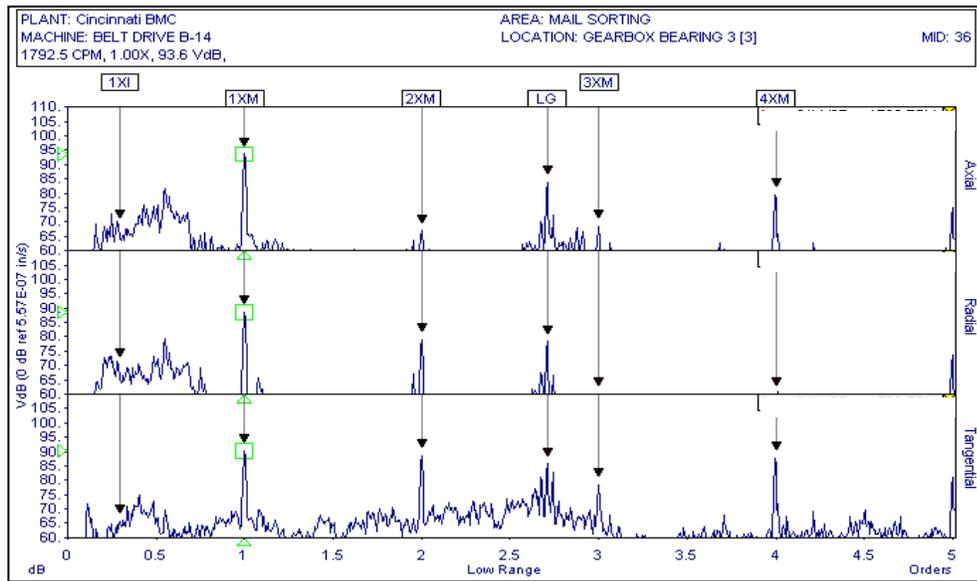
The replacement unit, while also a double reduction gearbox, came from a different manufacturer. The nameplate data was slightly different and had different gear teeth counts. Following the replacement of the unit, another vibration test was conducted. The spectra from this test are shown in Figure 3 to allow comparison of a fault free machine with the faulty machine. Note that the low speed gear mesh (LG) appears at a lower frequency than the previous gearbox due to the differences in gear teeth count.

Figure 3. Low range vibration data after replacement of the drive unit. Note that 1xI harmonic series is not present in the fault free machine

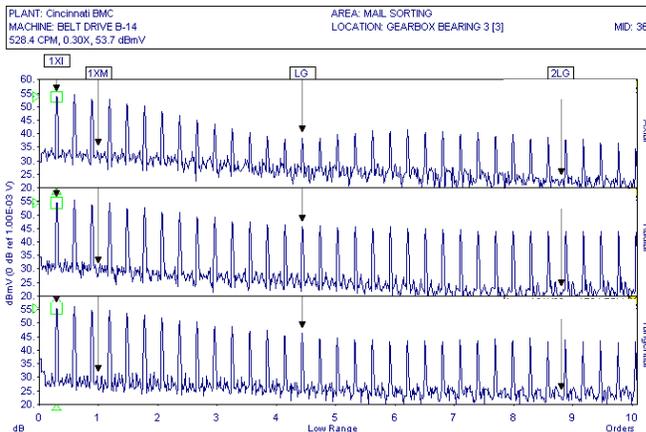
The DEMOD spectra are shown in triaxial format in Figure 4a for the October data set. The February data is shown in Figure 4b. The harmonic spacing is clearly at a frequency that corresponds to 1xI. Note that the noise floor is higher for the February data while the amplitudes in the harmonic series are slightly lower.

Figure 4a. Demod spectra, October

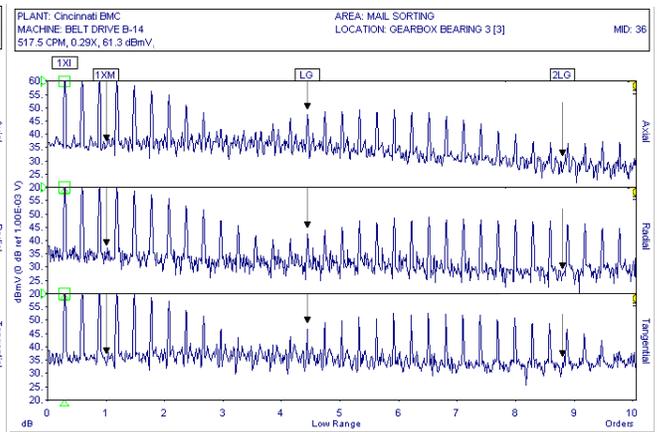
Figure 4b. Demod spectra, February. The amplitude scaling is slightly different from Figure 4a.

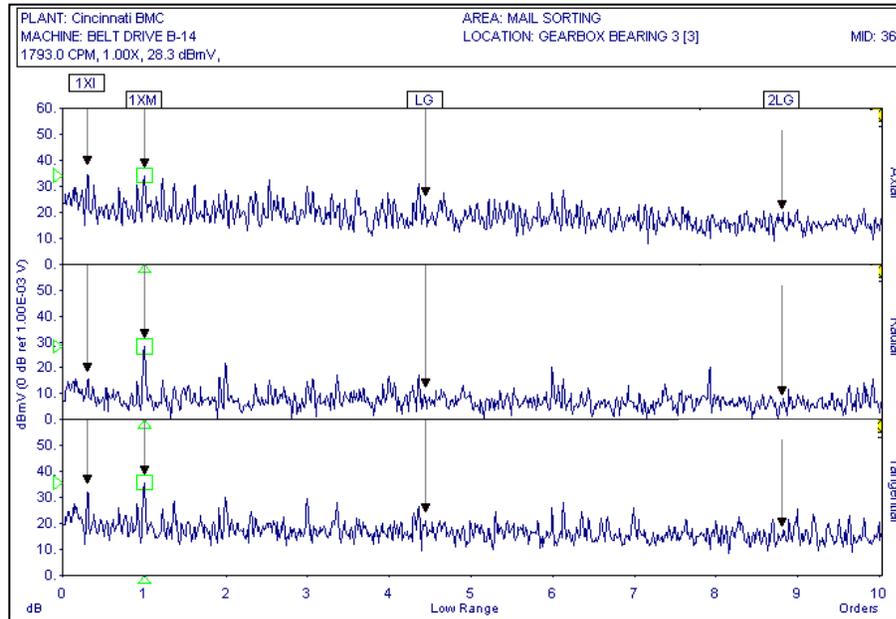
Again for comparison purposes, the post repair DEMOD spectra are shown in Figure 5. The amplitude scaling is slightly different from those spectra in Figure 4 due to a much lower noise floor.

Figure 5. Demod spectra, March. Note the amplitude scale is different from the data shown in Figure 4.
