Diagnosing a Low-Speed Gearbox Problem

VIBRATION ANALYSIS AT WORK

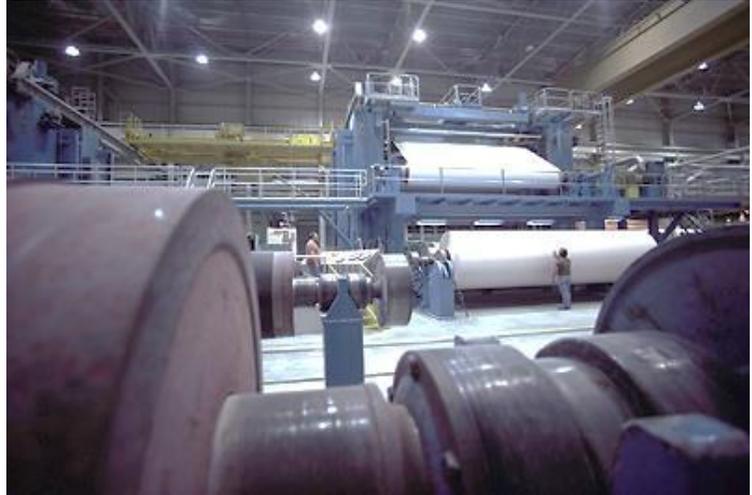
Azima DLI was called on to help in the diagnosis of a suspected gearbox problem in a large plant connected with the paper industry. The gearbox in question had an input shaft with a 23-tooth pinion driving a large bull gear with 132 teeth which in turn drives another bull gear of the same size. The two gears are connected to large steel rollers about 24 inches in diameter. The two output gears turn at 52 RPM and the pinion turns at 302 RPM. See Figure 1 below.

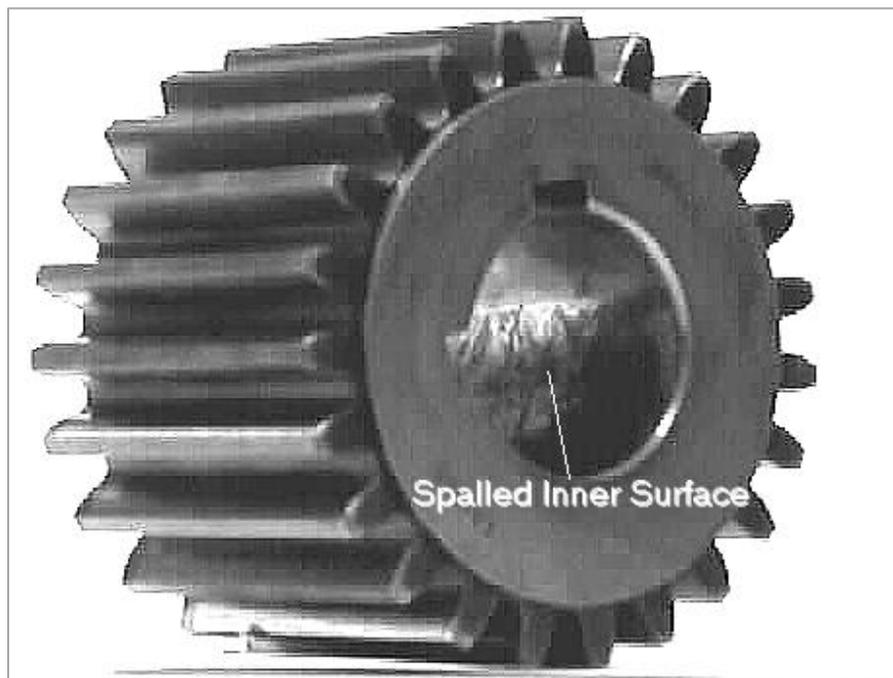
Azima DLI contacted one of the engineers at the gearbox factory and described the situation. It was reported that the problem occurred during installation when the interference fit between the pinion and the shaft was too loose. It was recommended that the shaft and pinion be replaced immediately to avoid a catastrophic failure.

The figure above shows the spalling in the pinion bore caused by the gear turning back and forth on the shaft.
