Roof Management Report

Test Company
TEST Company
5105 Glen Canyon Rd, Fort Worth, TX

Roof Section: Lab Area
Roof Size: 10,761
Overall Grade: B

Inspection Date: 05/30/2012
Inspector: Dennis Soule

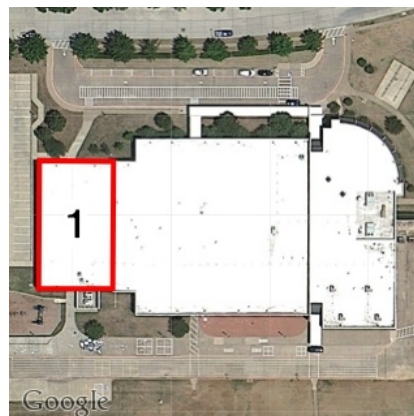
Membrane: B
Flashings: B
Sheet Metal: A

Overall: B

Estimated Replacement: 2022

Recommend repairing holes in roof membrane and inspecting roof systems on a yearly bases.

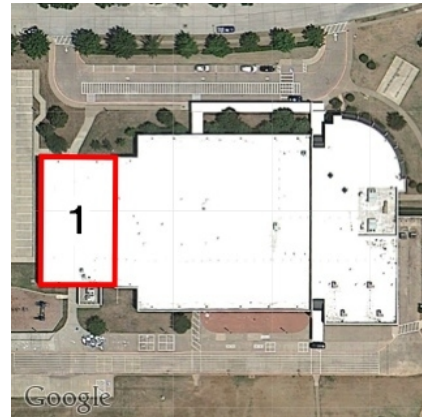
1 - Lab Area (10,761 SF) Grade B

Deficiency	Qty	Emergency	Remedial	Replacement
Punctures - Rips - Tears	65 EA	\$1,565.00		
Full Replacement	10,761 SF			\$96,849.00
Total		\$1,565.00	\$0.00	\$96,849.00
