Profile

BLUE DIAMOND GROWERS

Challenge *Exposed smooth BUR membrane*

Solution *AcryShield® Restoration System*

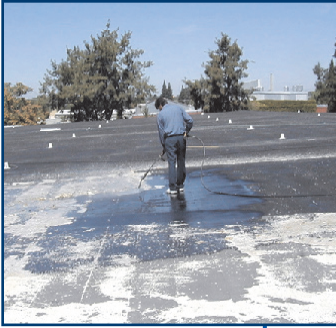
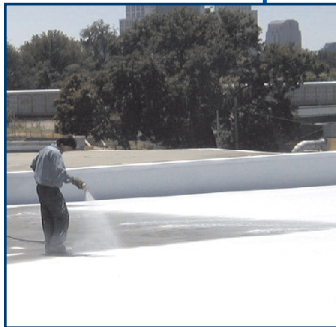
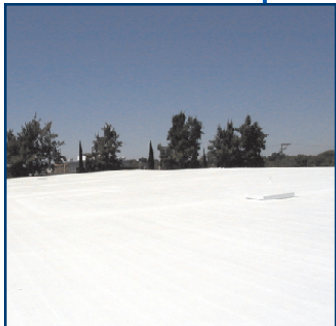
- Exposed smooth built up roof with deteriorating asphalt.
- Wall flashings prematurely degraded.
- Excessive membrane surface temperatures.

- Verified 90°F roof surface temperature drop at 86°F ambient.
- Extended roof life an additional 10 years.
- Reduced energy consumption in cold storage facility.
