# Historic Fort Pitt Block House

## Case Study - Computed Radiography Application

#### **Fort Pitt Block House in Pittsburgh, Penn., Kicks Off Preservation Work with X-Ray Exam**

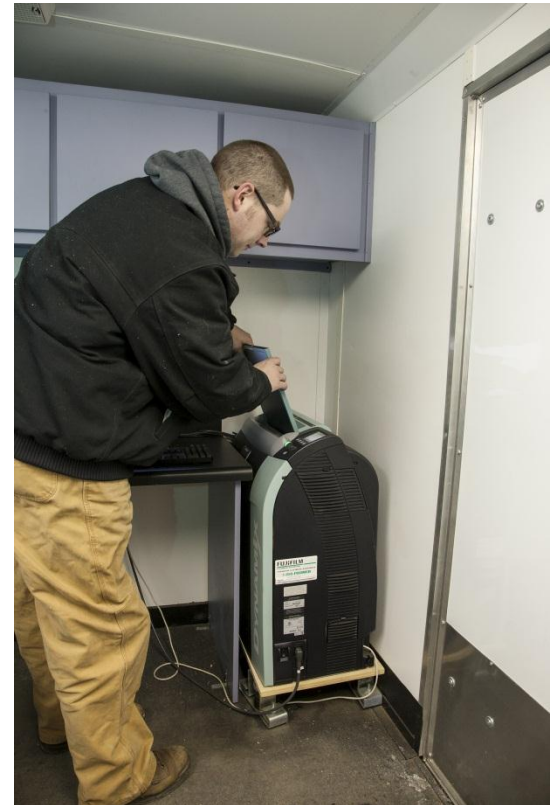
*Aaron Drake, Radiographer, is feeding an imaging plate from a previous exposure of the gun loop into the computer processing unit, which converts the plate to a digital file.*

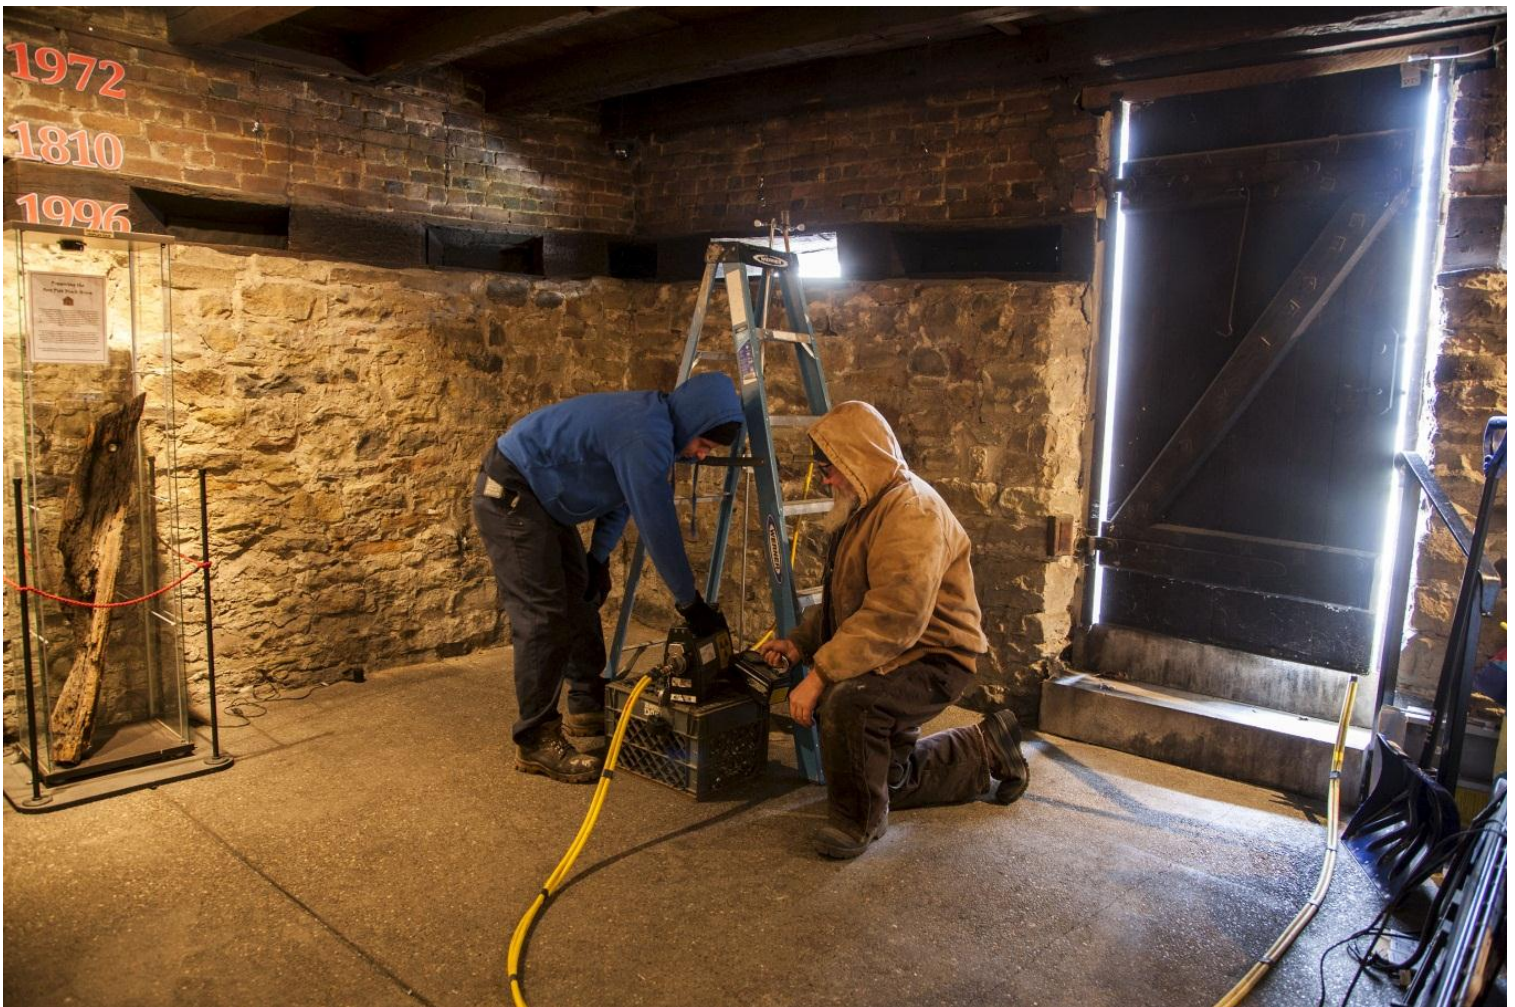
*Radiographic crew members Jake Fetchin, Assistant Radiographer, (left) and Phil Martin, Radiographer, (right) are performing a radiation survey of the equipment to ensure the radioactive material is returned to its safe and shielded position.*

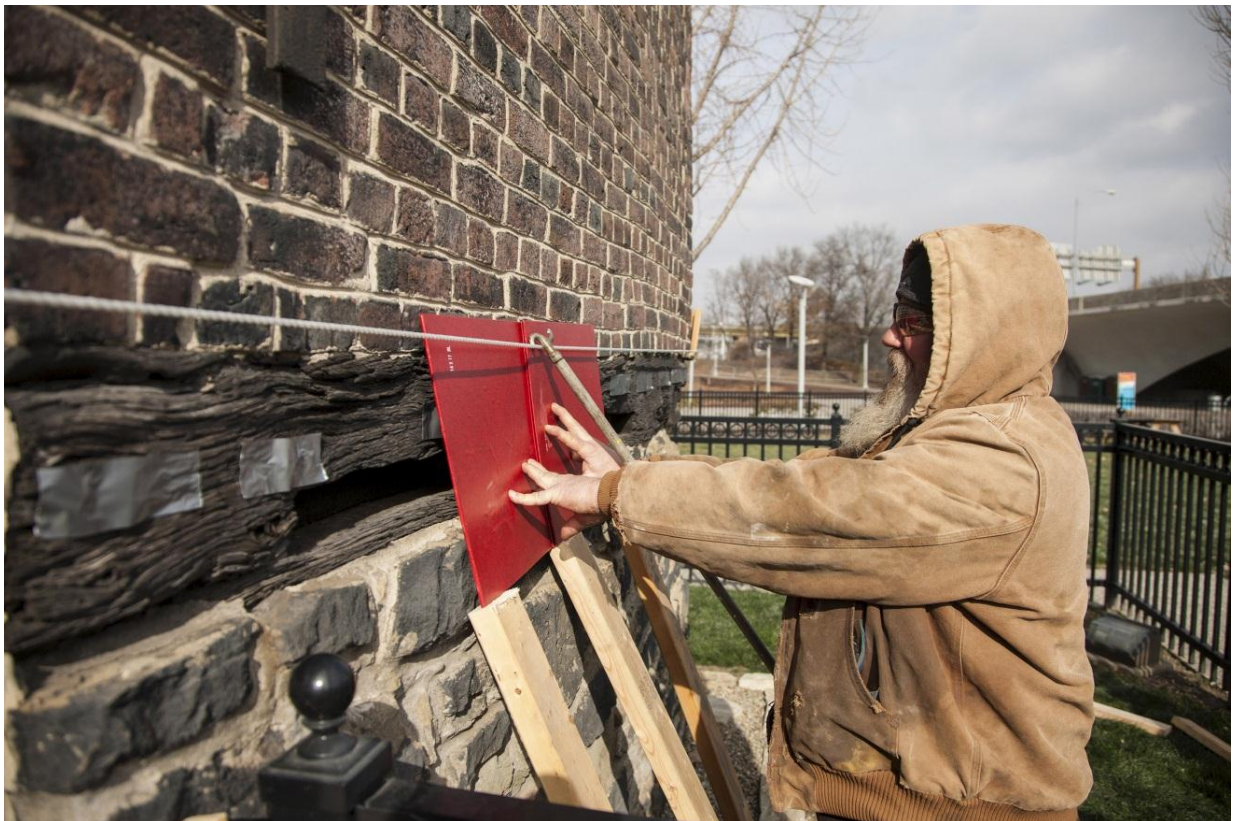
*Phil Martin, Radiographer, is setting up the imaging plates for the next exposure during the radiographic inspection of the gun loops at the Fort Pitt Block House*

Fortunately for the Fort Pitt Block House, the X-ray “exam” showed that the gun loops did not have any significant internal wood deterioration to require complicated internal structural repairs. Rather, wood deterioration worked its way from the exterior surfaces inward, requiring only relatively simple repairs applied to the surface. In addition to the structural repairs, the preservation experts specified treating the wood with a borate-based preservative for future protection against water and insect damage.
