Shooting Star

CONTINUOUS CURED-IN-PLACE LINING PROCESS HELPS A CONTRACTOR RESTORE A WATER MAIN AND PRESERVE A NATIONAL PARK'S SPLENDOR

PROJECT:	Rehabilitate small-diameter steel water pipe on a tight deadline
CUSTOMER:	Yosemite National Park Service
CONTRACTOR:	Express Sewer & Drain, Sacramento, Calif.
EQUIPMENT:	Top Gun continuous lining system, Perma-Liner 866/366-2568 www.perma-liner.com
RESULTS:	Water flow restored, deadline met

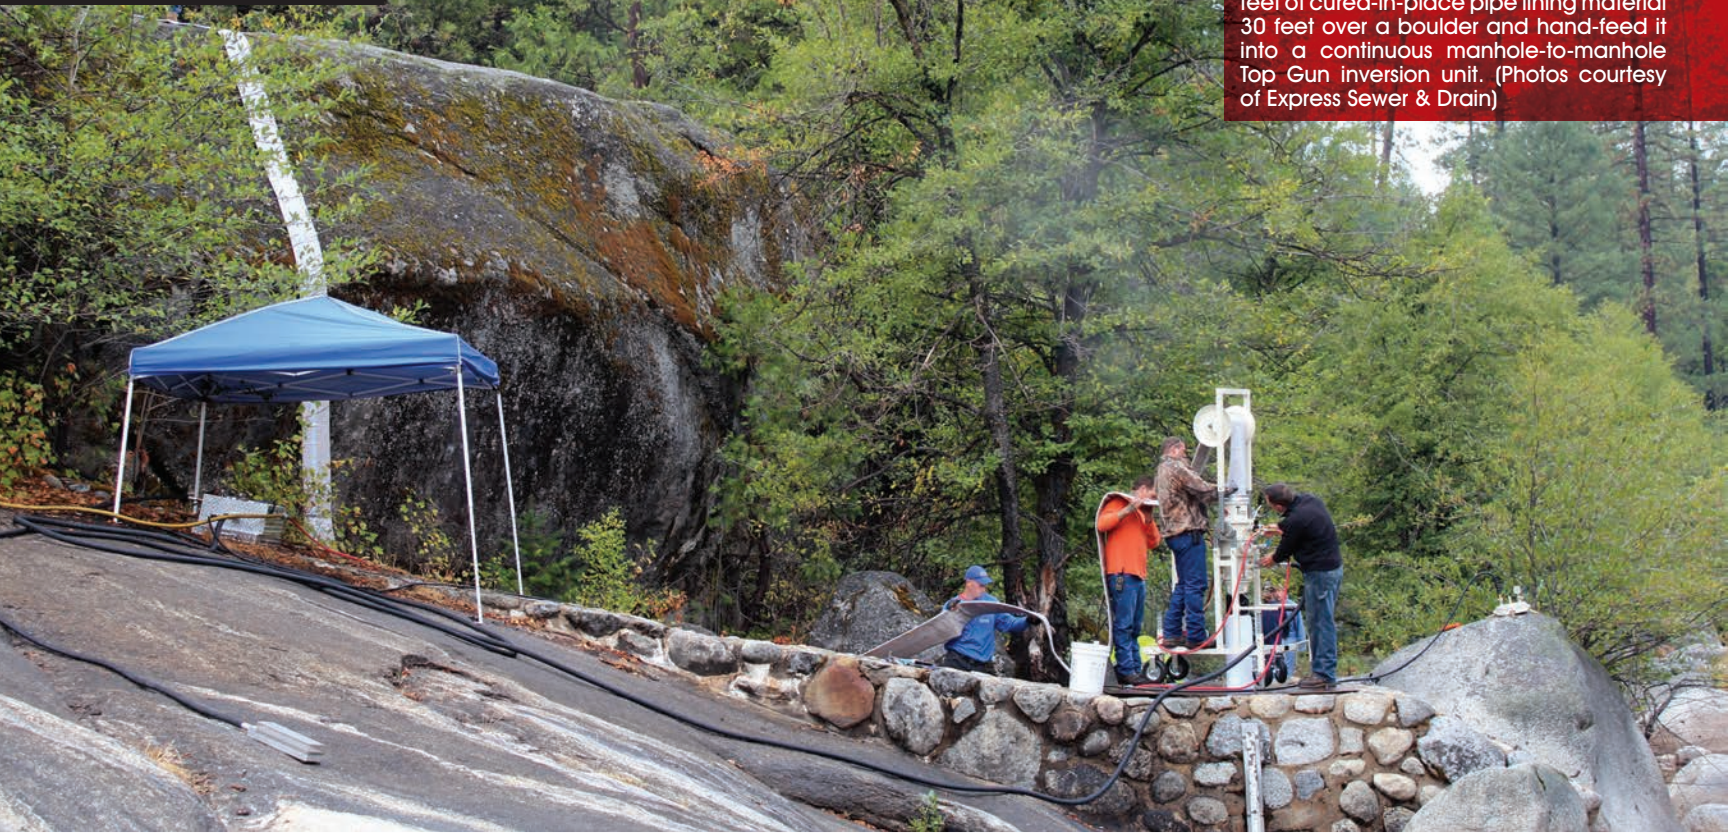
Workers from Express Sewer & Drain in Sacramento, Calif., manually lower 520 feet of cured-in-place pipe lining material 30 feet over a boulder and hand-feed it into a continuous manhole-to-manhole Top Gun inversion unit. (Photos courtesy of Express Sewer & Drain)

To shoot the 520-foot-long 8-inch liner to the downstream box, a worker attached to a tree by a safety line inched the material over the side of the boulder. “The smooth moss was great for moving the liner, but not good for traction,” says Heinselman. Three workers then carried the liner to the inversion unit, hand-fed the material onto the tower roller, and shoved it down into the gun’s diaphragm bladder.

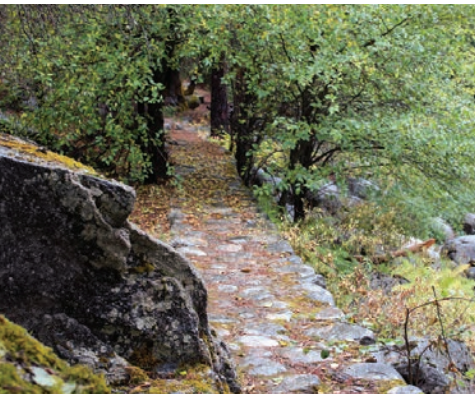
The 8-inch steel water main is encased in concrete and decorated with river stones to blend into the landscape. The structure prevents spring floods from washing away the pipe.

The National Park Service had replaced all but this section of the 95-year-old line with C900 pipe. It was encased in a 4-foot-square block of concrete embedded with river stones the size of bowling balls. The massive aboveground structure paralleling the Tuolumne River prevented the pipe from washing away in spring floods.
