# SINGER SOLUTIONS

## Pittsfield Township, Michigan USA

## Singer Eliminates Cavitation Damage in Pittsfield Township's Reservoir Filling Station

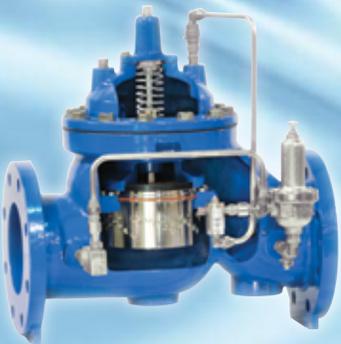
Single Rolling Diaphragm with Anti-Cavitation Trim

Once the actual flow ranges along with inlet pressure ranges and the required outlet pressure were measured, the data was given to the Singer Valve engineering team who created a drilling pattern for the multiple orifices in the dual anti-cavitation cages, specific to this application. The key is to supply orifices that can manage maximum flow while creating enough backpressure in the cage to prevent the microscopic vapor bubbles from escaping. The dual anti-cavitation cages are then included in the new control valve.

Singer's control valve operates hydraulically with system line pressure as well as with dual solenoids and an interface controller that communicates with the Township's SCADA. The SRD allows the valve to operate steadily at both high and low flows and the pilot controls are built to be self-flushing for reduced maintenance.

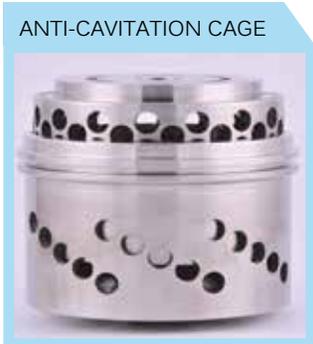
#### CAVITATION DAMAGE

The consequences of cavitation can be strong vibrations, loud noise, choked flow, erosion of valve components, destruction of the actual valve, erosion and destruction of downstream piping and finally plant or distribution system shutdown. For Pittsfield, the downstream eccentric reducer failed first and the cavitation destroyed the cement lining in the ductile iron reducer and eventually eroded into the reducer walls. Pin holes formed, leaks sprung, and the Township had to replace

the fitting. During the second reducer replacement, the cavitation damage was not reserved to just the fitting, it had begun eating into the seat of the plug valve as well. The Township needed a solution to stop the cavitation damage immediately as well as maintain the current valve functions with their control programming.

Visible damage from cavitation prior to Singer Valve

"After two reducers were destroyed, it was clear that the plug valve was not working in this application," said Jennifer Zelski of Kennedy Industries. "We recommended Singer Valve's Single Rolling Diaphragm (SRD) actuated control valve with Anti-Cavitation Trim because it was the only plausible solution for this scenario." Pittsfield Township's engineer evaluated options with other valves as well as looking at closing upstream valves to help create pressure losses prior to the fill valve. All parties agreed that the SRD with Anti-Cavitation Trim would provide the all-around solution needed to eliminate cavitation damage without sacrificing other valves, changing processes or system dynamics.

Installation took three days, most of which was putting on the pipe wrap and some minor concrete work to modify the pipe supports under the valve. The new valve was integrated with the Township controls without modification of their existing programming.

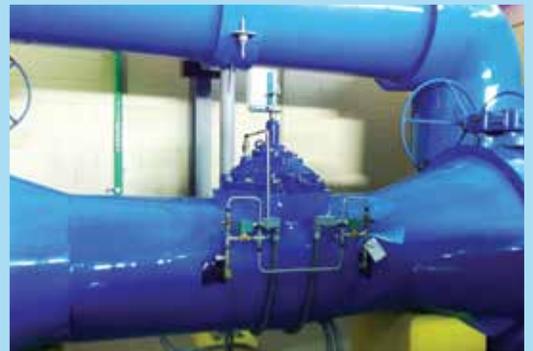
#### SINGER VALVE INSTALLATION

2SC-PCO-AC Model
