CASE STUDY

DATA CENTER, NORTHERN VIRGINIA

Expedited, rigorous mock-up testing verifies design and pressure drop calculations for massive noise control solution.

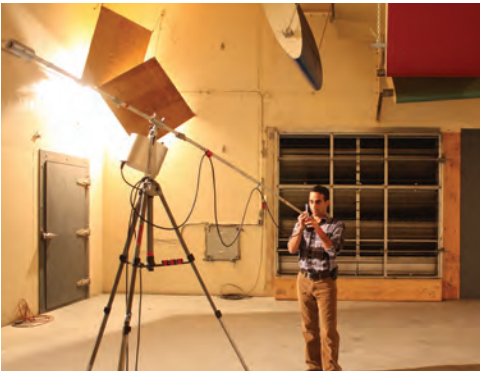
3. **Fully witnessed system sound transmission loss test** to measure the sound transmission loss of the entire system.

To test the design, Vibro-Acoustics performed the following: 1. Computational Fluid Dynamics (CFD) analyses, 2. Fully witnessed system aerodynamic pressure drop test, 3. Fully witnessed system sound transmission loss test, 4. Finite Element Analysis (FEA). (See right)

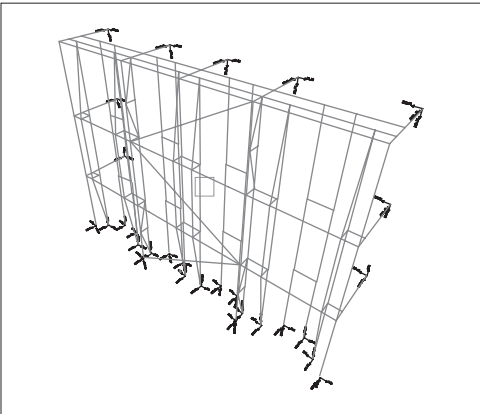
4. **Finite Element Analysis (FEA)** to evaluate structural capacity, ensuring the solution would withstand 150 mph winds.

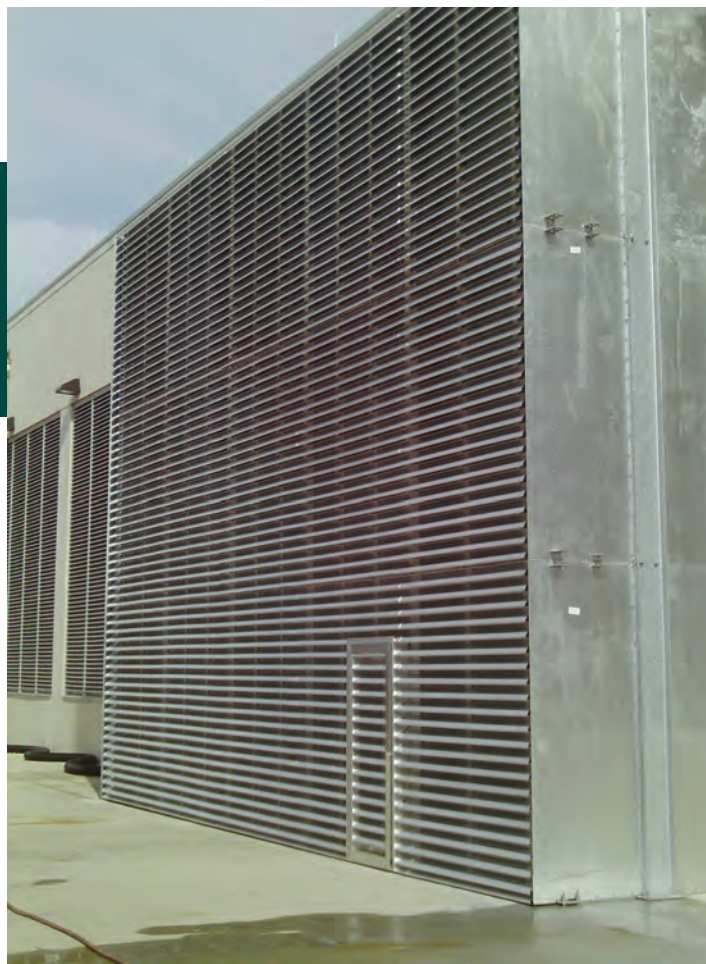
Right: On-site installation of the verified noise control solution

After successfully completing all four tests, Vibro-Acoustics then proceeded to implement the solution on one of the 11 bays of the data center's generator room. With site dimensions gathered, the damper, acoustic louvers, baffles, structural steel and storm louver were all manufactured simultaneously to meet the tight delivery requirements. Vibro-Acoustics overcame all obstacles and managed to provide the solution on time with the added benefit of single-source responsibility.

On top of supplying the noise control solution with detailed installation instructions, Vibro-Acoustics also sent a team of engineers on-site to supervise the installation of the solution on the 11 bays.
