# Failure Analysis of World Trade Center 5

Kevin J. LaMalva

Simpson Gumpertz & Heger, Inc.

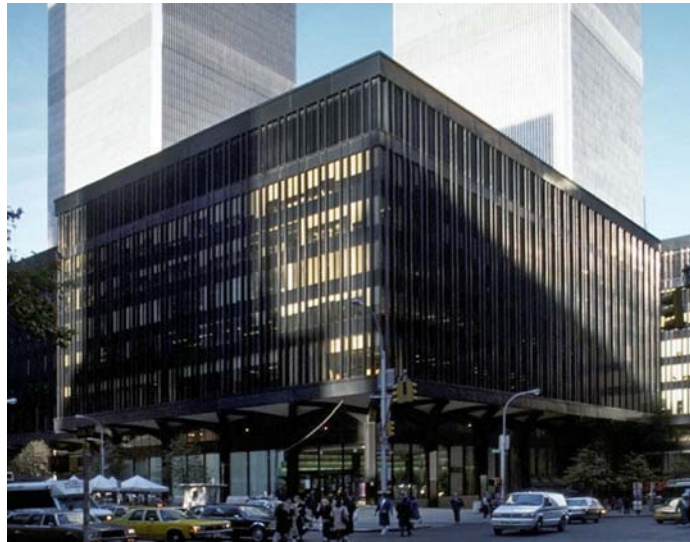
**Figure 1. Exterior View of WTC 5.**

World Trade Center 5 (WTC 5) was a nine-story building in the World Trade Center complex in New York City, NY (Figure 1). On September 11, 2001, flaming debris from the World Trade Center Tower collapses ignited fires in WTC 5. These fires burned unchecked, ultimately causing a localized interior collapse from the 8<sup>th</sup> floor to the 4<sup>th</sup> floor in the eastern section of the building (Figure 2). Debris impact was not a direct factor in this failure; the collapse was caused by fire alone.

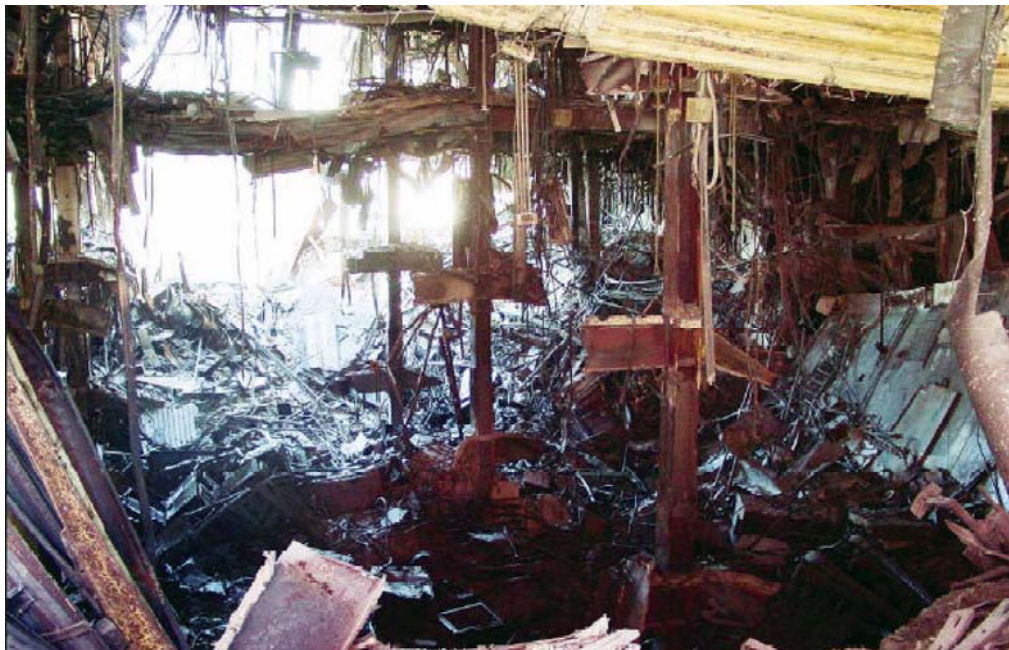
Forensic evidence suggests that the collapse occurred during the heating phase of the fire. The columns remained straight and freestanding after the collapse (Figure 2), suggesting that the girders never developed catenary action that would have pulled columns inward, particularly as the girders cooled late in the fire. In general, the timing of this failure (early in the fire when occupants and firefighters could be in the building and therefore at great risk) is not typical for steel structures.

**Figure 2. Internal Collapse Area in WTC 5 (World Trade..., 2002).**
