BELL ADDITIVES MIX-I-GO (MXO) GAS TREATMENT TEST MAY 1985 TOWNSVILLE COLLEGE OF TECHNICAL AND FURTHER EDUCATION

This test was undertaken at the Townsville College of T.A.F.E. to provide an accurate comparison of results on a locally manufactured engine, before and after treatment with Mix-I-Go gas treatment under Australian conditions.

We obtained an H.Q. Holden 202 C.I.D. engine with sufficient kilometerage to represent normal wear and combustion chamber deposits.

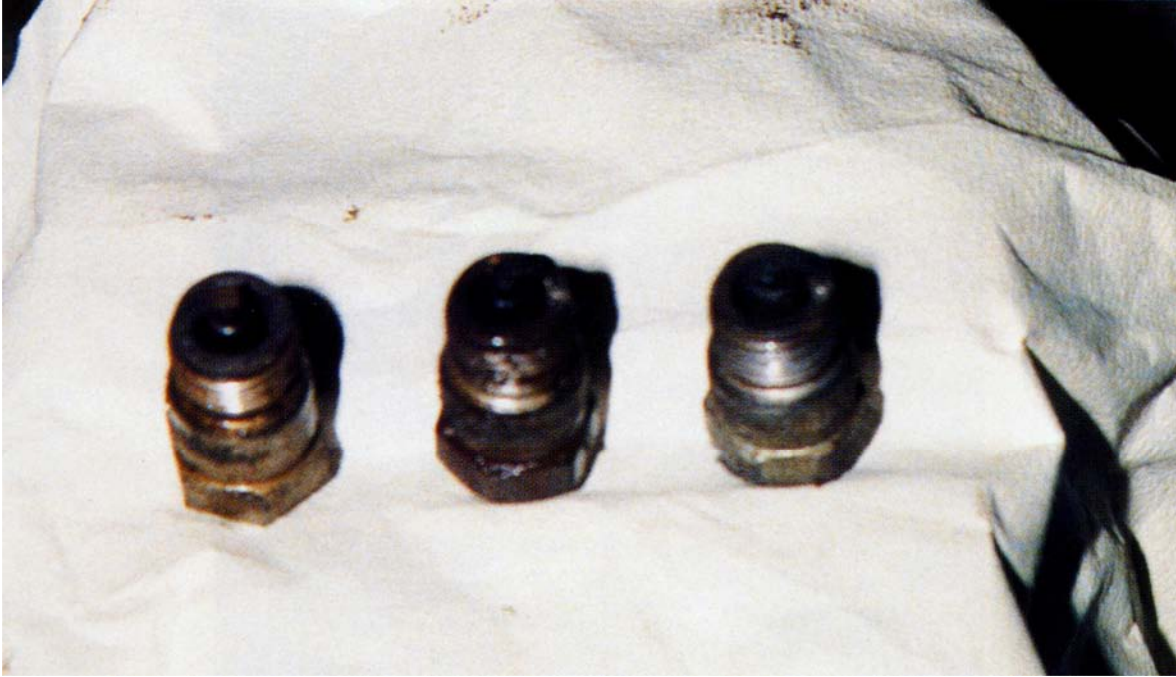
Photograph 5 – Spark Plug Deposits - Before

The spark plugs were photographed, and were found to be coated with heavy black deposits.

At the start of the test the spark plugs were black and oily (photograph 5), and attachment sheet 1 shows the Computer printout recording 16.5 KV to fire the spark plugs. This is twice the ideal voltage, and could result in misfiring under load, and increased strain on the electrical system and insulation.

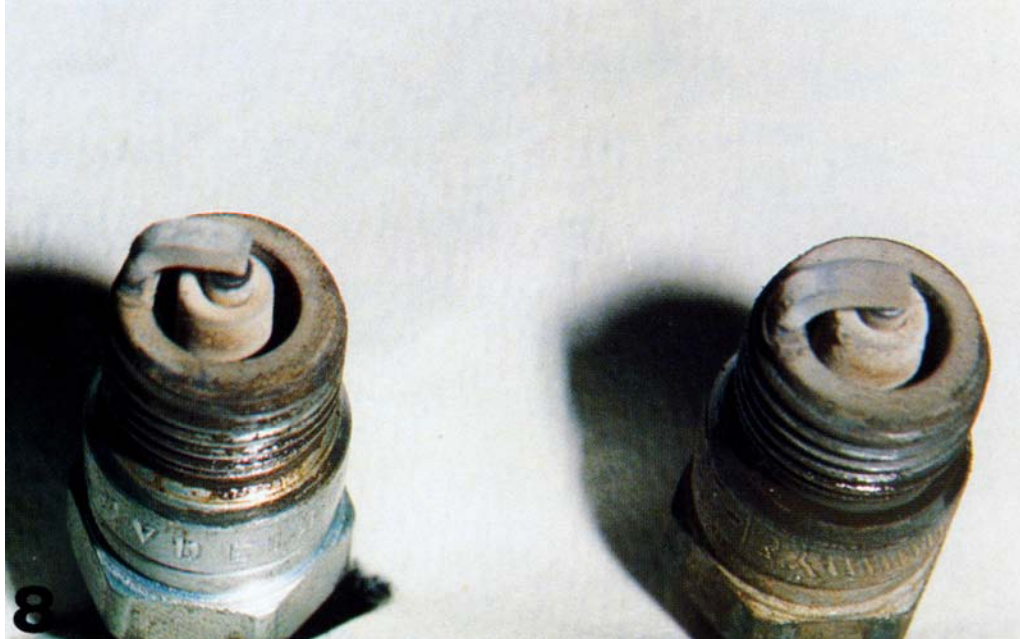
Photograph 8 – Spark Plugs - After

At the end of the test the spark plugs were clean and coated with a grey/white powder (photograph 8).
